Phytotechnology Studies for Passive Groundwater Management at a Closed Waterfront Landfill: Lessons Learned

Steven Rose,
Malroz Engineering Inc.

Third international Phytotechnologies Conference
Atlanta, Georgia
April 20-22, 2005

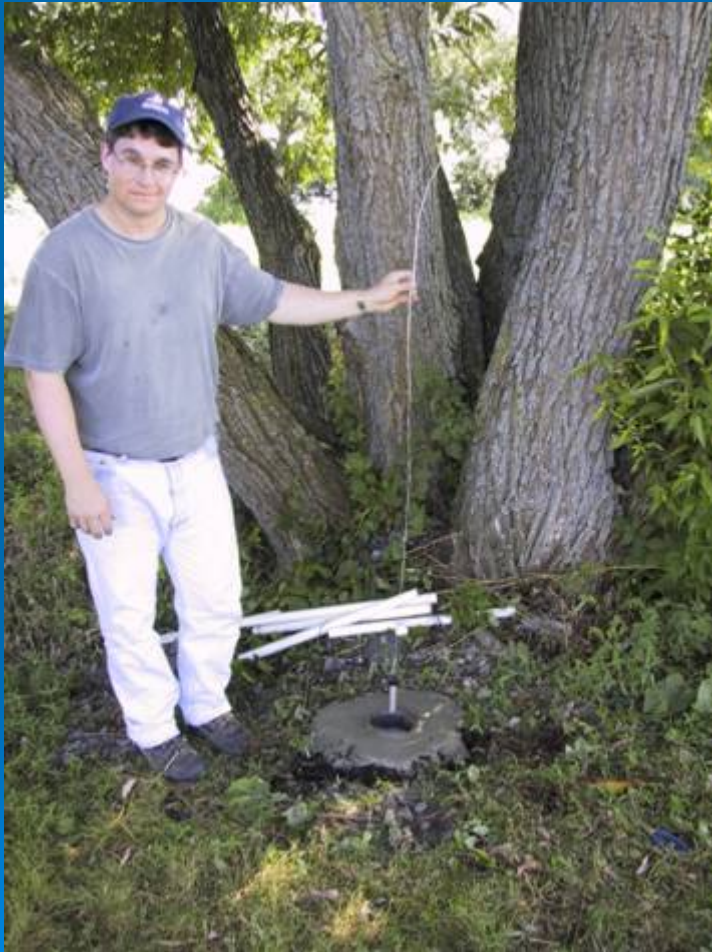
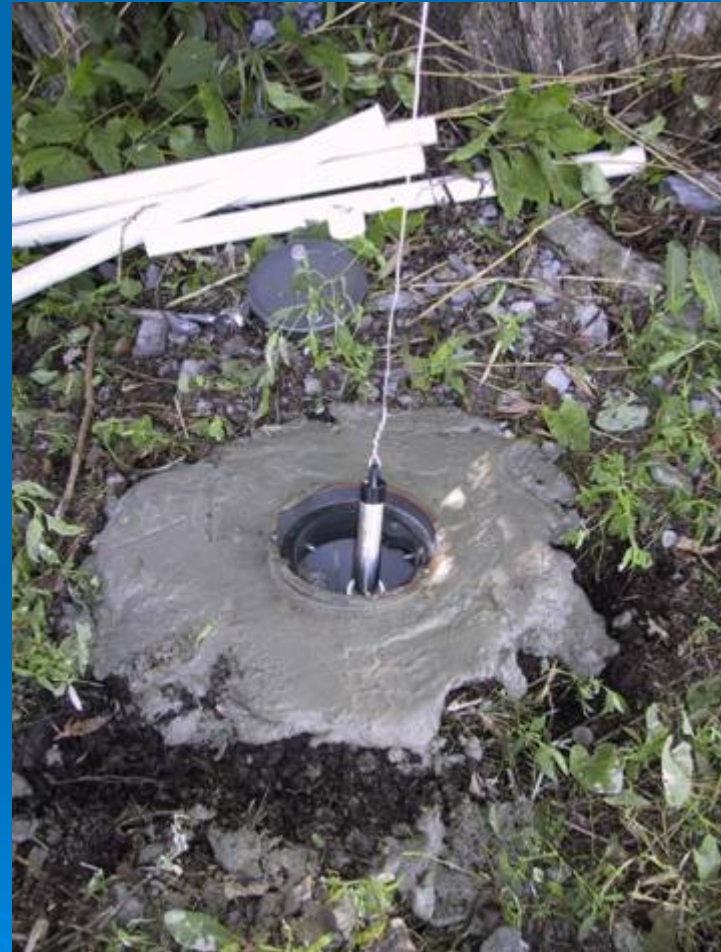
Monitoring Well with LeveLogger

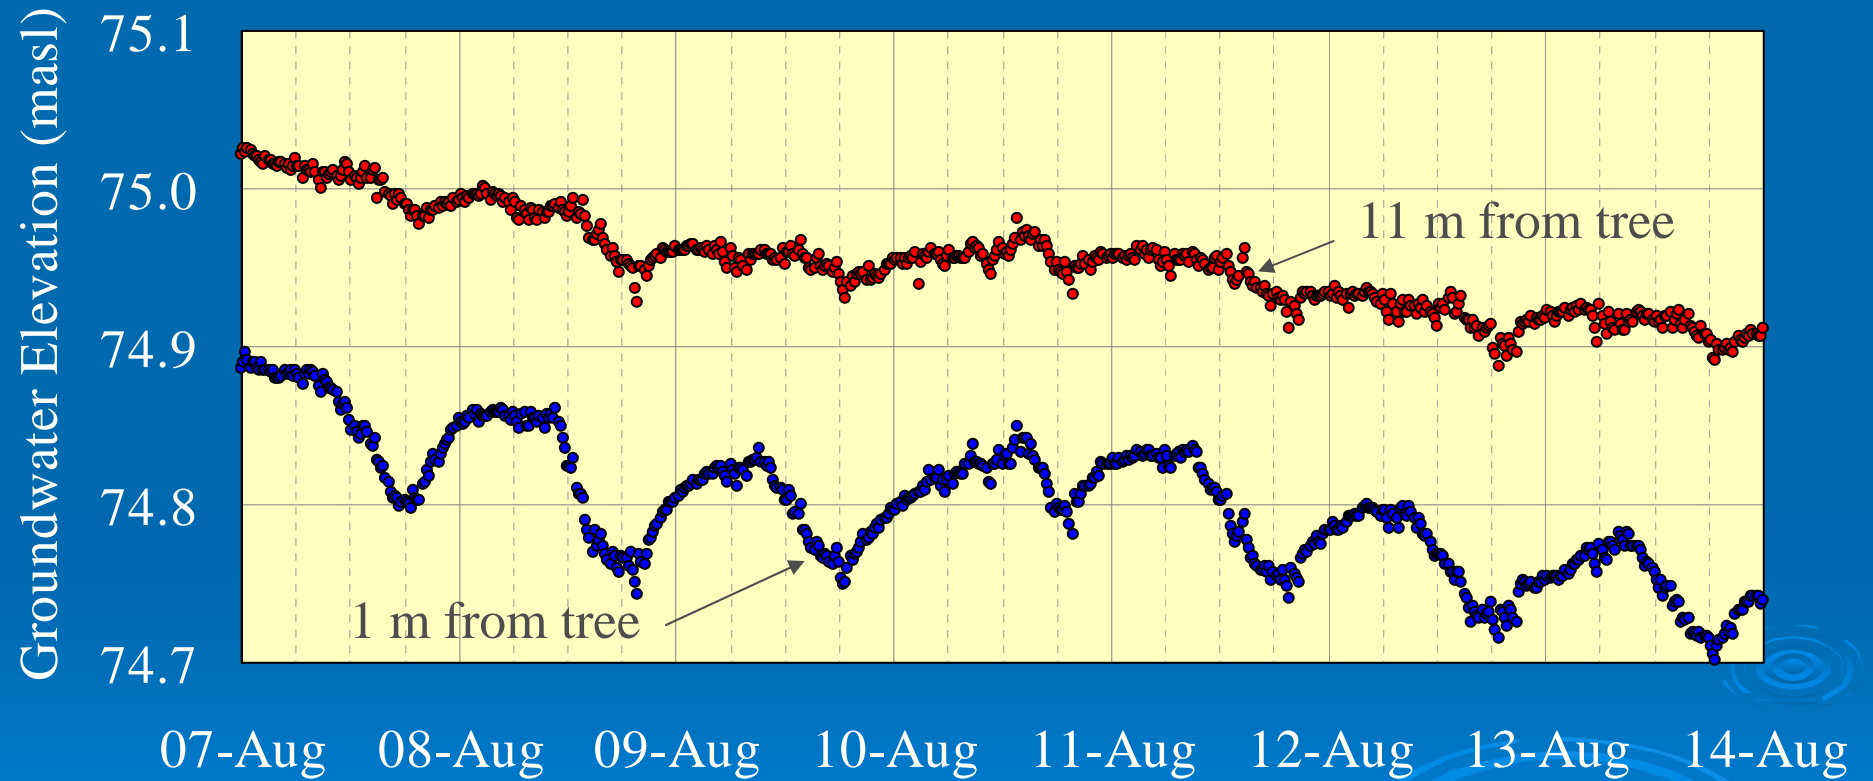
Water Level Fluctuations

➤ Groundwater Fluctuations:

- diurnal patterns (but not in May)
- numerical modelling ~20,000 L/day
(appears to violate theoretical maximum)
- order of magnitude discrepancy with sap flow measurements

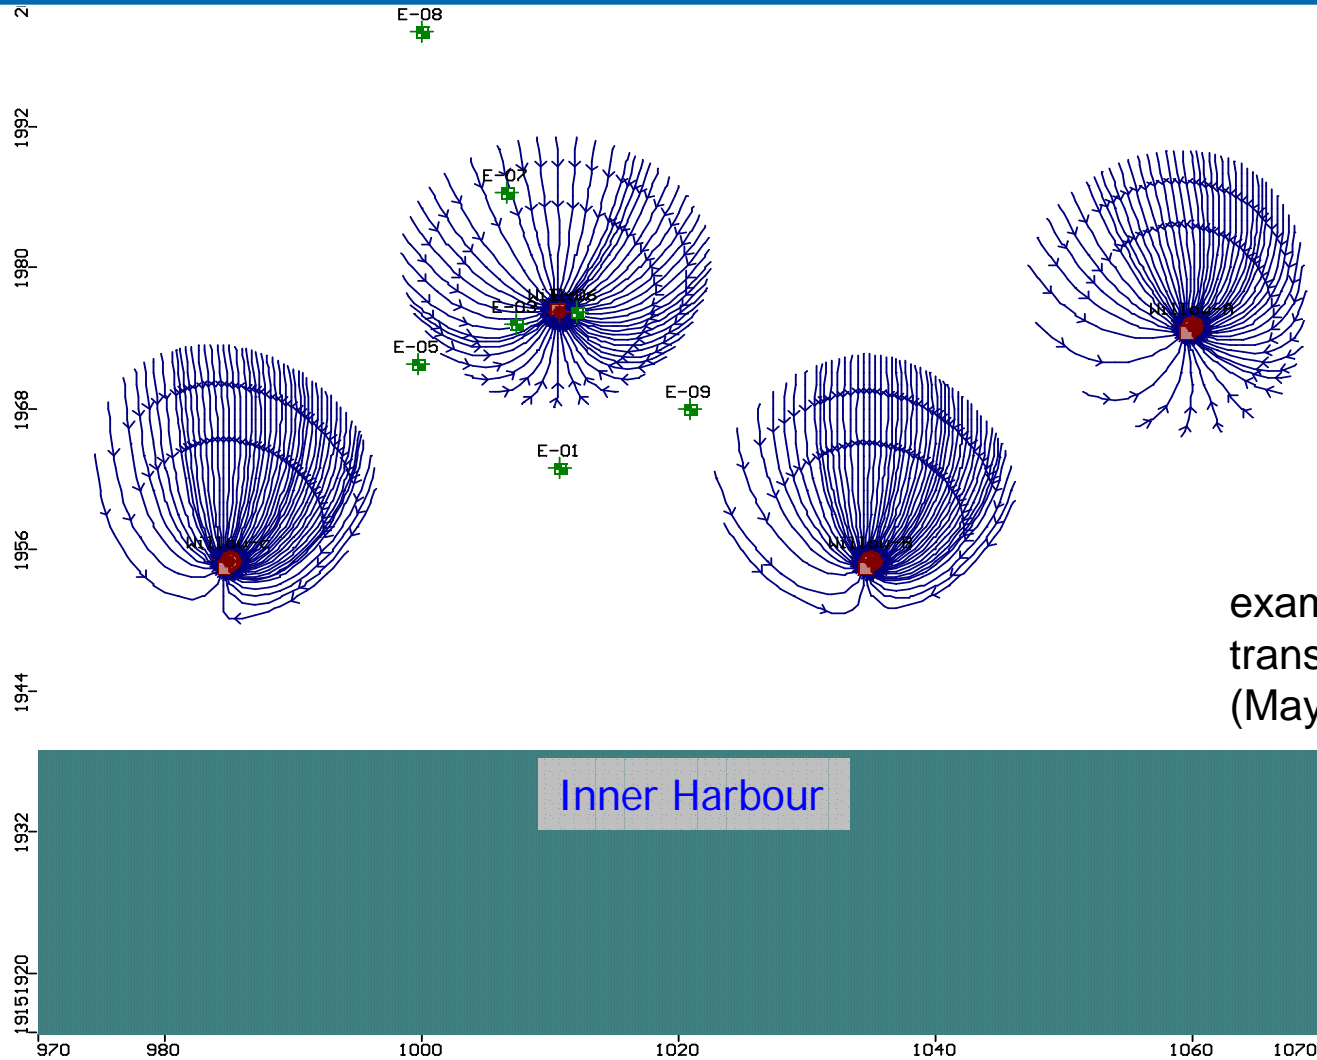
90-Day Capture Zone Analysis
