Cosolvent Flushing and Enhanced Bioremediation at a Dry Cleaner Site

Michael D. Annable

Department of Environmental Engineering Sciences

Sages Dry Cleaner Site Jacksonville, Florida

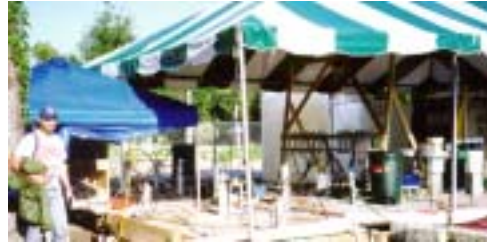
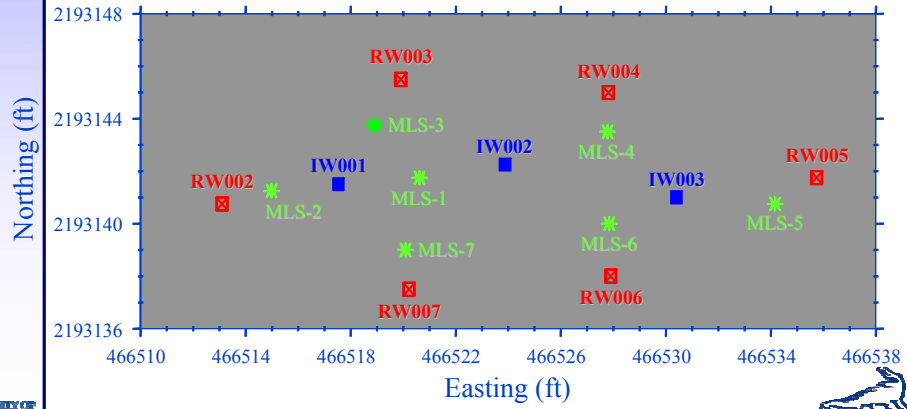
Sages Site

- Dry Cleaner PCE source zone
- 8 to 9.5 m below ground surface
- 7 m long by 3 m wide
- Performance based cores and tracers

- 3 Injection Wells (IWs)
- 6 Recovery Wells (RWs)
- 7 Multi-Level Samplers (MLSs)

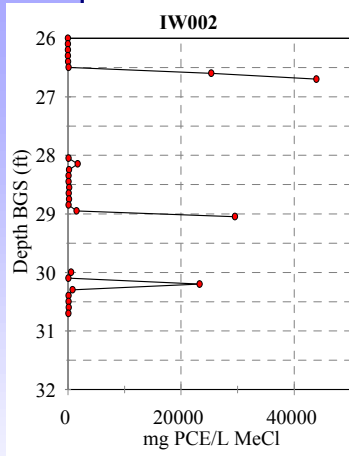
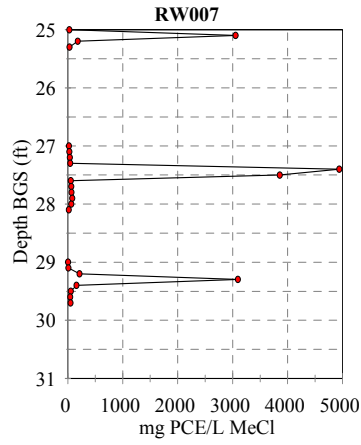
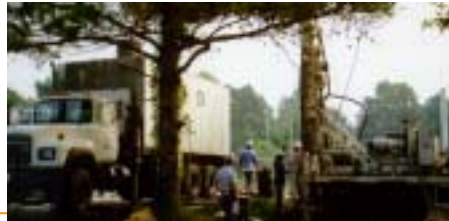
High Frequency Soil Sampling at Sages

Thin lenses of
DNAPL on
minor
permeability
contrasts

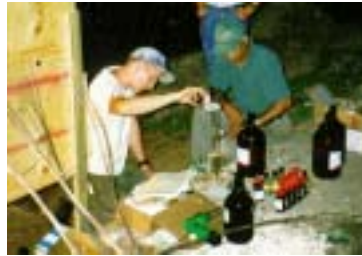
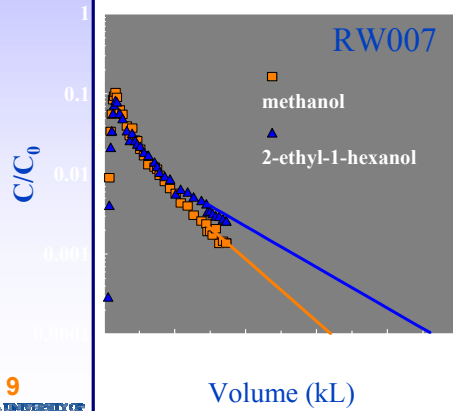
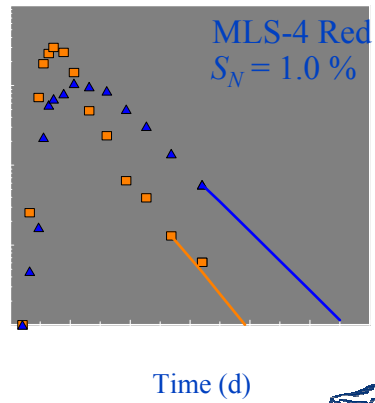
Sages Site

Partitioning Tracer Test:

$$S_N = 0.26 \%$$

$$V_{PCE} \approx 50 \text{ L}$$

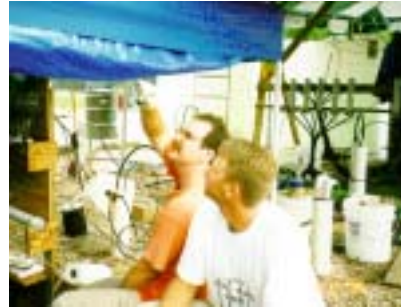
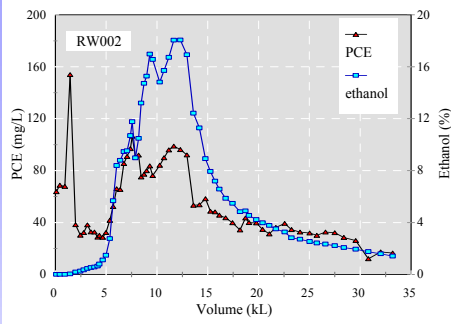
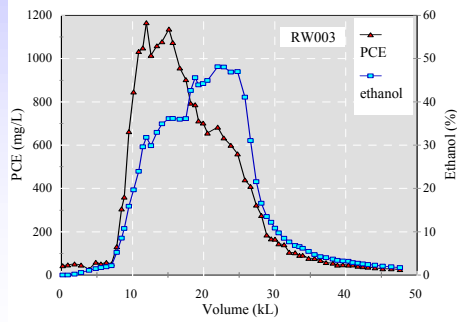
Cosolvent Flushing

**Total PCE
Removed**
67.4 kg
41.5 L

Cosolvent Extraction:
43 L PCE Removed (Mass Recovery)
~63 % PCE Removed (Partitioning Tracer)
65% Removal based on Soil Core Data

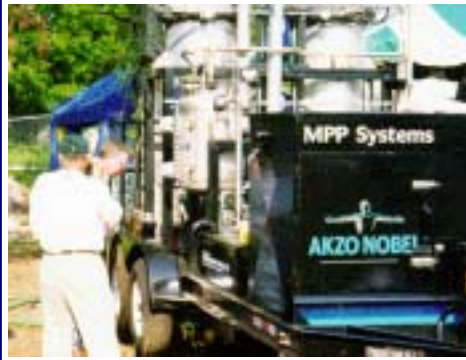
Waste Treatment:
Air Stripping
Macro Porous Polymer (MPP)

Trailer-mounted MPP system

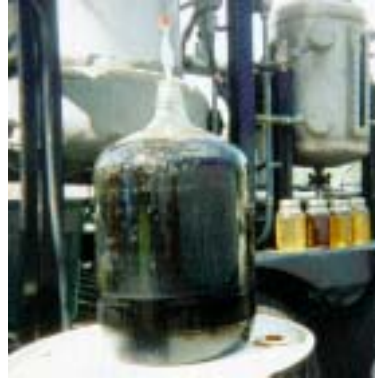
PCE recovered from effluent

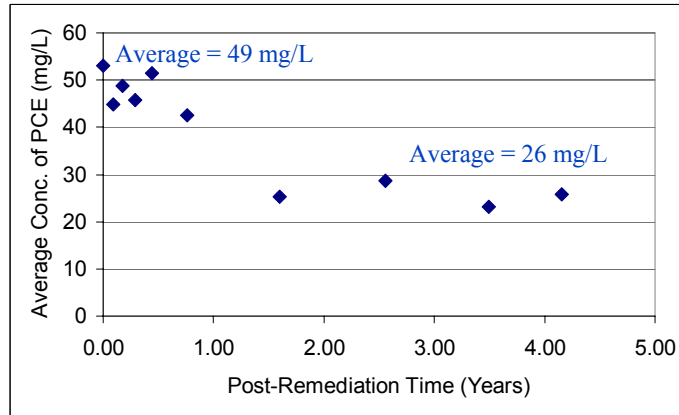
Concentration (or Flux) Reduction in the Source Zone

Mass Reduction = 64% : Flux Reduction = 47%
n = 35 sampling locations

47% reduction in PCE concentration in
the source zone multilevel sampler network

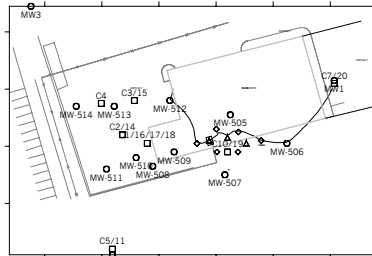
Pre-Ethanol Flush (with Day 29 data)

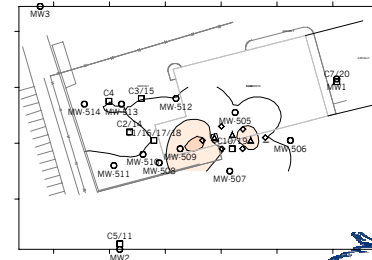
~4 Months Post-Flush

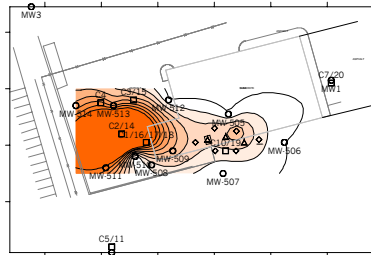
cis-DCE

~25 Months Post-Flush

Significant increase in *cis*-DCE mass

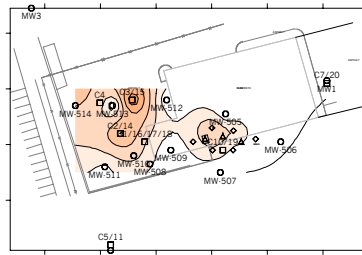
~28 Months Post-Flush

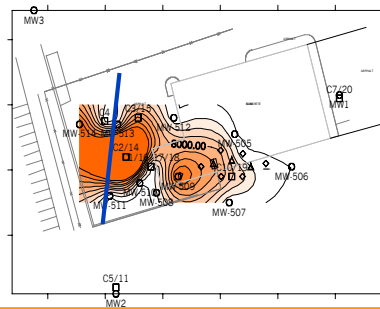
~31 Months Post-Flush

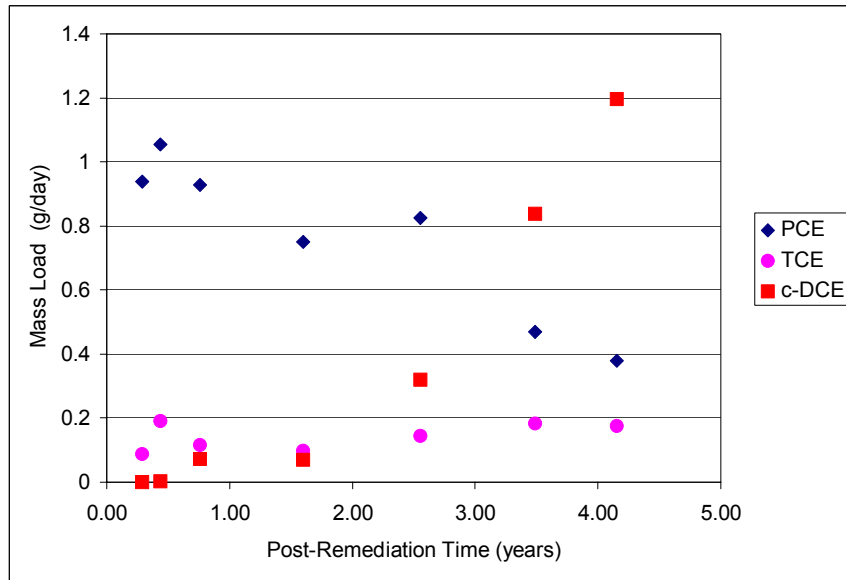
Next look at flux
across a multilevel
sampler transect

Total Plume Mass Load

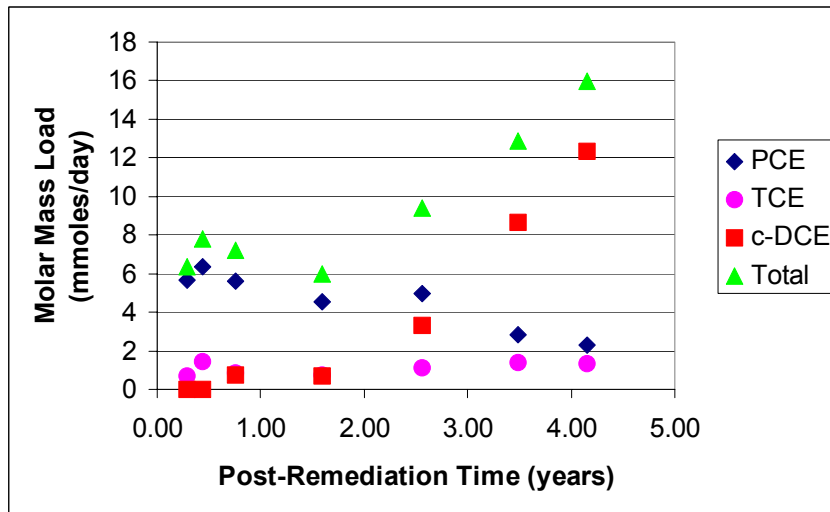
Molar Based Total Load

Increased mass flux caused by enhanced dissolution?
