The New Normal – Planning for Sediment Project Water Management Considering Climate Change

Cannon Silver, PE

**CDM
Smith**

OCTOBER 26-28, 2020

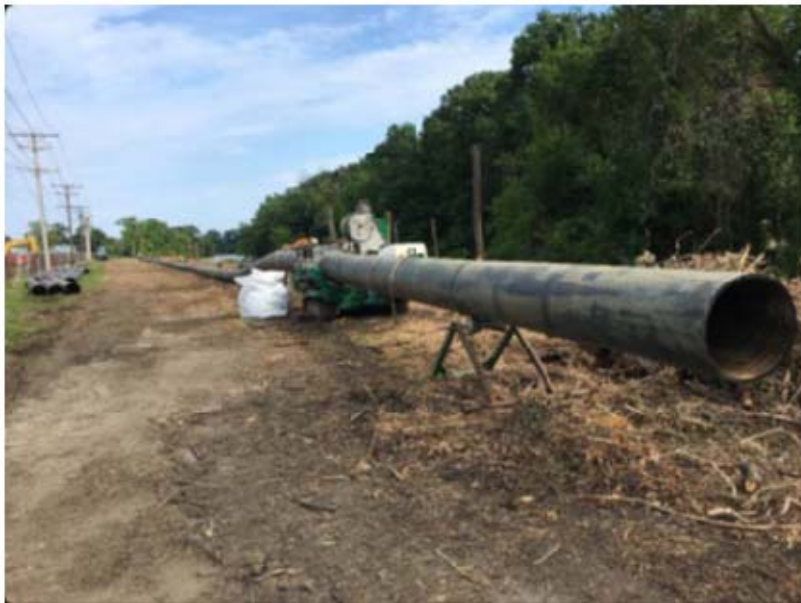
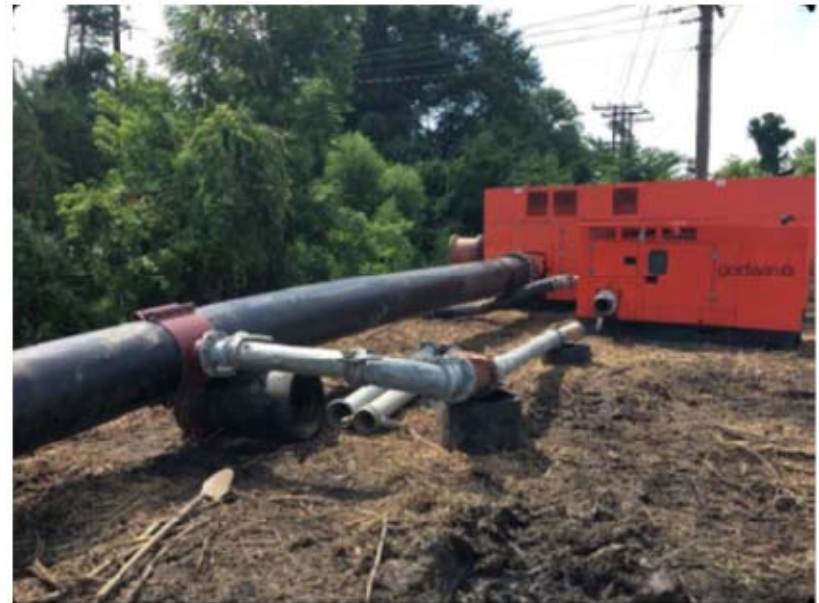
Bypass Pump Around System

- State regulations required sufficient capacity to convey 2-year (24-hour precipitation event) flows
 - Equates to 3.3 inches precipitation, or 20 cubic feet per second [cfs]
- Pumping equipment **over-designed** to handle 10-year storm
 - Added redundant pumping system to accommodate total of 5.1 inches precipitation, or 30 cfs

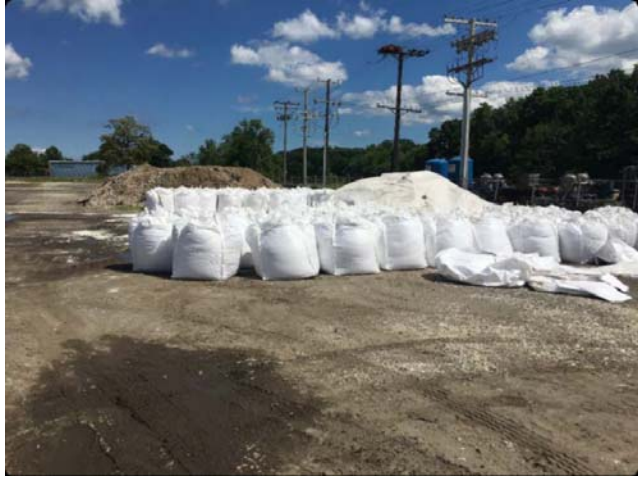
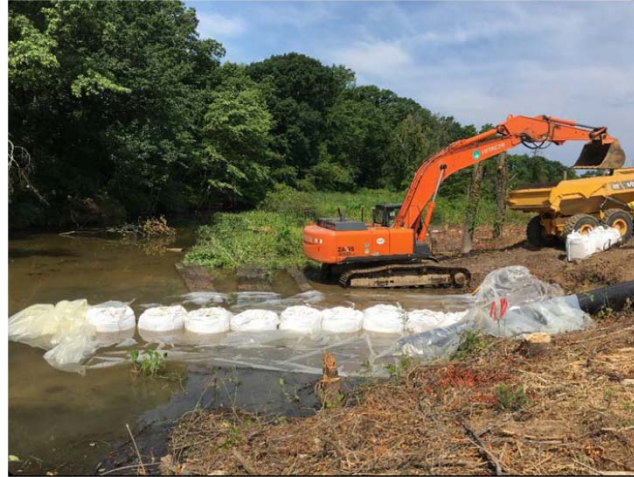
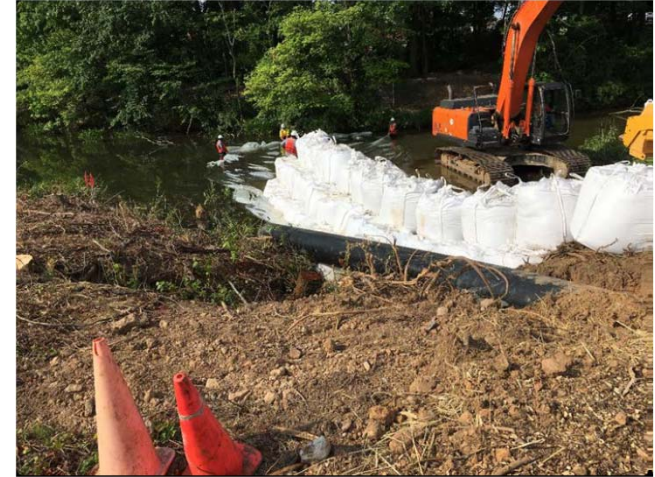
Dam System

- Dams used in conjunction with bypass pump-around system to create dry working conditions
- Dam heights designed for **2-year flow event**
 - Included 1-foot freeboard

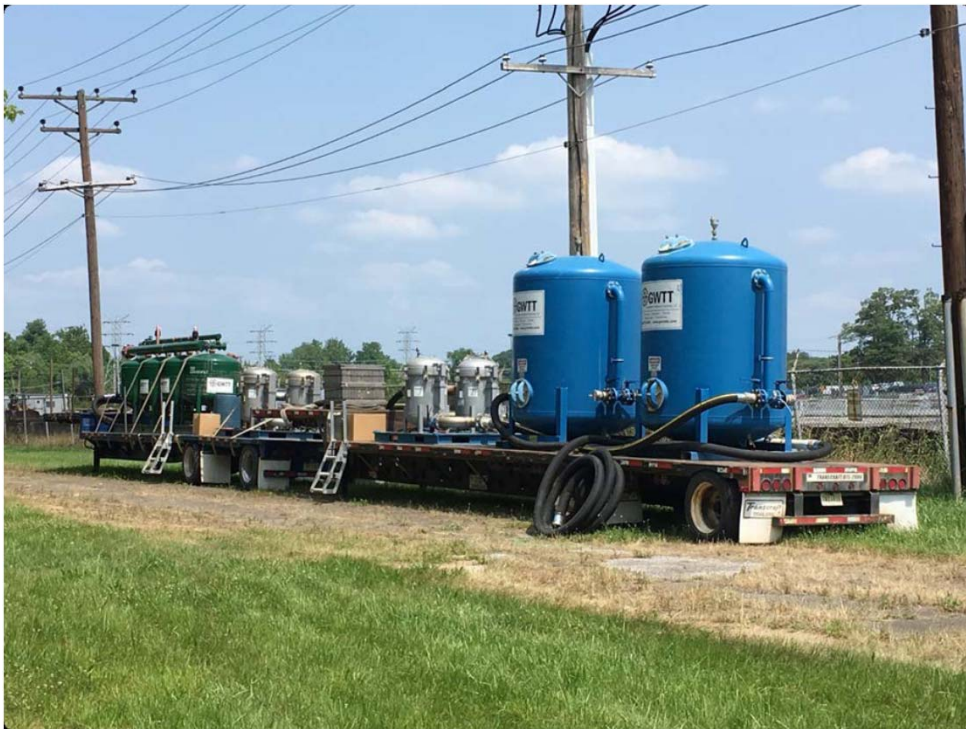
Water Treatment System

- Frac tank, sand filter unit, bag filters and 5000-lbs of activated carbon filters
- Design capacity 300 gallons per minute
 - <1 cfs
