American Cyanamid Superfund Site

Climate Change Adaptation Webinar 4/1/2015 cluin.org

Hurricane Irene Summary

Impacts on Impoundments 1 & 2

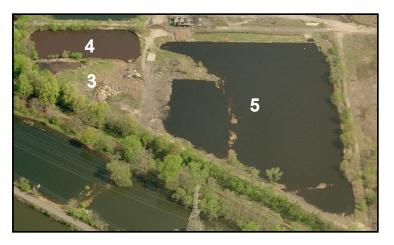
Impoundments 3, 4 and 5

Maximum concentrations of 36 ppm (benzene), 240 ppm

(naphthalene), 75 ppm (nitrobenzene) and 30ppm (1,2-DCB)

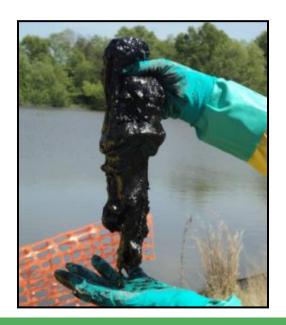
Impoundments 1 & 2

- Approx 2 acres each, 13-16 feet deep (about 6 feet below grade)
- Located outside of flood control berm (700 feet from Raritan River)
- Heterogeneous acid tar byproduct from refining coal light oil
 - Hard crumbly & viscous tarry layers
- PH ranges from 0.56 to 12.83
- Elevated VOCs and SVOCs, particularly
 BTEX and naphthalene
- Maximum benzene concentration of 207x10⁶ ug/kg (20.7%)

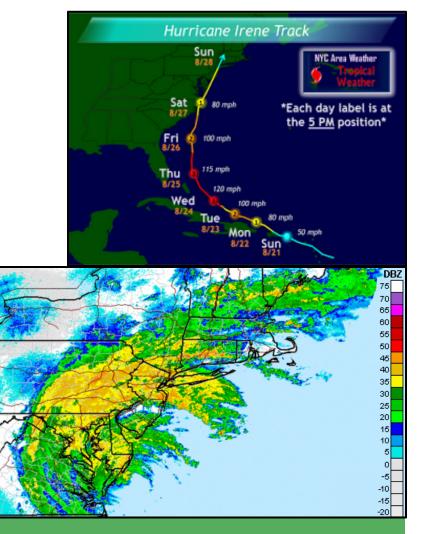
Impoundments 1 & 2 Area (Looking SW)

- Preceded by wet conditions (8"-16" of rainfall in the 3 weeks prior)
- NJ Governor declared state of emergency on Aug 25, 2011
- Up to 10" of rain in NJ from Aug 27-28, 2011 (Over 7" at site)
- Over 4M without power along East Coast
- All 21 NJ counties designated as a FEMA
 Major Disaster Area

- Post-flood surface water sampling conducted from Aug 29 to Sep 2
- Post-flood berm inspection completed after flood waters receded
- No significant release occurred
 - Some minor tar splatters observed on berm walls

Synthetic liners installed as a cap to reduce the potential for mobilization of waste material

- Berm-reinforcing material installed on the exterior slopes of impoundments 1 and 2 to increase the strength of the berms and prevent scour during future flood events
 - Completed in October 2013
 - Can withstand water velocities in excess of 8ft/s
- Pilot study scheduled outside of hurricane season

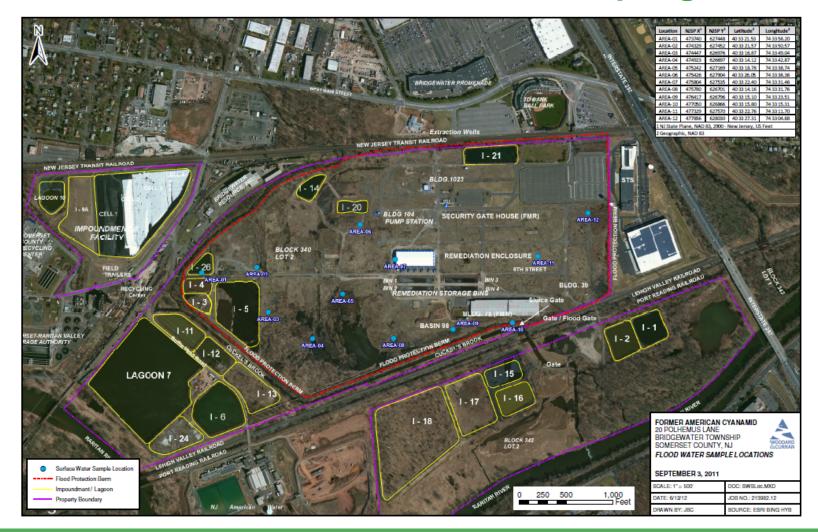
Post-Flood Surface Water Sampling

Generator-powered pumps used to controllably discharge 152M gallons of flood water to Cuckel's Brook by Sept 28

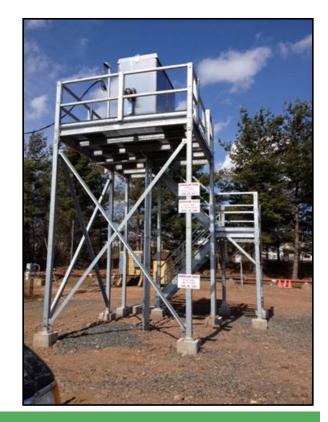
- 214 M gallons of standing water within North Area (5 ft high)
- Sluice gate for drainage of flood water concreted and dismantled
- Flood control berm, office trailers and records damaged
- No electrical power
- Groundwater extraction system to maintain hydraulic control in North Area did not operate for 30 days (no electricity or submersible pumps)

- Office trailers relocated out of the floodplain
- Flood control berm repaired and armored
- All electrical instrumentation re-constructed 5 feet higher than Hurricane Irene levels
- Submersible pumps installed in the two bedrock groundwater extraction wells so that hydraulic control can be maintained throughout a flood event.
