EPA-540-R-013-018

**Optimization Review**  
**Valley Park TCE Superfund Site**  
**Valley Park, Missouri**

Report of the Optimization Review  
Site Visit Conducted at the Valley Park TCE Superfund Site on  
24 January 2013

Final  
4 June 2013

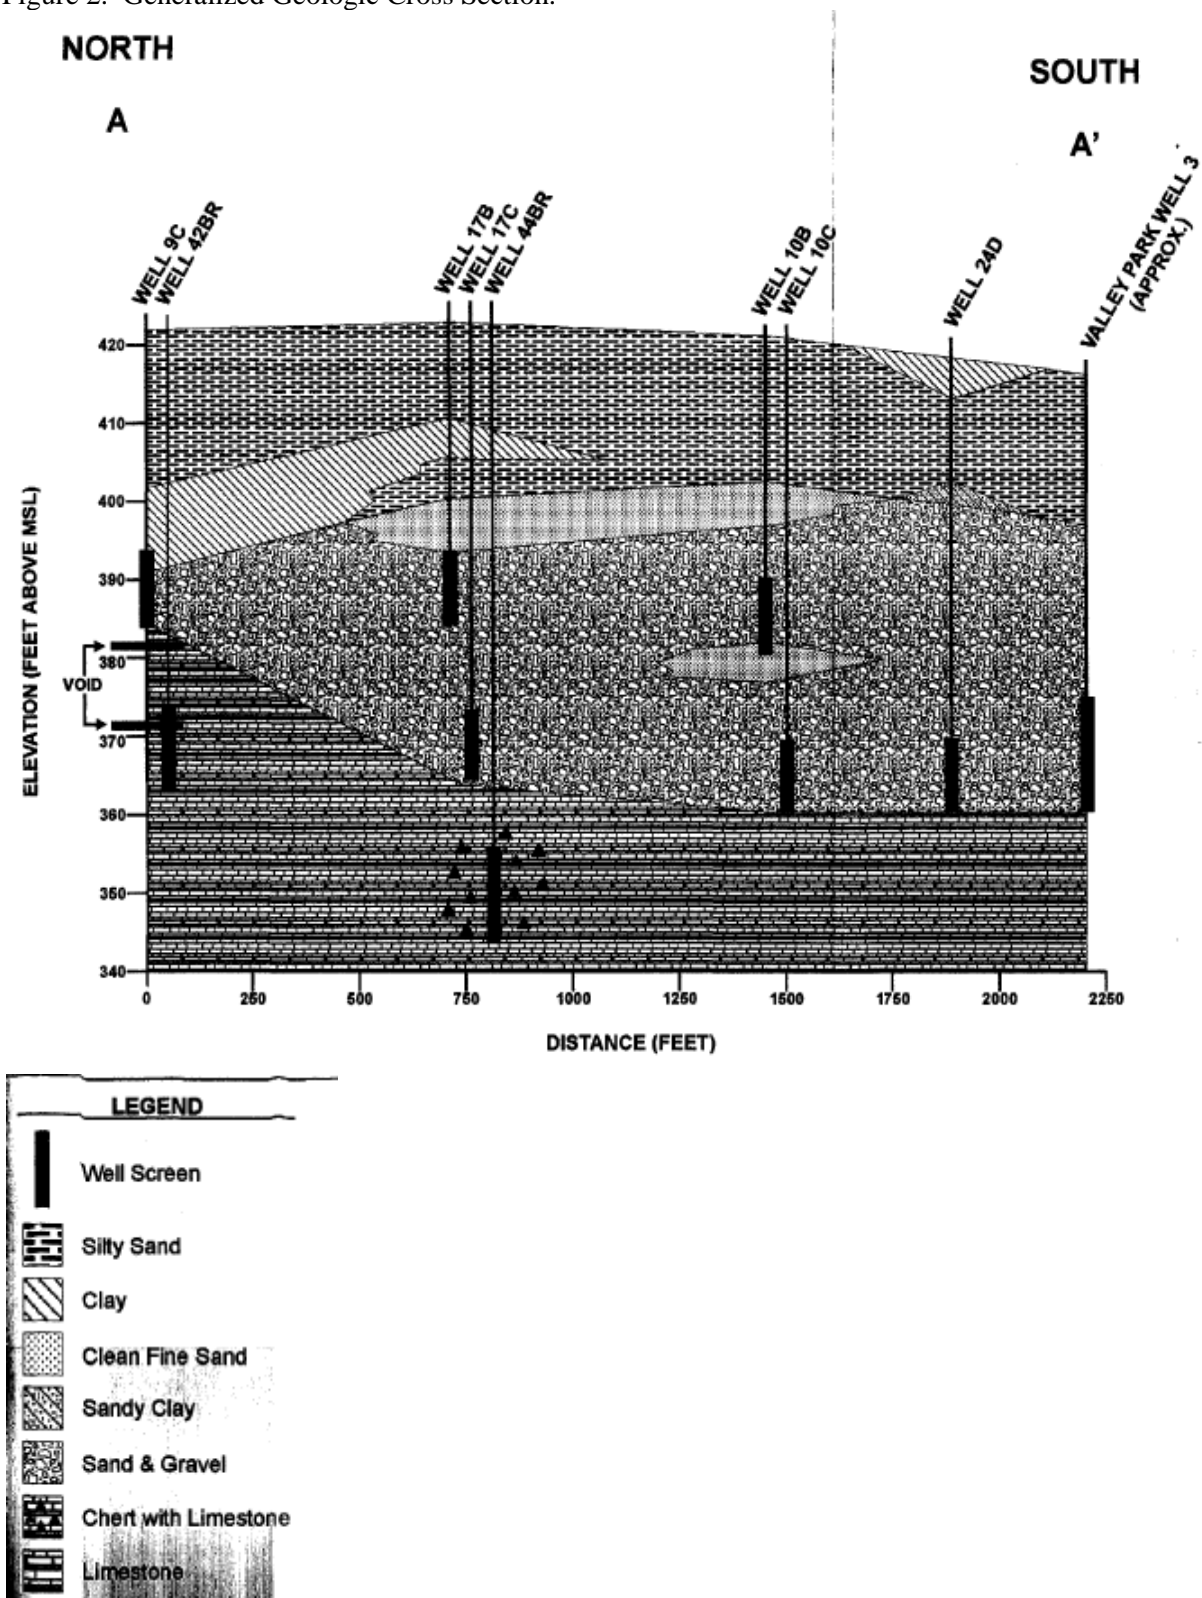
Figure 2. Generalized Geologic Cross Section.

The Valley Park TCE Superfund site is located on the floodplain of the Meramec River and the site soils represent alluvial deposits. These deposits consist of silty clay materials (with some intervals of fine sands) from near the surface to a depth of approximately 20 feet. These materials are often moist with relatively low hydraulic conductivities of less than 1E-6 cm/sec (0.003 feet per day [ft/day]). Coarse materials, including sand to coarse gravels are found below the silty clay from a depth of about 20 feet to bedrock of the Burlington-Keokuk Limestones at depths of around 60 feet (Ecology & Environment, 2001). A geologic cross section is provided as Figure 2. The coarse materials represent a significant source of water for the surrounding area and have estimated hydraulic conductivities of over 300 feet/day

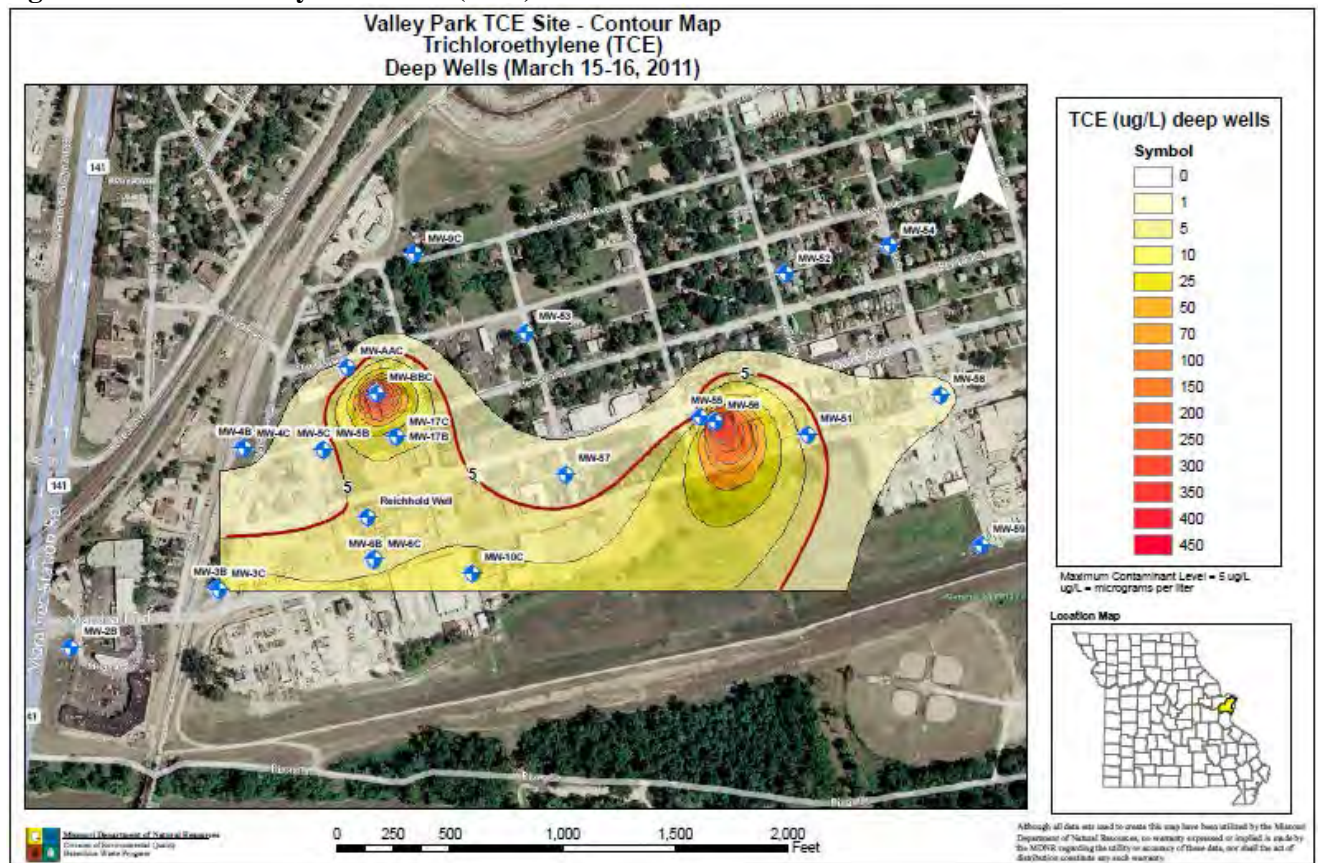
**Figure 4. Trichloroethylene Plume (2011)**

Since the start-up of the ground water remedy at the Valley Technologies site, volatile organic compound (VOC) concentrations were detected above Maximum Contaminant Levels (MCLs) at on-site wells MW-55 and -56 as well as off-site deep wells MW-3C, MW-6C, MW-10C, MW-17C, MW-51, and MW-57. High concentrations of contaminants were also found at the Wainwright site in monitoring well MW-BBC. Low detections near or just above the MCLs were found in the shallow wells near the Wainwright site. The VOCs detected above MCLs generally were TCE, PCE, cis-1,2DCE, and vinyl chloride. Maximum concentrations were observed in MW-56 at the Valley Technologies site where the maximum concentrations were: TCE – 2,110 ug/L and cis-1,2DCE – 2,640 ug/L, both in February 2010. Maximum concentrations were observed in MW-BBC at the Wainwright facility where the maximum concentrations were: PCE – 416 ug/L, TCE - 2,150 ug/L and cis-1,2DCE - 1,800 ug/L, all in April 2008. PCE is much more common near the Wainwright site. The most comprehensive recent ground water sampling event occurred in March 2011. Figures 3 and 4 present contours of PCE and TCE, respectively from that round. The ground water plume is defined to the north and east, but has not recently been defined to the south and west. Presumably, the contamination does not extend west of the inactive Valley Park municipal wells or south of the Meramec River.

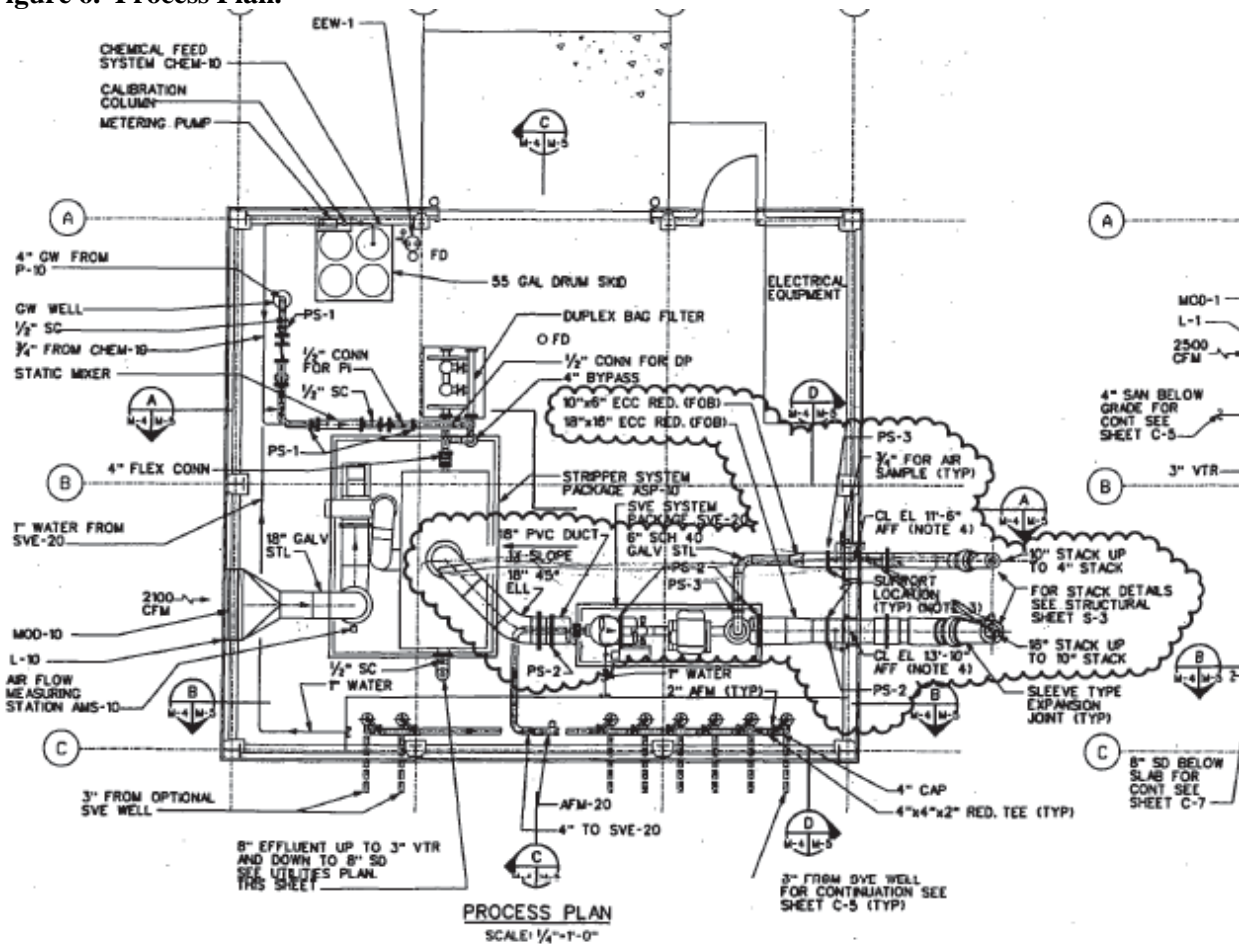
Figure 6. Process Plan.

Installation and testing of the ground water extraction and treatment system (GETS) was completed in summer of 2006, with the Operational and Functional phase starting in August 2006. The GETS includes one extraction well located in the treatment plant and employs a low profile air stripper (Carbonair Model STAT-400 with six trays) to remove VOCs from the extracted groundwater. Bag filters are used to remove particulates before the water enters the air stripper. A chemical feed system is used to feed anti-scalant chemical into the water. After it passes thru the air stripper, the water is discharged to a storm sewer that conveys the treated water to the river. Figure 6 provides a process flow diagram of the treatment system.

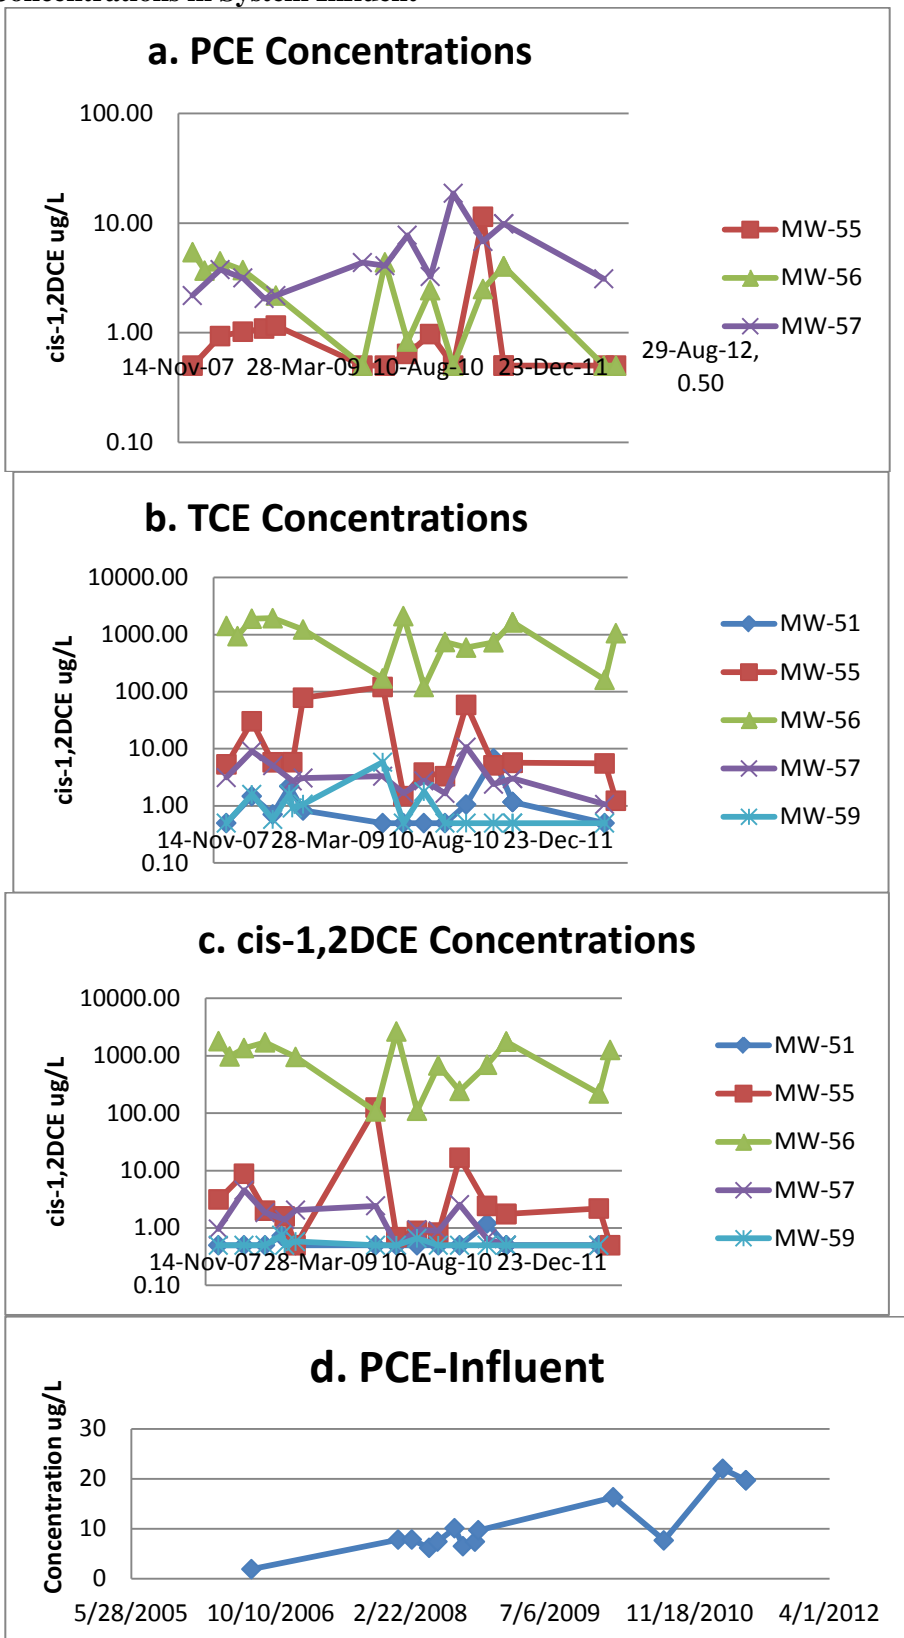
**Figure 7. Concentrations of PCE, TCE, and cis-1,2DCE in Key Monitoring Wells and PCE Concentrations in System Influent**

The other component of the assessment was the analysis of the response of the contaminant concentrations to pumping. The TCE and 1,2-cisDCE concentrations in MW-51, located downgradient of the Valley Technologies site, are not increasing and are relatively low and the concentrations in MW-58, even farther downgradient, have declined to non-detectable levels since the extraction system began operation. MW-57, located upgradient of the extraction well appears to show an increasing trend for PCE concentrations, as does the influent to the treatment system, suggesting that the Wainwright PCE plume is being pulled eastward by the extraction at the Valley Technologies site. Concentration trends for PCE, TCE, and cis-1,2DCE in key wells are illustrated on Figure 7a, b, and c, respectively.
