**FIRST FIVE-YEAR REVIEW
FOR THE
MOUNTAIN PINE PRESSURE TREATING SUPERFUND SITE
PLAINVIEW, YELL COUNTY, TEXAS**

September 2010

FIRST FIVE-YEAR REVIEW REPORT
Mountain Pine Pressure Treating Superfund Site
EPA ID No. ARD049658628
Plainview, Yell County, Arkansas

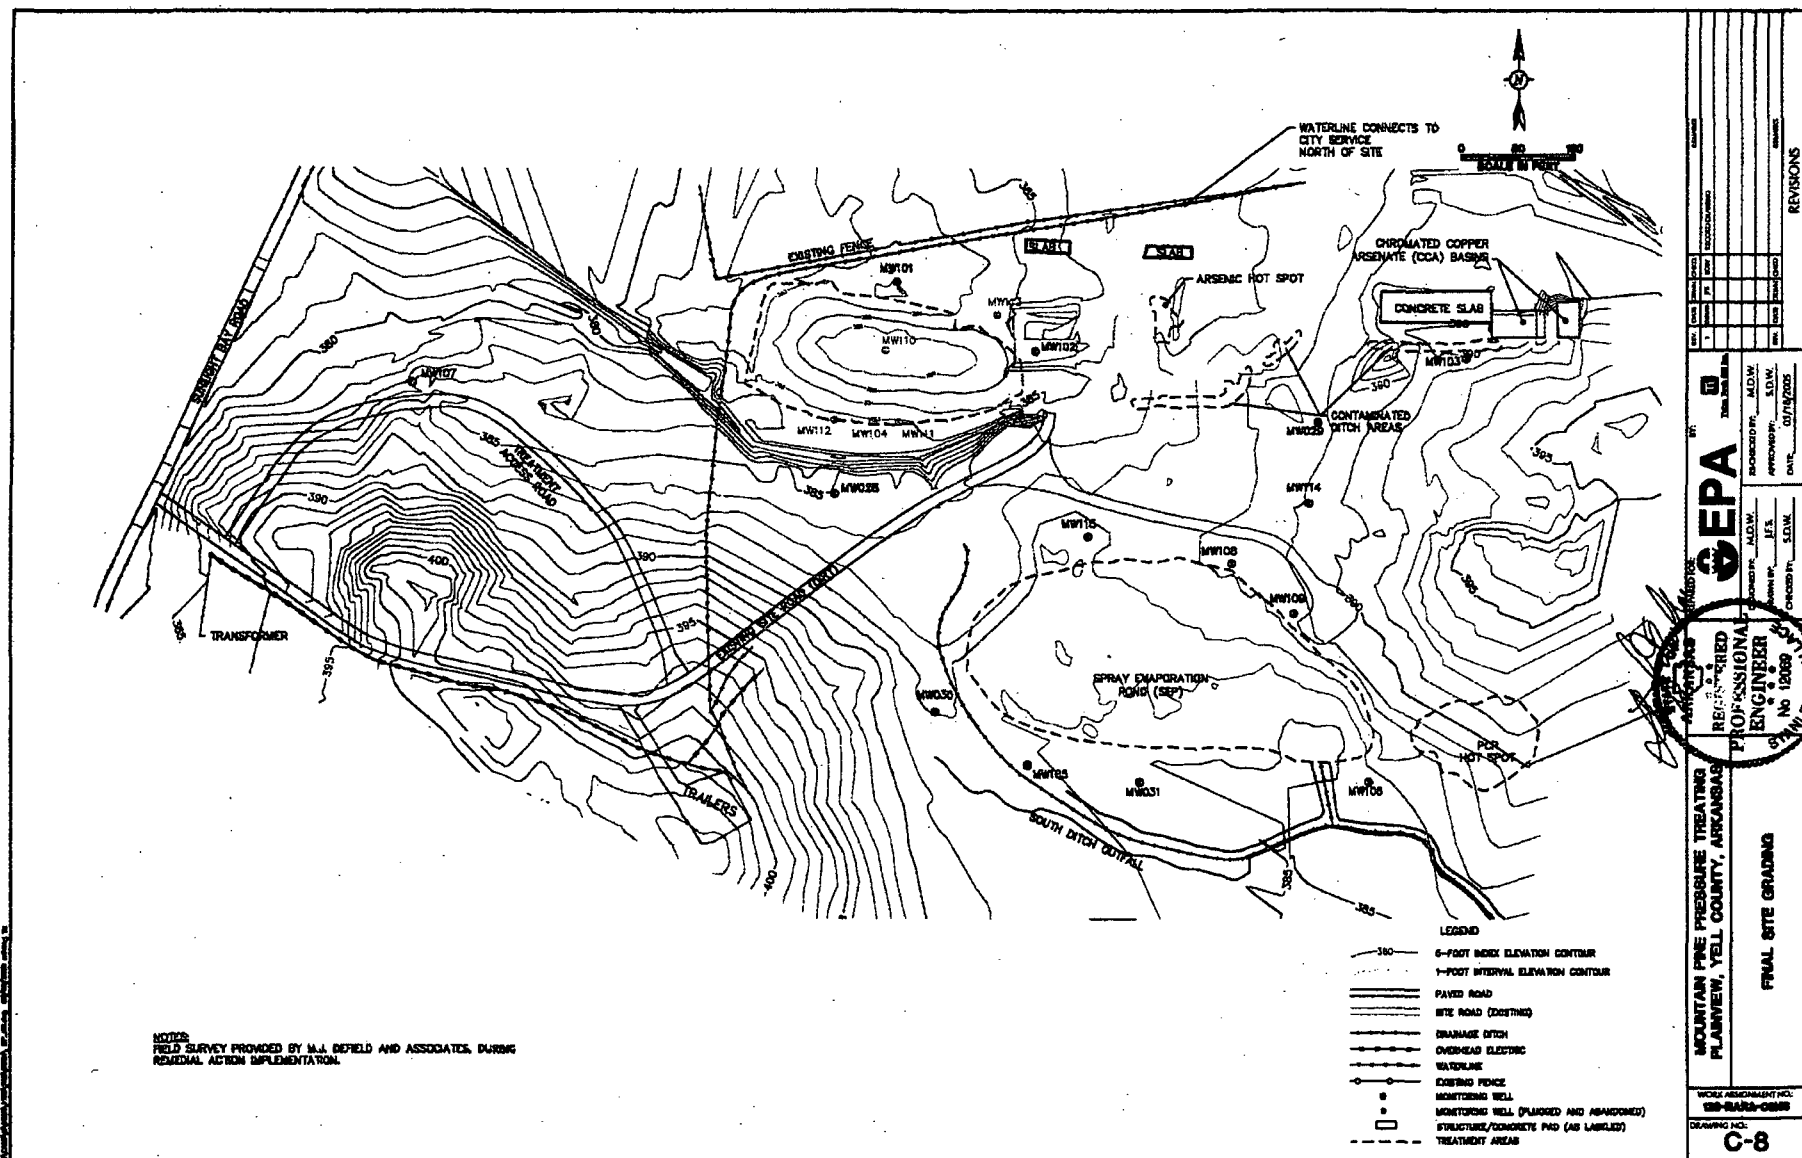
Figure 3. Site Map.

The area of the site addressed in the remedial action encompasses approximately 19.44 acres. The remediated site is now covered with grass and is partially enclosed by a fence. The site contains two waste burial cells covered with soil and grass, and has 19 groundwater monitoring wells. **Figure 3** shows a plan view of the Mountain Pine site, and the location of the monitoring wells.

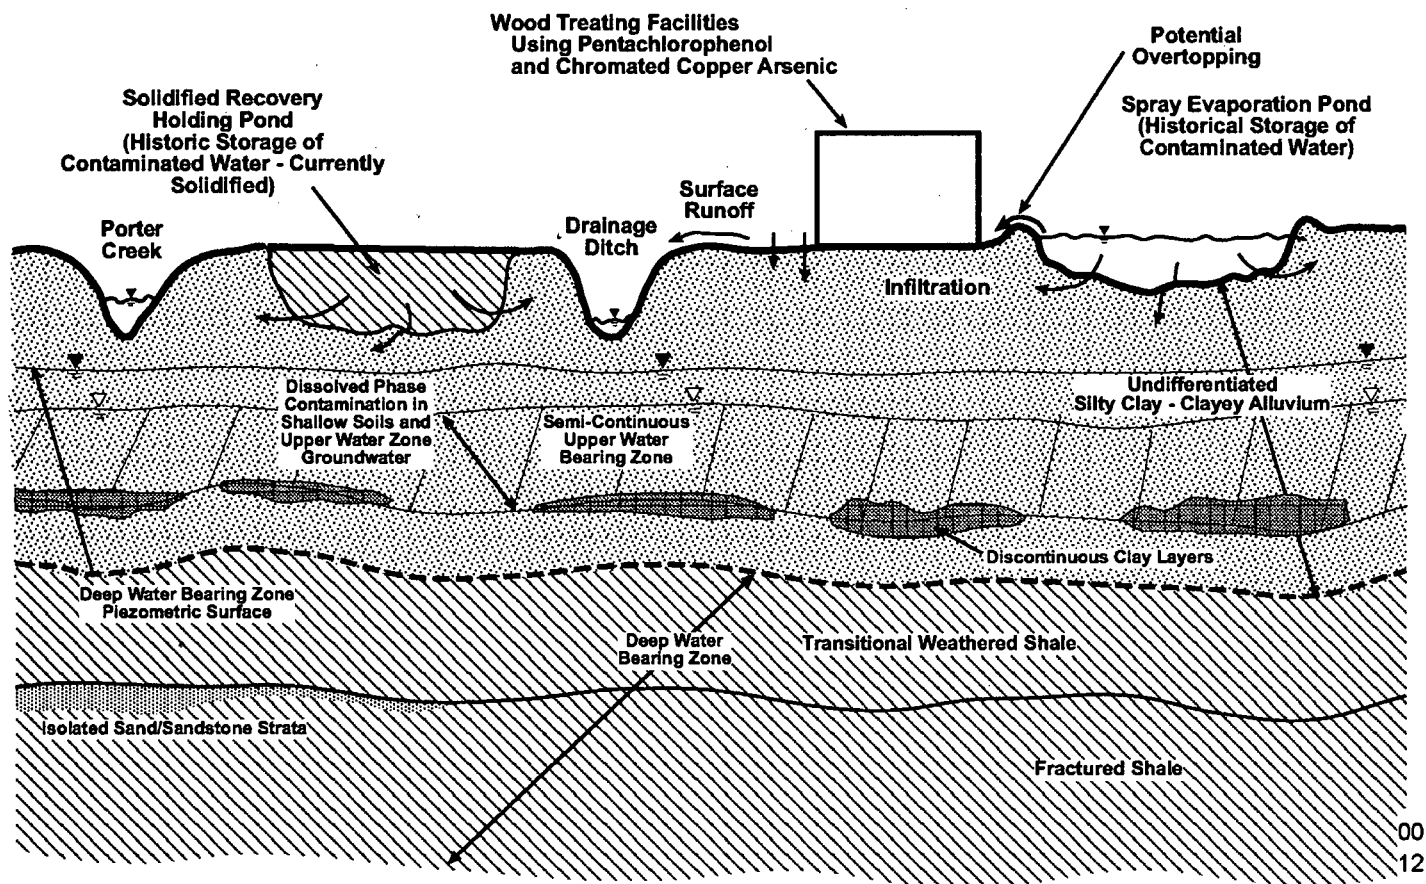
Figure 4. Generalized Hydrogeologic Profile.

During the RI, saturated conditions were encountered in two geologic units at the site: the silty clay in the alluvial zone, and in portions of the weathered and competent shale. These two horizons were labeled as the upper water-bearing zone (UWBZ) and the lower water-bearing zone (LWBZ). The UWBZ was approximately 5 feet thick and occurred between 4 and 9 feet bgs. The LWBZ consists of the lower portions of the weathered shale unit, including the sand to clayey sand horizon in the weathered shale or at its base (CH2M Hill 2002). **Figure 4** shows a generalized hydrogeologic profile for the site. **Figures 5 and 6** show groundwater elevations in the LWBZ and UWBZ in April 2003, and the locations of the monitoring wells at the site.

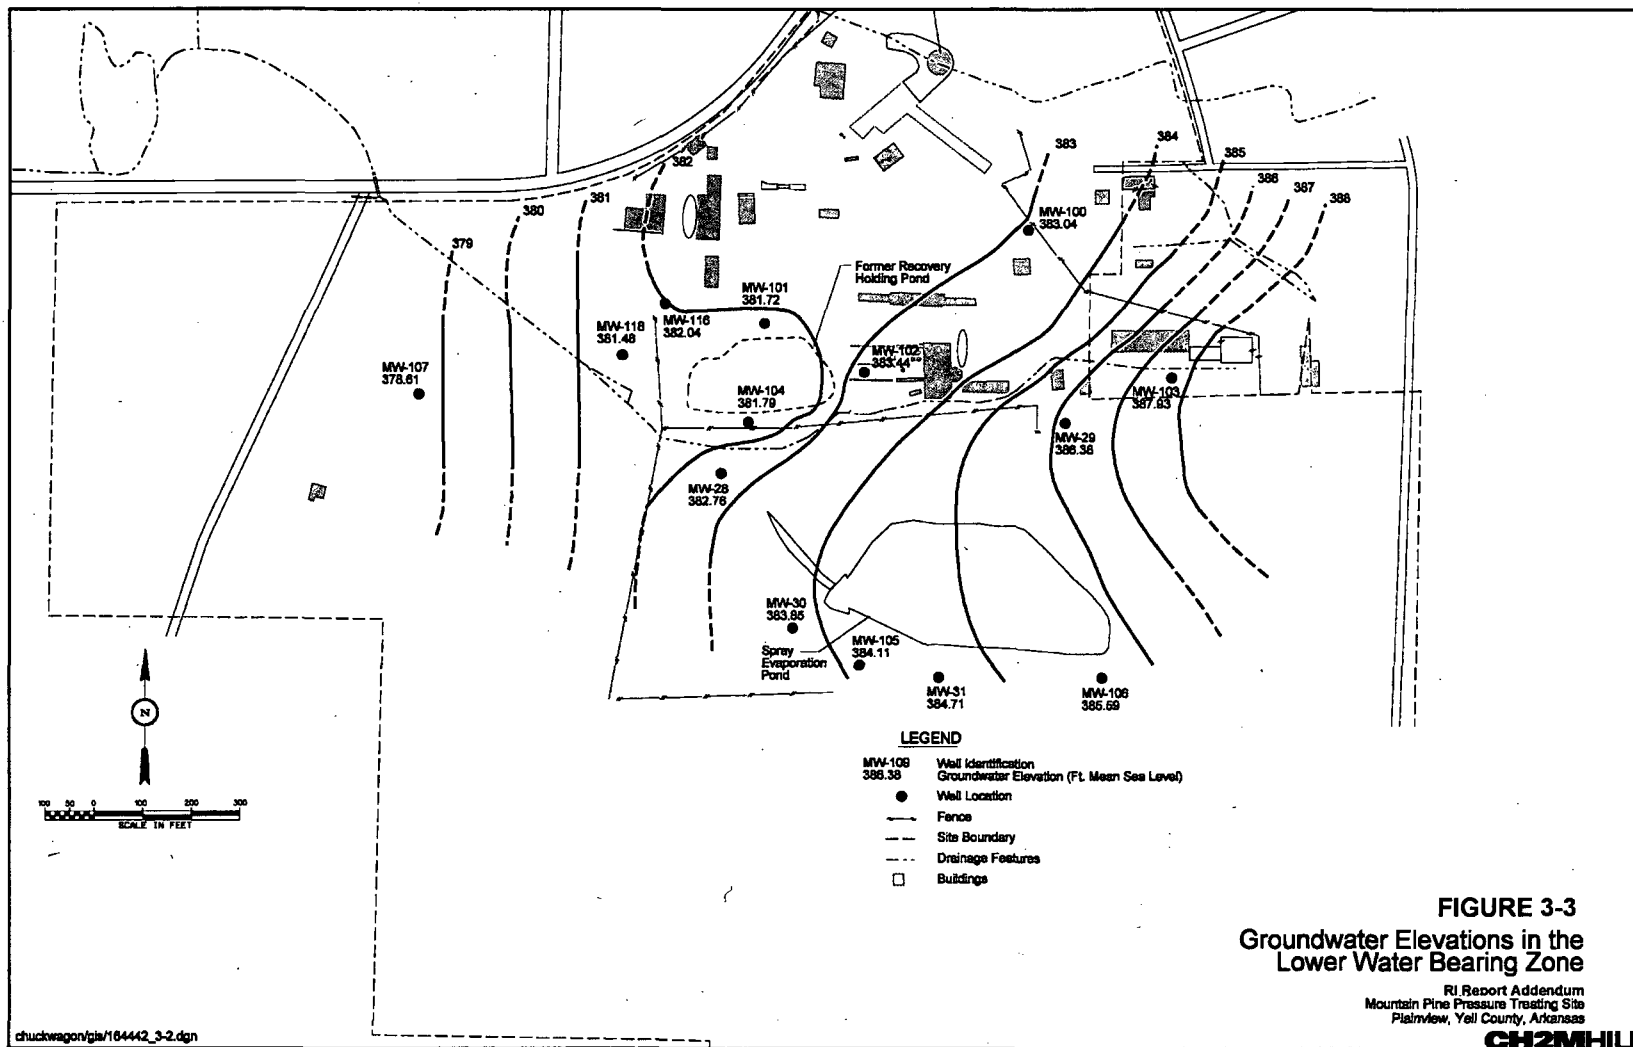
Figure 5. Groundwater Elevations in the Lower Water Bearing Zone

Arsenic and PCP were the principal constituents of the two treatment liquids used during wood treating operations at the site, and were the two primary COCs specified in the remedial action objectives in the ROD. Chromium and diesel fuel were also constituents of the wood treatment processes used at the site. Post RA groundwater monitoring includes PCP, arsenic, chromium and total petroleum hydrocarbons/diesel range organics (TPH/DRO). The analytical results for PCP, arsenic chromium and TPH/DRO detected in monitoring wells in the UWBZ and LWBZ are provided in **Attachment 6**. **Figures 5 and 6** show the location of the monitoring wells in the LWBZ and UWBZ.

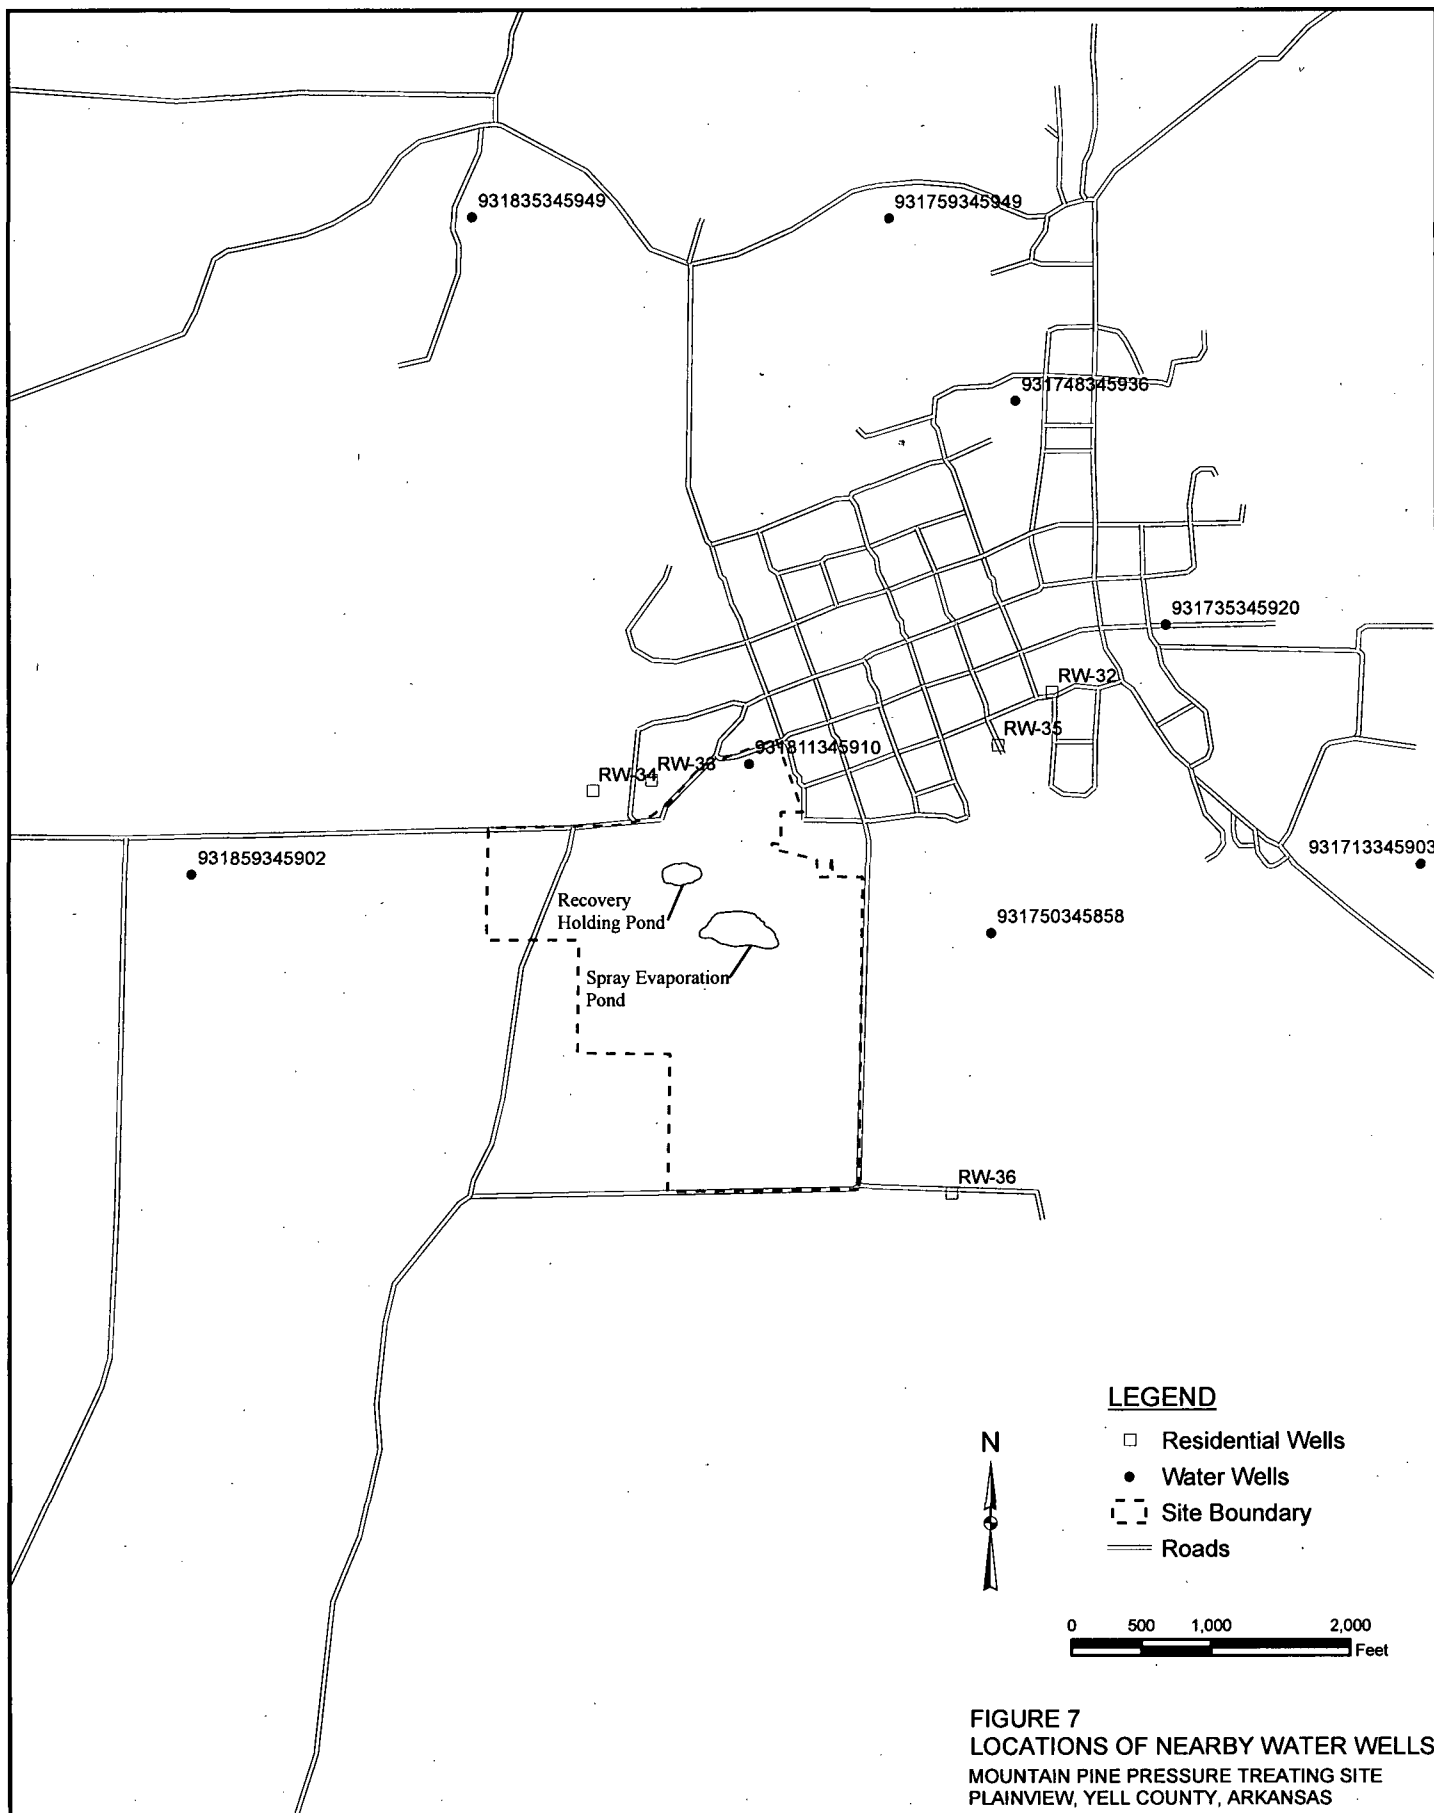
Figure 7. Locations of Nearby Water Wells.

Water Well Inventory: A water well inventory of wells located near the Mountain Pine site was obtained from a water well database maintained by the Arkansas Water Well Construction Commission, made internet accessible by the USGS (USGS, 2010). A water well inventory developed during the RI shows an additional five wells located near the site, designated as residential wells, which do not appear in the USGS database. The wells identified from these two sources are listed in **Table 3**, and the locations of the wells are shown in **Figure 7**.

The LWBZ at the site consists of the lower portions of a weathered shale unit, including a sand to clayey sand horizon occurring within the weathered shale or at its base. The LWBZ was determined to have sufficient yield and quality to be considered a potential drinking water source during the RI. Groundwater samples taken from the LWBZ during the five-year review period have shown that arsenic and PCP levels have increased to levels above the MCLs. Monitoring wells in the LWBZ at the site have depths ranging from about 27 to 41 feet. Nearby water wells identified in the USGS database and shown in **Figure 7** have depths ranging from 40 to 180 feet. Water well 931811345910 has a depth of 180 feet and is located within the historical site boundaries near the northern edge of the site, but is outside of the areas found to be contaminated and remediated during the RA. Its depth of 180 feet is about 140 feet deeper than the LWBZ at the site. Water well 931735345920 is about 3000 feet northeast of the site and has a depth of 40 feet, and is very likely completed in the same weathered shale geologic unit as the contaminated LWBZ at the site. The five residential wells shown in the RI were identified in investigations previous to the RI, and no information on the depths of the wells was found in the RI. However, at least one other water well in the area appears to be completed in the same geologic unit as the LWBZ, and it is possible one or more of these nearby residential wells may also be completed in this geologic unit. Two of these residential wells, RW-33 and RW-34, are located just a few hundred feet north of the site boundary. Because the areal extent of site groundwater contamination is unknown, and because there is a possibility that water wells near the site may be withdrawing water from the same geologic unit as the contaminated LWBZ, the water wells near the site should be evaluated to determine if they have been impacted by the site groundwater contamination.

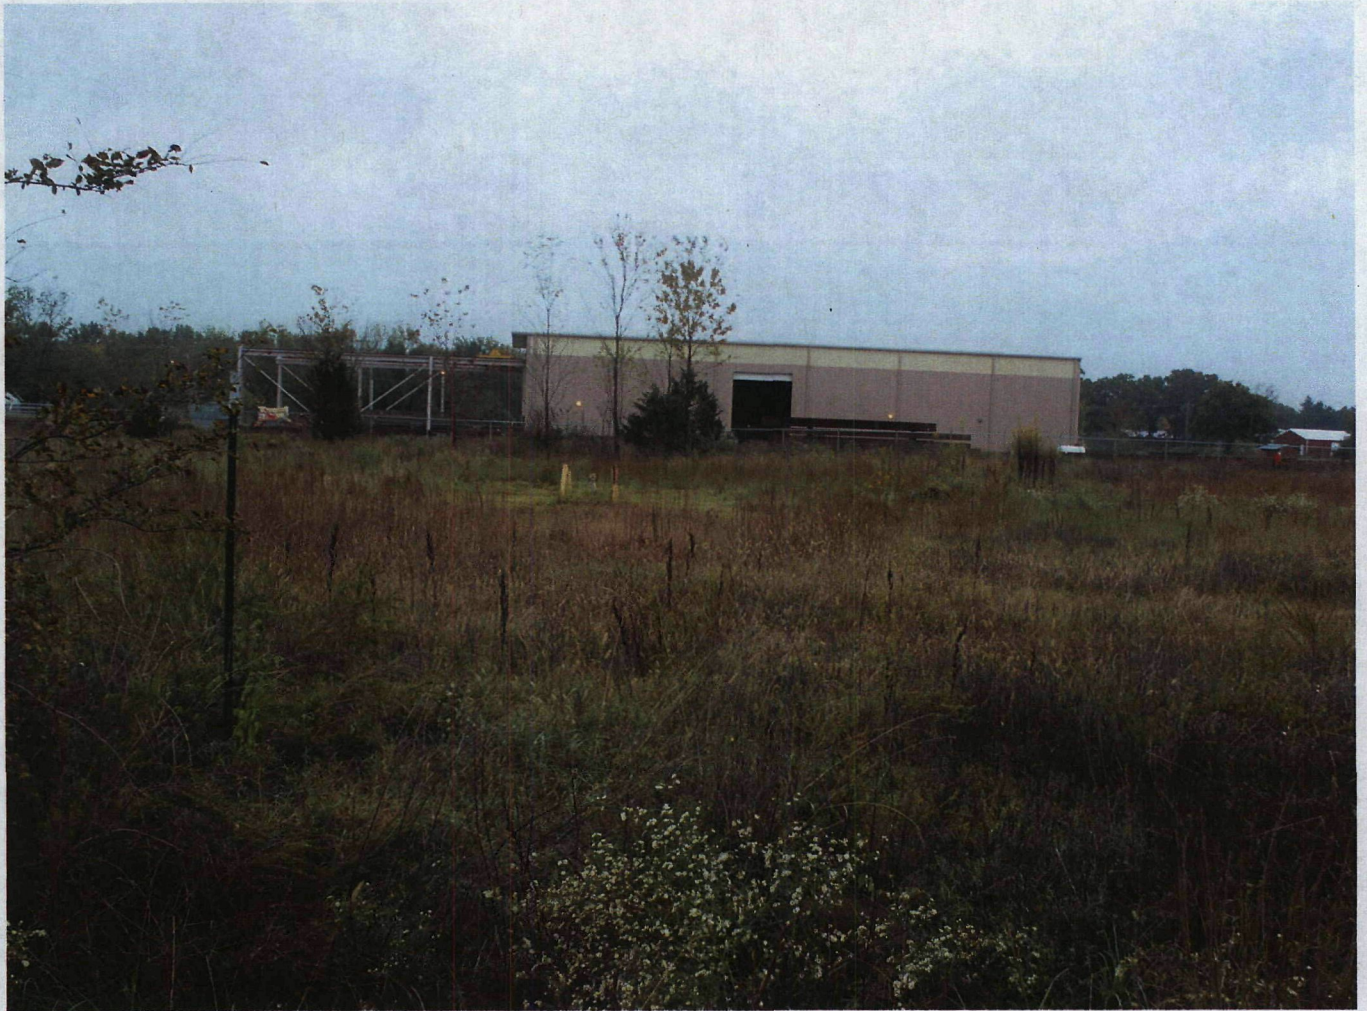
Photo 1: RHP waste cell cover.

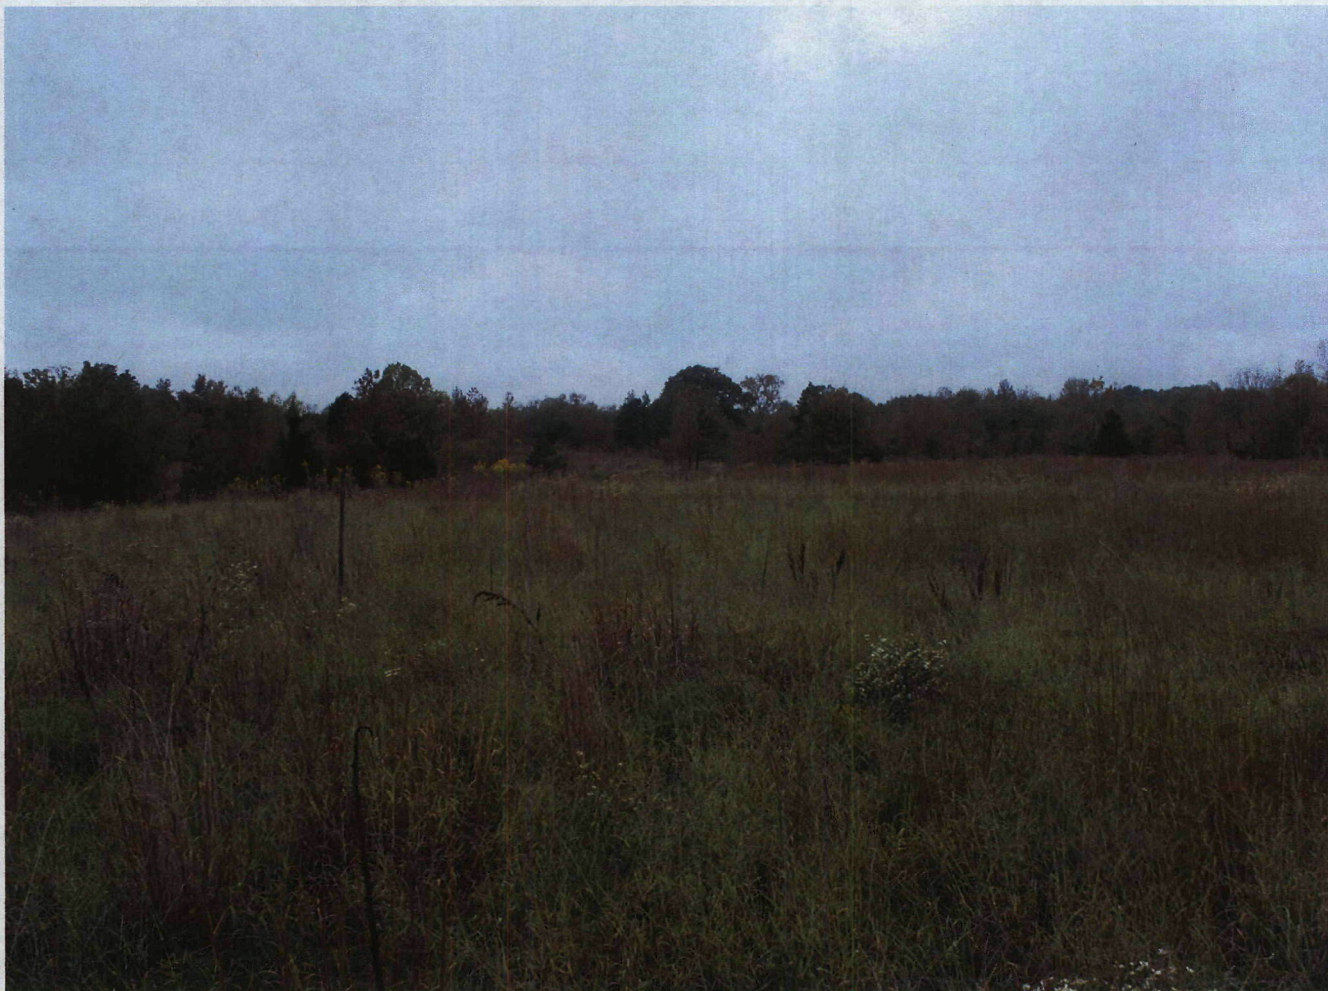
Photo 3: RHP waste cell cover.

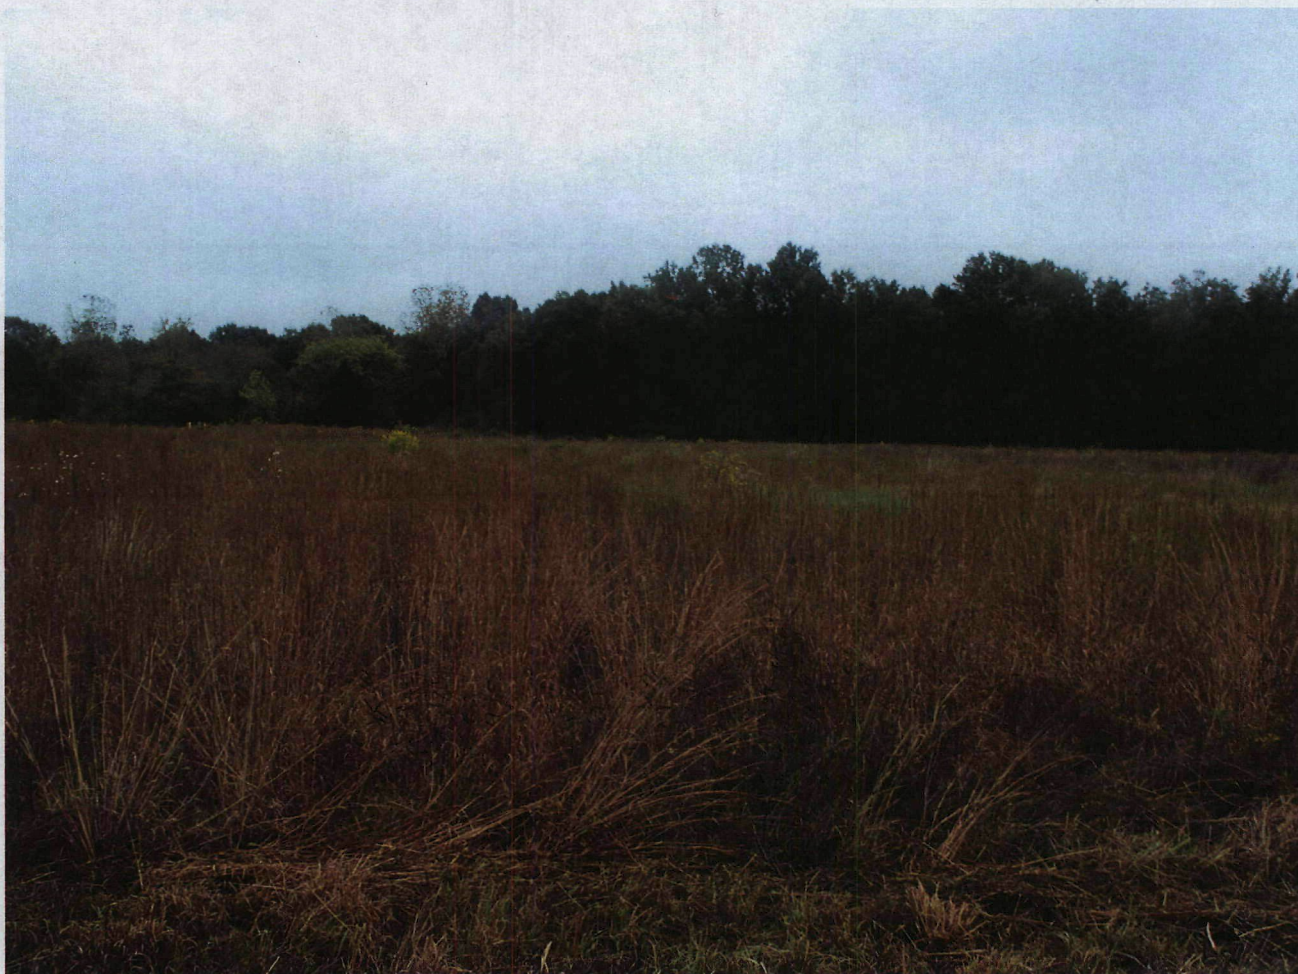
Photo 8: SEP waste cell cover.
