# Remediation of a Heavily Congested Urban Site Toronto, ON, Canada

Former Gasoline Dispensing Station contaminated with hydrocarbons at depths of up to 14 meters below grade. A second gasoline dispensing station was located across the street causing contamination under the public roadways.

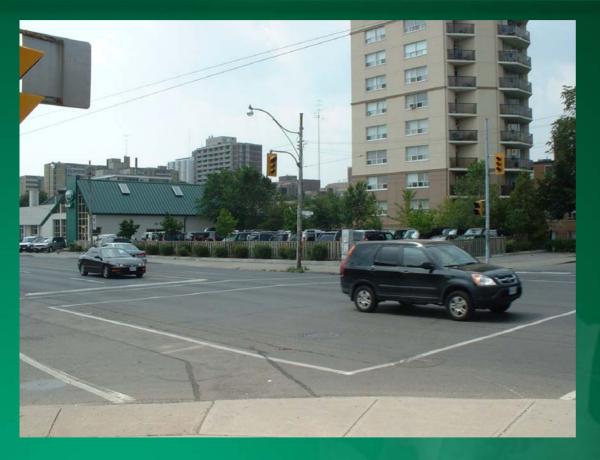
#### **Geotechnical Conditions**

Highly disturbed soils to a depths of 6 m below grade (due to previous remedial excavation) overlying silt/clay till to 7mbg overlying saturated, unconsolidated sands to full depth.

Water table at 8
meters below grade

Sands becoming "flowing" or "boiling" at depths in excess of 8 meters below grade

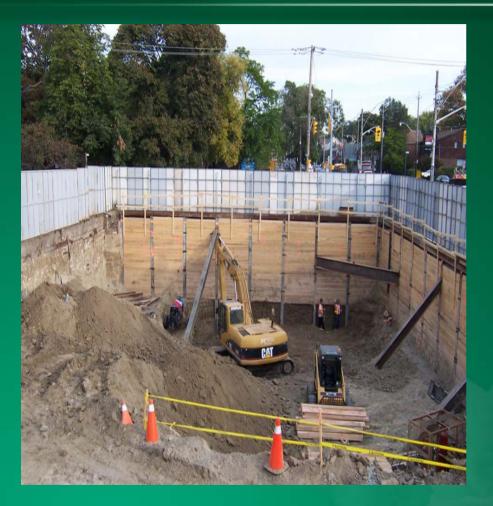
## **H-Pile and Lagging**

- 600 mm caissons open drilled to 11m, filled with H-pile and low strength concrete (4MPa)
- Whaler installed at grade and excavation between H-Piles completed with timber lagging
- Once at 4 mbg, rakers welded and set in 30 MPa concrete footings excavated at 6 mbg
- Bulk excavation completed to 6 mbg in north and east portion of site.

- Installation of H-pile to 11mbg and lagging (inc. rakers) to 7mbg to shore excavation wall on N and E P/L
- Slurry slots excavations backfilled with low strength concrete from 7 to a maximum of 14 mbg on N and E P/Ls to remove impacted soil and provide hydraulic barrier
- Installation of caisson wall on W P/L to 11m below grade to support adjacent parade and provide hydraulic barrier
- Slot excavation of impacts at depth along caisson wall, backfilled with low strength concrete
- Wet excavation of entire central portion of site

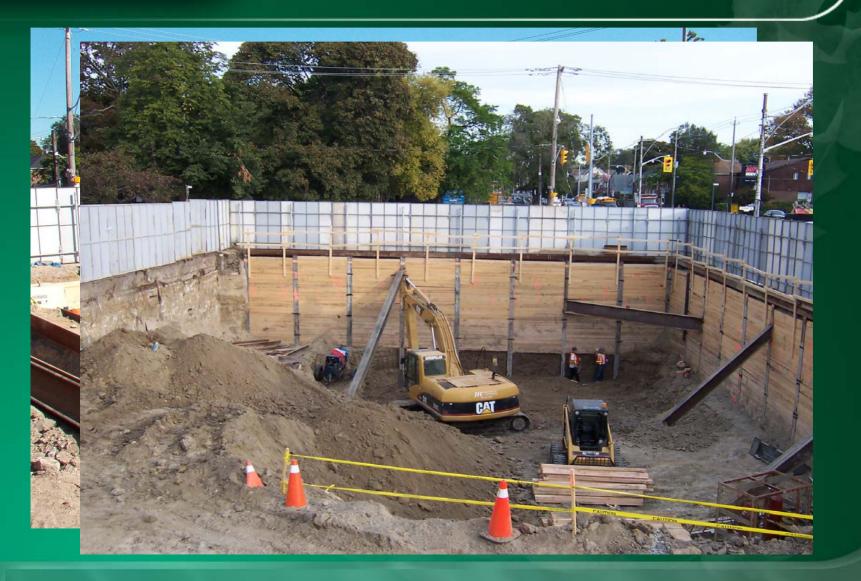
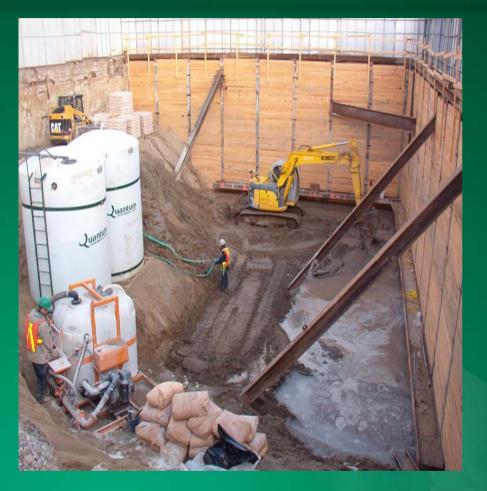
Confidential Site, Toronto, ON -Bentonite Slurry, Concrete, Caisson Wall

- Slots excavated up to 14mbg using 5% bentonite slurry to shore excavation wall
- Slot backfilled with low strength concrete to provide impermeable barrier
- Alternating slot technique used with over excavation into adjacent slot to ensure continuous impermeable wall
- Bentonite mixed using shear pump to meet 45 second Marsh Cone viscosity test

- Quality of bentonite will affect stability of slurry
- Proper field mixing and QA/QC of bentonite slurry is critical
- Entrained sediment will reduce viscosity of slurry in slot (ongoing testing required)
- When using slot techniques, over-excavation of low strength concrete is critical to ensure continuous barrier
- Slot depth measurement must be accurate to ensure design depth of barrier is correct

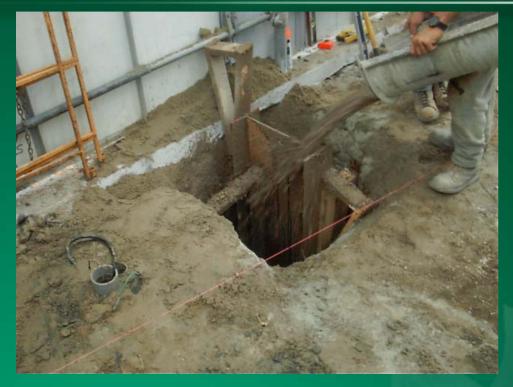
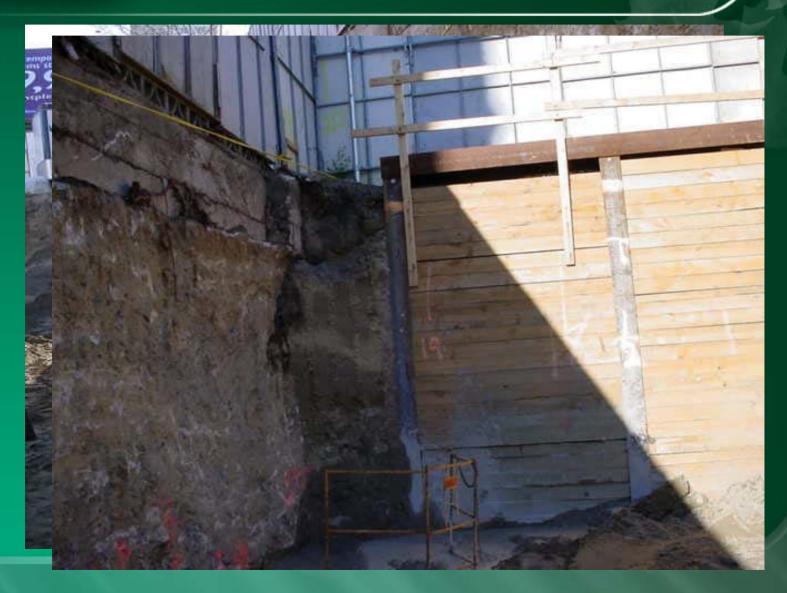
- From 3mbg bench, 13, 600 mm dia. open boreholes were drilled on a specified spacing ~11mbg and filled an H-Pile and LS concrete to 3 mbg; H-Piles were used in select caissons to construct a shoring support wall
- Subsequently, 3 'filler' boreholes were advanced between each of the 13 previously drilled, reinforced and filled boreholes
- Filler' boreholes were drilled with a minimum 0.1m overlap into the

adjacent caisson and filled with LS concrete; 'filler' borehole 2 was drilled first, followed by 'filler' boreholes 1 and 3

- A whater was installed at 4 mbg to further stabilize the cantilevered wall
- Bulk excavation was continued to ~8mbg, with slots excavated and backfilled to 11mbg with LS concrete.

- QA/QC of caisson locations is critical to ensure correct overlaps
- Auger/caisson advancement must be closely monitored for plumb, particularly for deep barrier walls as off-plumb alignment will cause gaps in the barrier wall
- Soils should be free of large obstructions as augers will drift off-plumb
- Soils should be sufficiently consolidated so that augers do not drift off-plumb when advancing 'filler' boreholes
