## Nyack Gas Plant Site

### Excavation—In Situ Stabilization/Solidification—Flowable Tar Recovery—In Situ Chemical Oxidation

**Site Name:** Nyack Gas Plant Site (Operable Unit 1)

**Site Location:** Nyack, New York

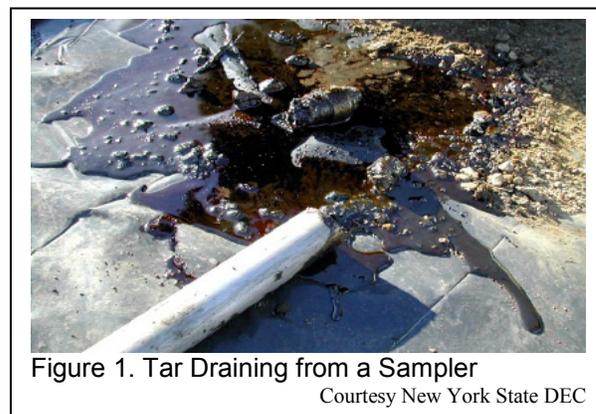
Figure 1. Tar Draining from a Sampler

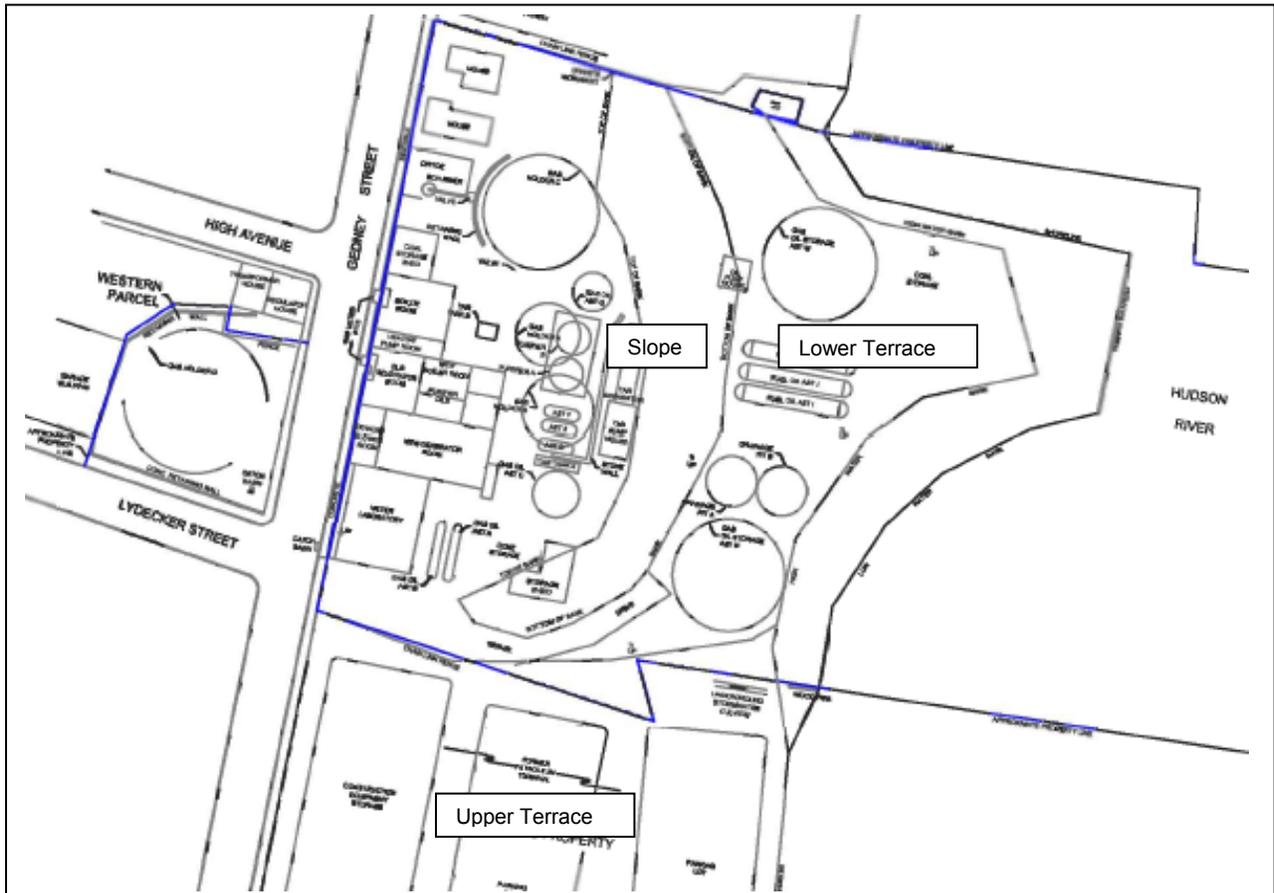
Figure 2. Cleanup Areas at Nyack Gas Plant

**Hydrogeology:** The topography of the site is characterized by an upper terrace with a bank leading down to a lower terrace that ends at the Hudson River (Figure 2). Both areas are covered with varying thicknesses of fill. The jetty area, which protrudes into the Hudson River, has the thickest layer of fill (13 ft). The second significant area of fill forms the slope between the upper and lower terraces, which was placed there after plant operations ended. A layer of native silty sand generally underlies the fill material. A layer of glacial till was noted in one boring on the upper terrace. Sandstone bedrock underlies the silty sand.
