## Background & Approach

Former Naval Ordnance Plant with a partially delineated trichloroethylene (TCE) plume in a sandy surficial aquifer and absorbed into the underlying clay confining unit. Ordnance manufacturing and metal plating were conducted at the site. Explosives blending (former) and on-site storm drains lie within the area of interest (red square, Fig. 1). Currently operates as an industrial park.

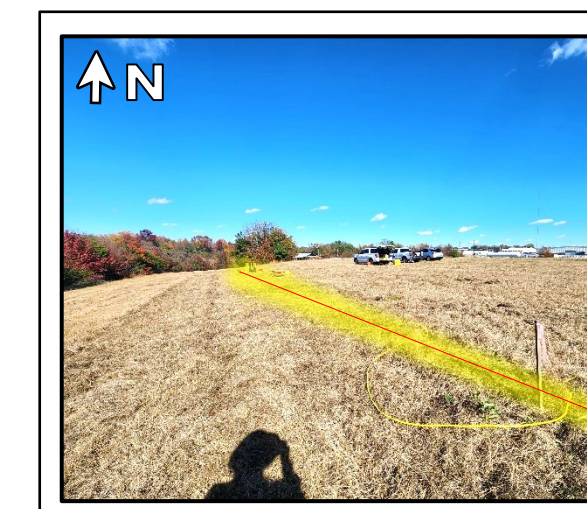
Fig. 8: MNOP03 (left; view N)

Fig. 9: MNOP05 (mid; view NE)

Fig. 10: MNOP01 (right; view E)

- Very sandy formations; very plastic clay lenses
- Heaving sands; produced sufficient water given limited screen and development
- No PID response, only the bottom 5-ft of MNOP02\_TMW was positive; **No DNAPL**
- Only detections in analytical samples was at 30-40 ft bgs
  - TCE < 29 ug/kg in soil, <45 ug/L in GW; both above MCL but only in one sample
  - Only other detection is Cis-1,2-DCE
