INTERGEO

ENVIRONMENTAL TECHNOLOGY - BRANCHES WORLDWIDE

Region of intervention of Municipality of Evosmos

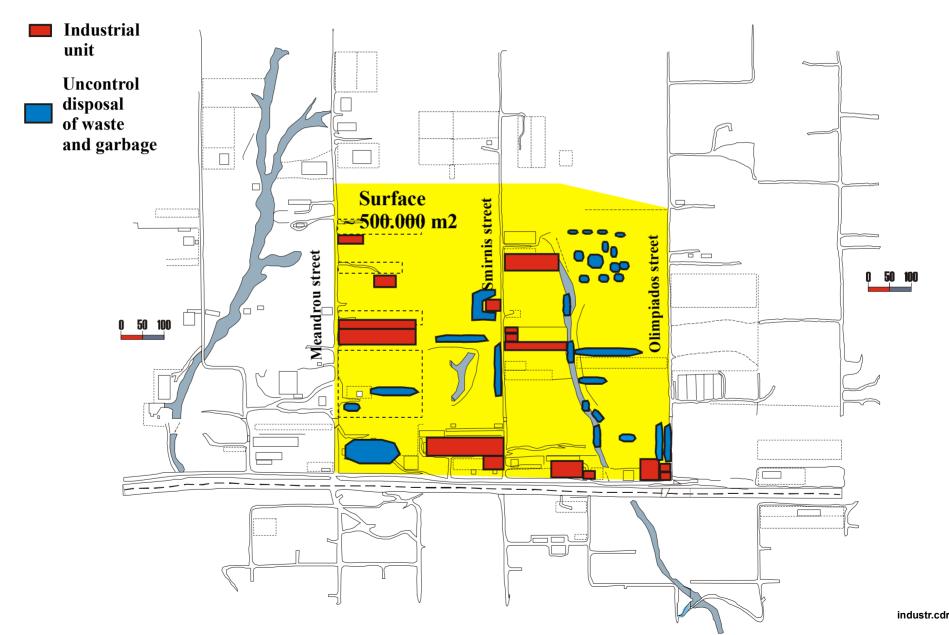
Location points of the industrial units and of disposed waste and garbage within the investigation area

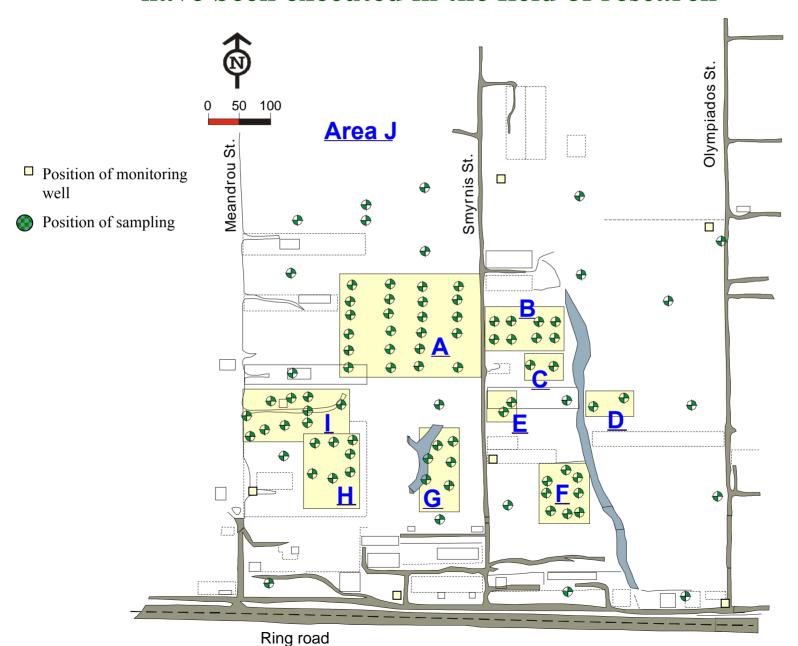
Places of investigation boreholes and monitoring wells that have been executed in the field of research

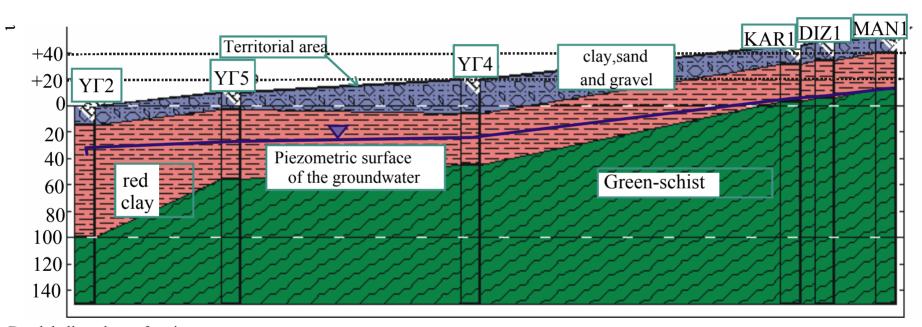
Cross section in the research area according the boreholes data and the information from the relative bibliography

South

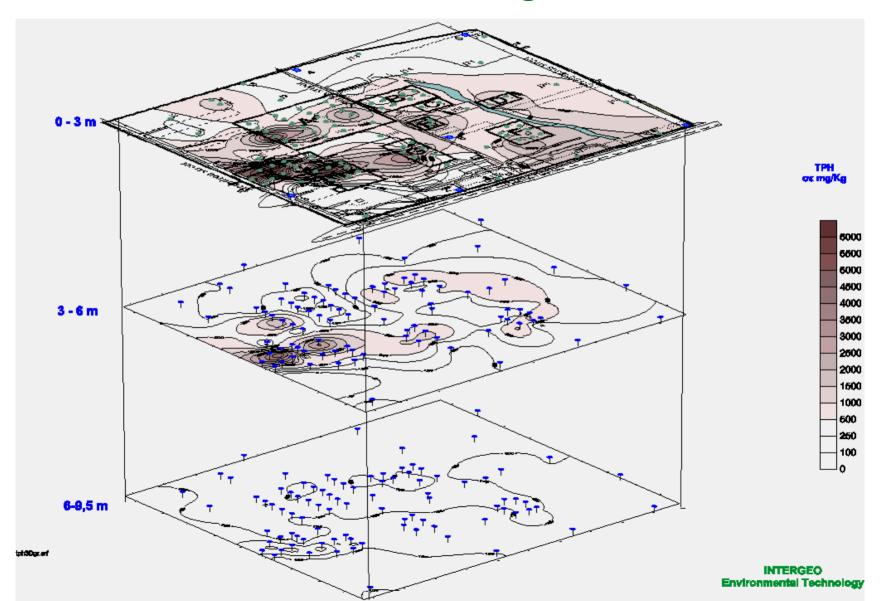
Distribution of the concentration of total hydrocarbons in the soil in the area of research in three different levels bellow the surface of the ground

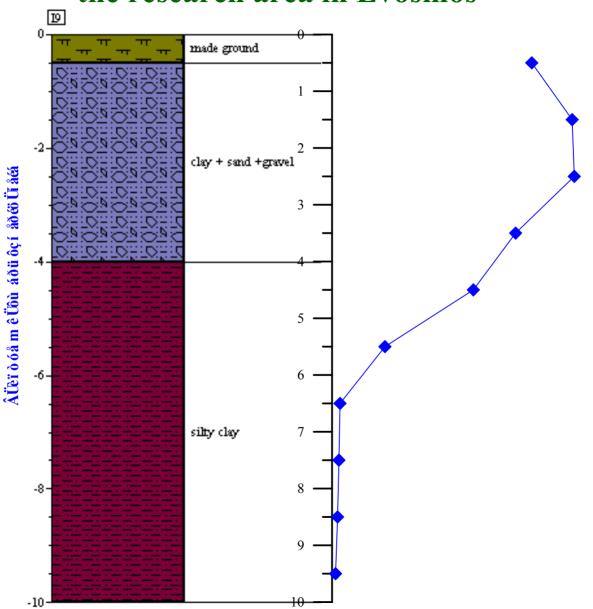
Relation of the concentration of total hydrocarbons (TPH) with the sampling depth in the investigation borehole 19 in the research area in Evosmos

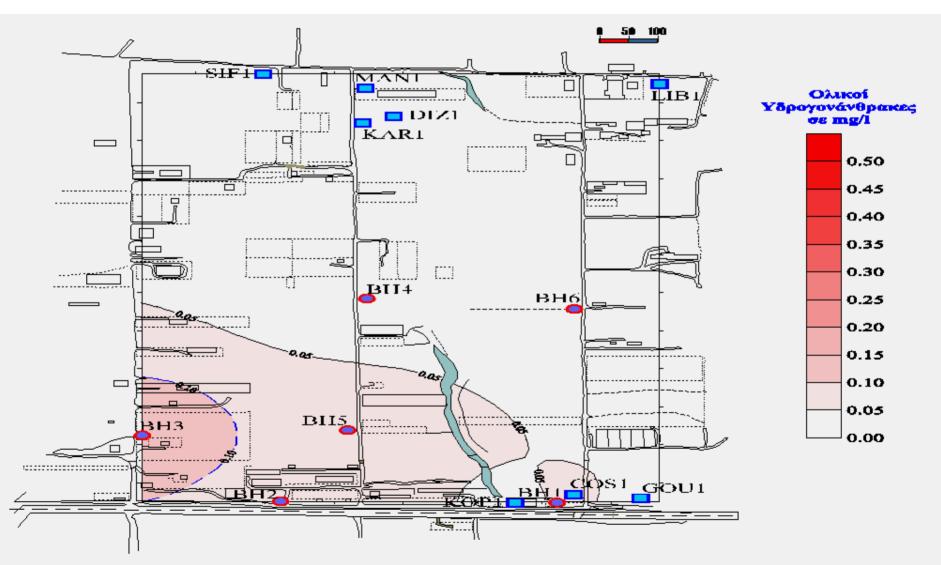
Distribution of the concentration of total hydrocarbons (TPH) in the groundwater in the area of research of Evosmos

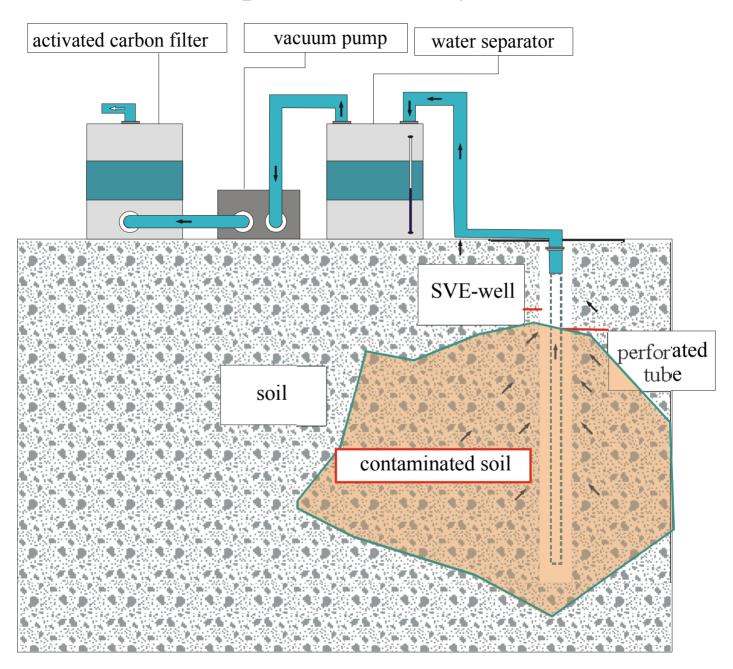
Soil vapor extraction system

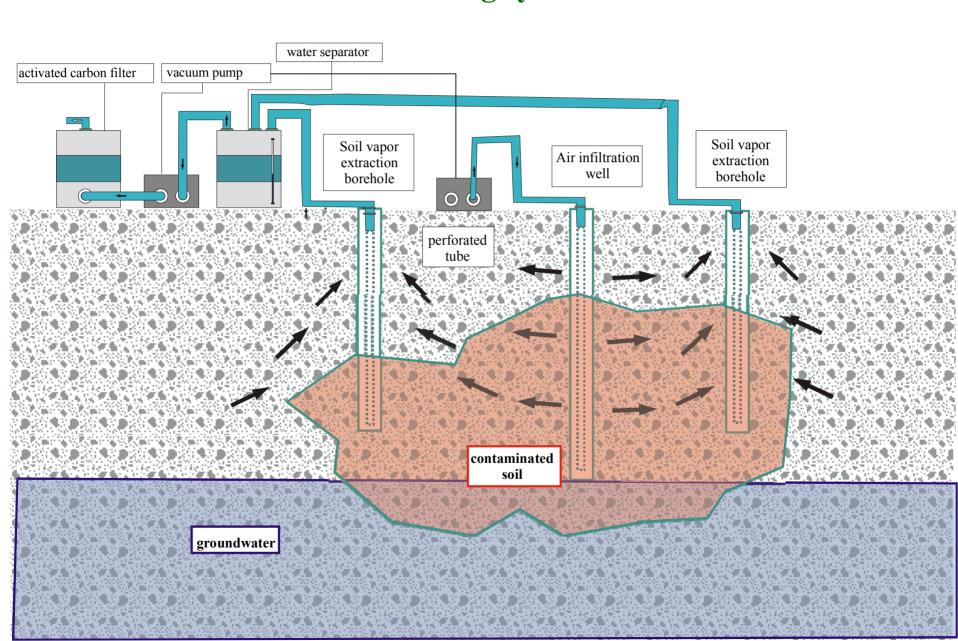
Remediation system of the unsaturated zone with the bioventing system

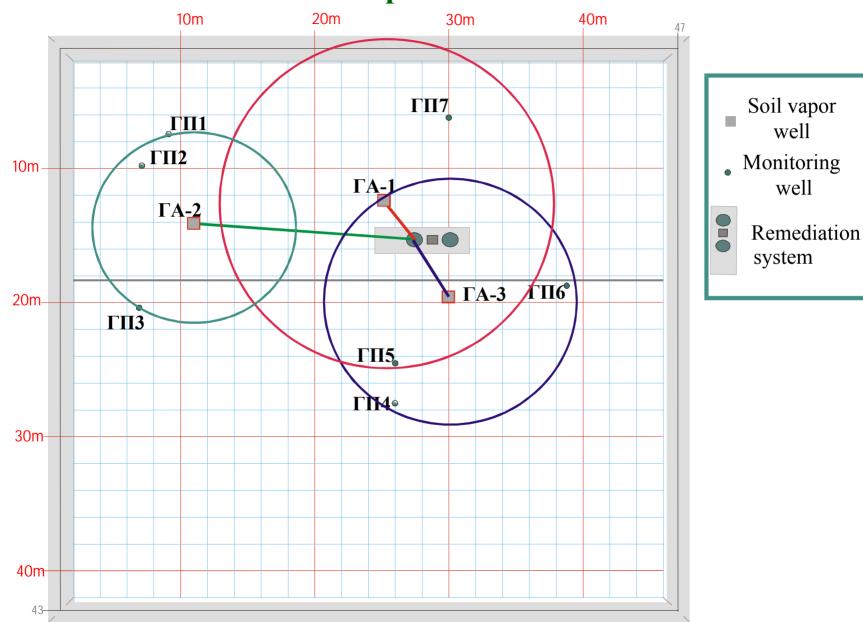
Affected ray of the recovery wells that were achieved during the pilot test

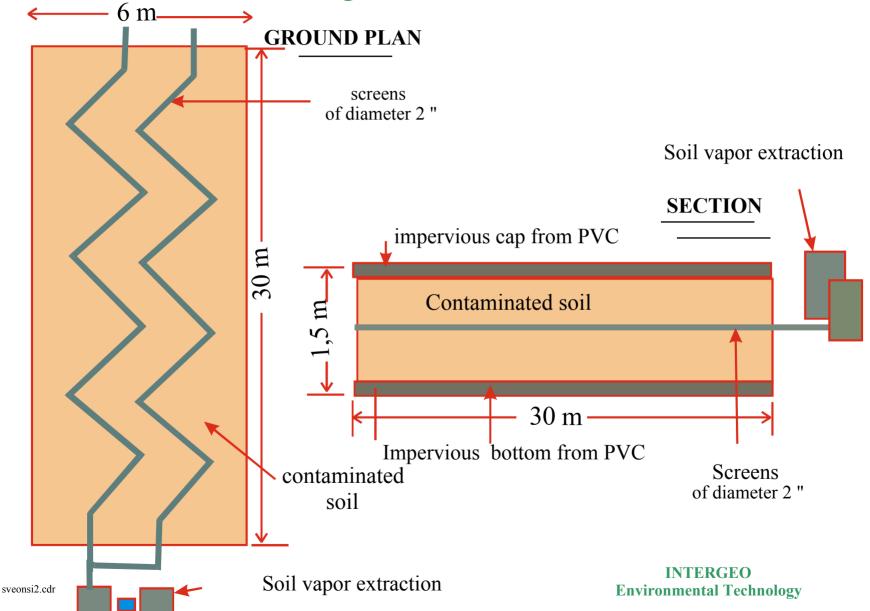
Schematic representation of the pollution of the contaminated ground with the "on site" method

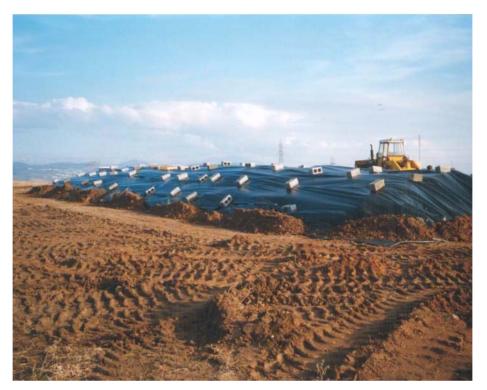
Suggestion of remediation for the contaminated soil with // hydrocarbons with "In situ" and "On site" methods **Contaminated soil** With hydrocarbons that needs remediation Soil vapor extraction Absorption drilling of underground air and vapor of the underground St. Deposition area of contaminated soil **Olympiados** j10 from the areas H, G F and A for "on site "remediation 100m Tarandro

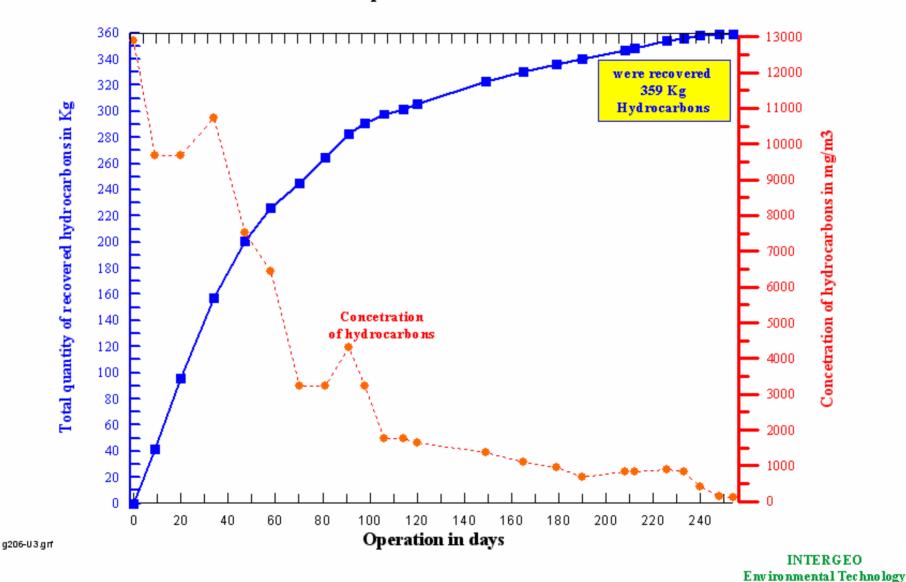
Progress of the course of the soil remediation in unit 3 (in situ processing) in Evosmos, Thessaloniki. Duration: 1/11/98 - 13/7/99 Technique: BIOVENTING

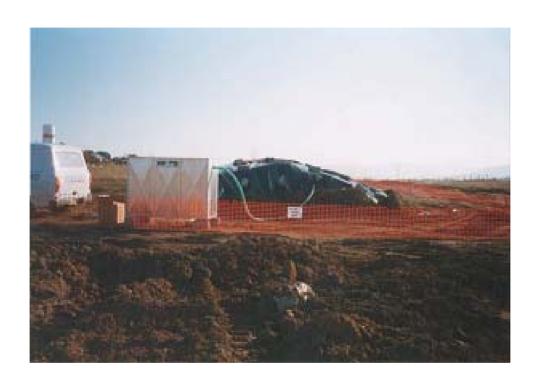
On site Soil Venting

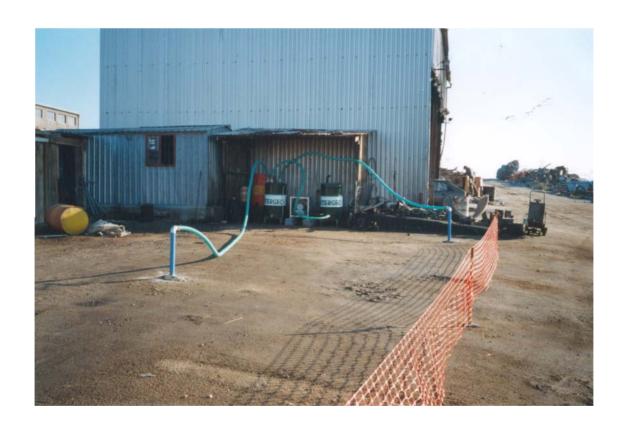
In situ Soil Vapor Extraction

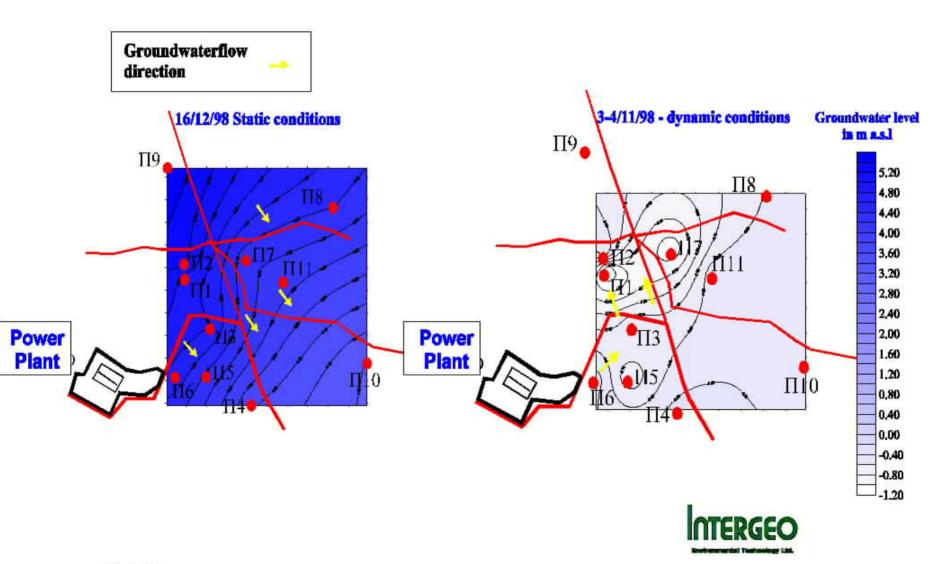
Case study Groundwater flow conditions

Groundwater table and movement direction of the groundwater under static and dynamic conditions

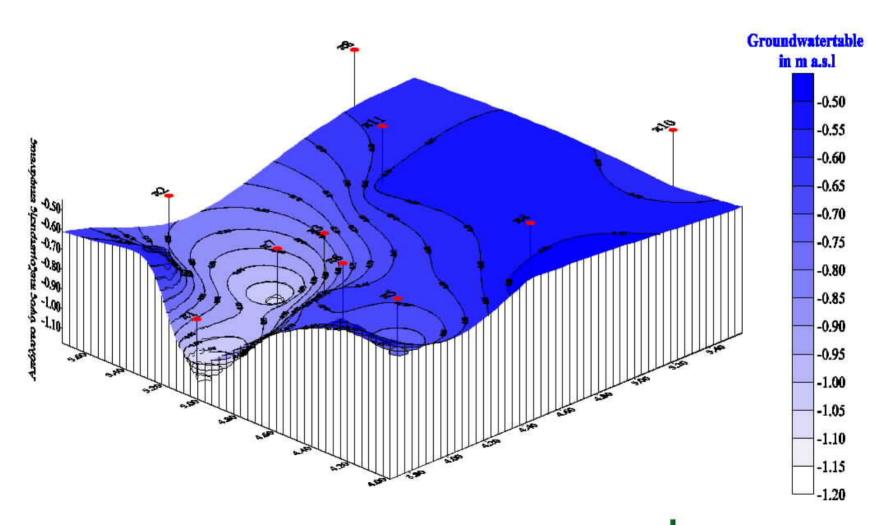
Case study Groundwater flow dynamic conditions 3D

Grondwater table under dynamic conditions on 3-4/11/98

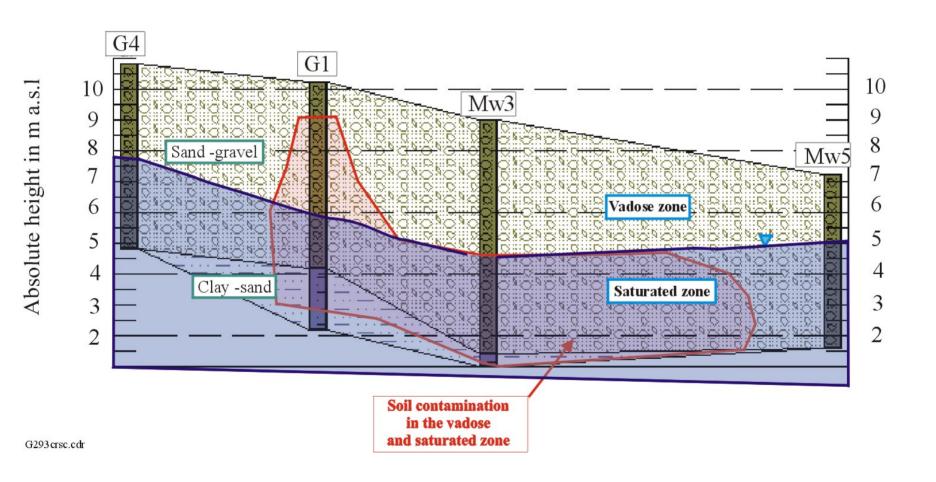
Case study Geological cross-section along the groundwater flow direction

Geological cross-section along the groundwater flow direction

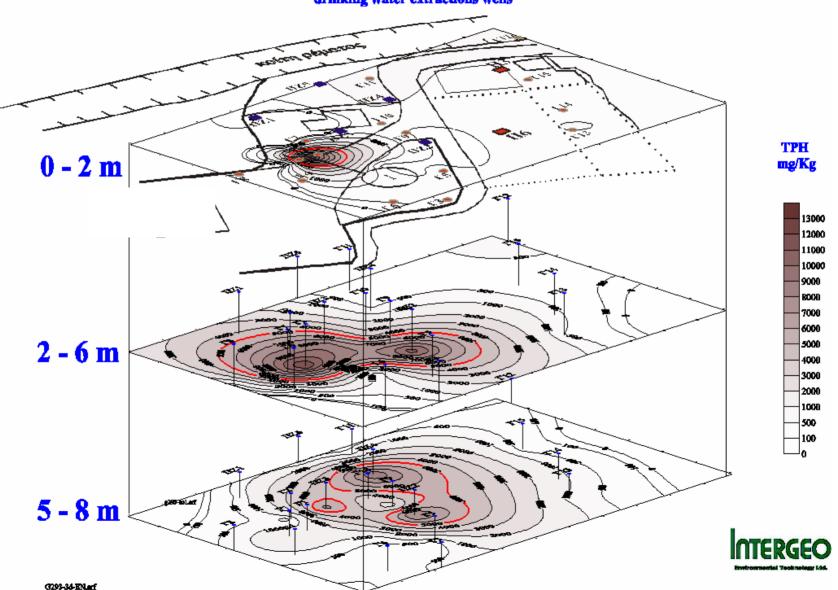
Case study site investigation

Figure 3: Distribution of TPH concentreation in the soil in three different levels - Contaminated site - Power plant close to drinking water extractions wells

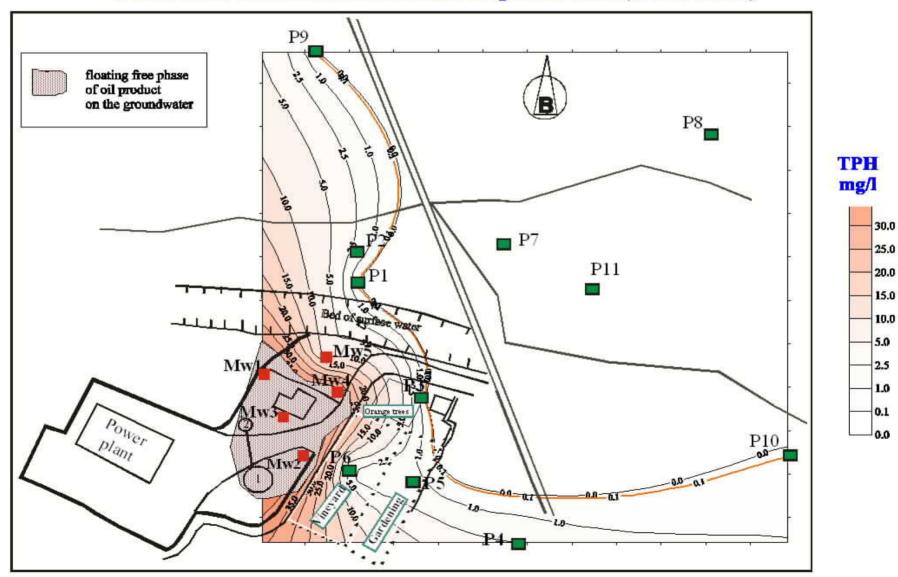
Case study TPH in the groundwater

Distribution of TPH concentration in the groundwater (date 16/12/98)

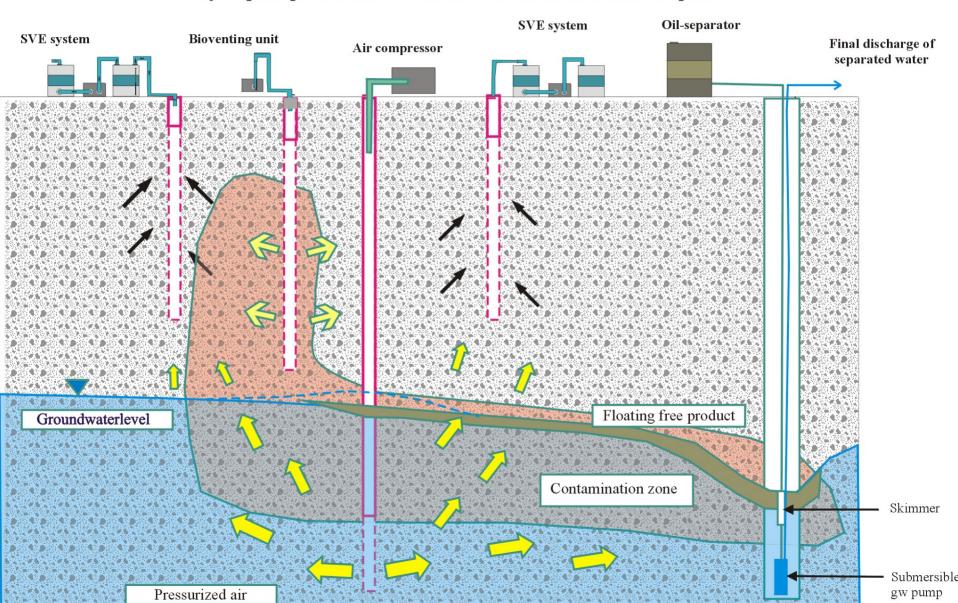
Case study Remediation Action Plan

Synoptic presentation of the remediation action plan

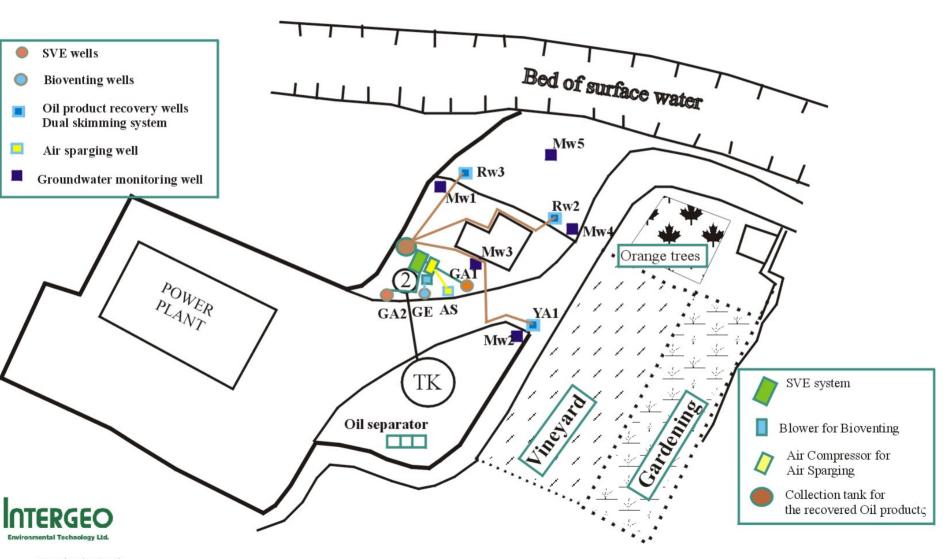
Case study Location of the remediation systems Locations of the remediation systems at the contaminated Power plant site

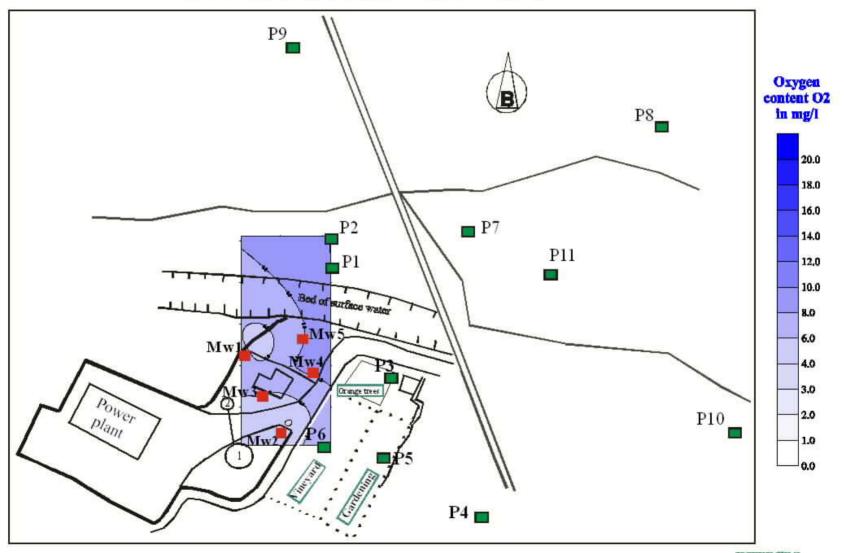
Case study o₂ content in the groundwater before remediation

Distribution of O2 content in the groundwater, date 14/2/99 before the start of groundwater remediation measures

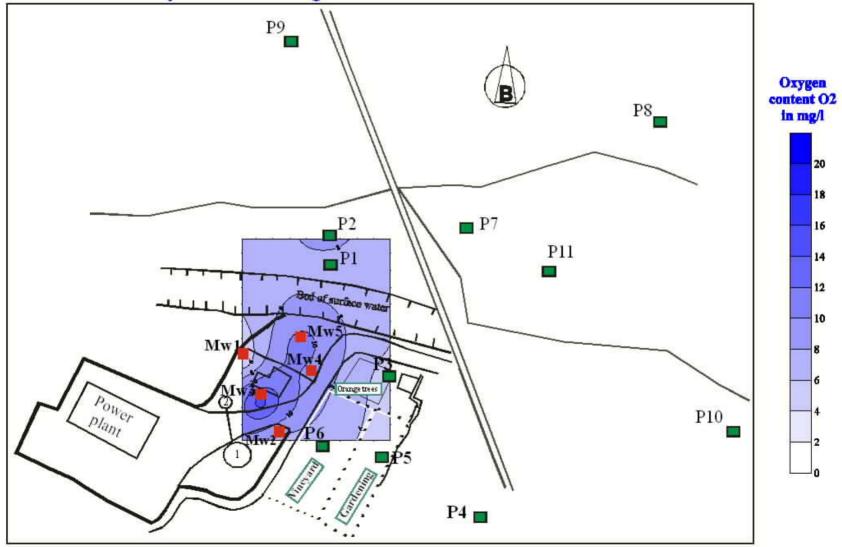
Case study o₂ content in groundwater shortly after the start

Distribution of O2 content in the groundwater. date 06/04/99 shortly after the start of groundwater remediation measures

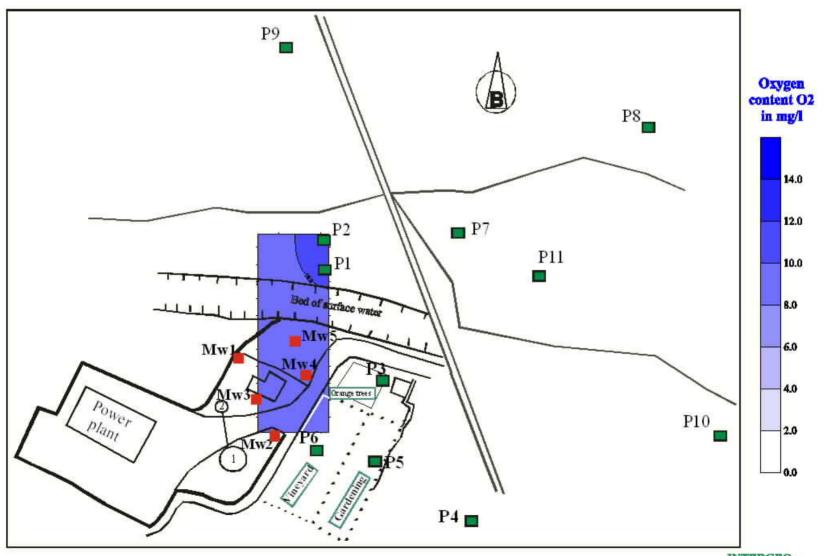
Case study o₂ content in groundwater after completion

Distribution of O2 content in the groundwater, date 14/2/01 after completion of the remediation measures

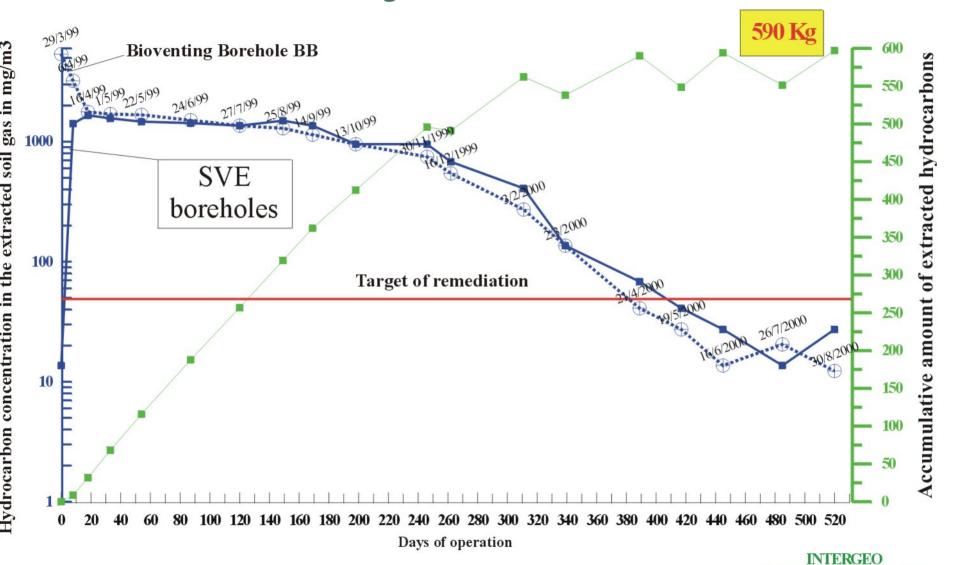
Case study soil Vapor Extraction Progress

- •The soil remediation (source) was completed after 20 months implementation of the airsparging technology
- •The groundwater TPH concentration was radically reduced below the drinking water standards after 16 months of system operation

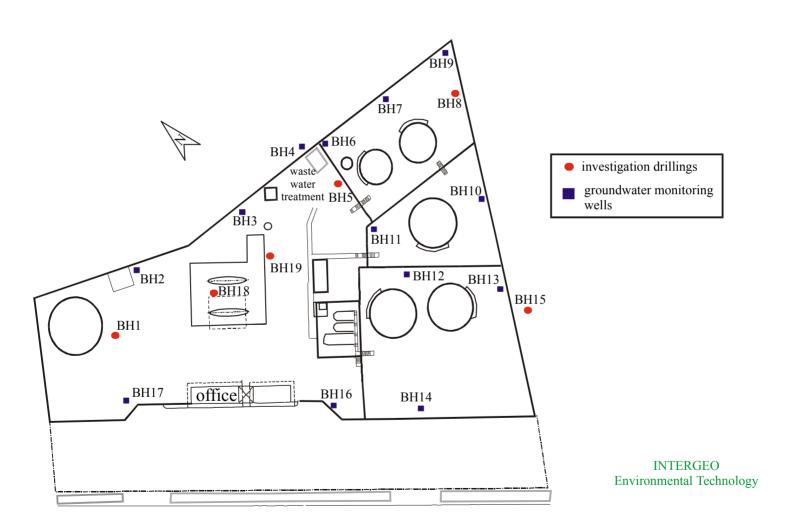
Location of investigation drillings and groundwater monitoring wells at the depot terminal

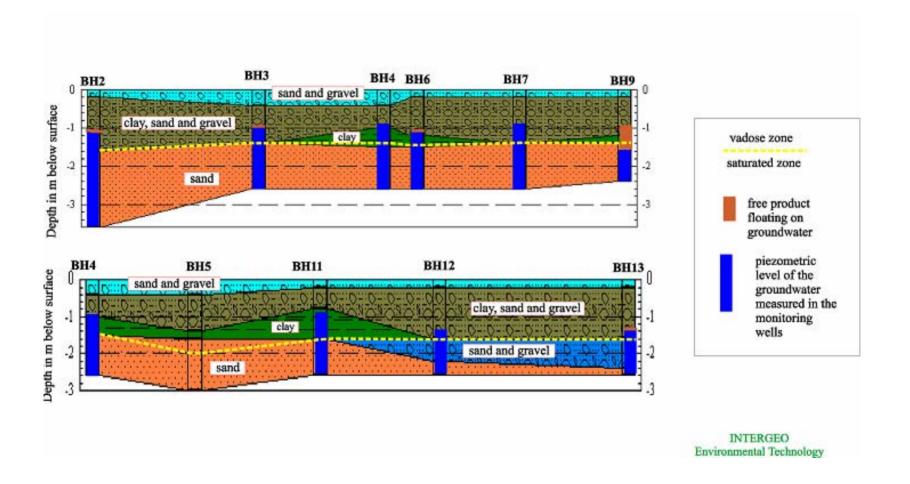
Simplified geological cross section at the depot terminal

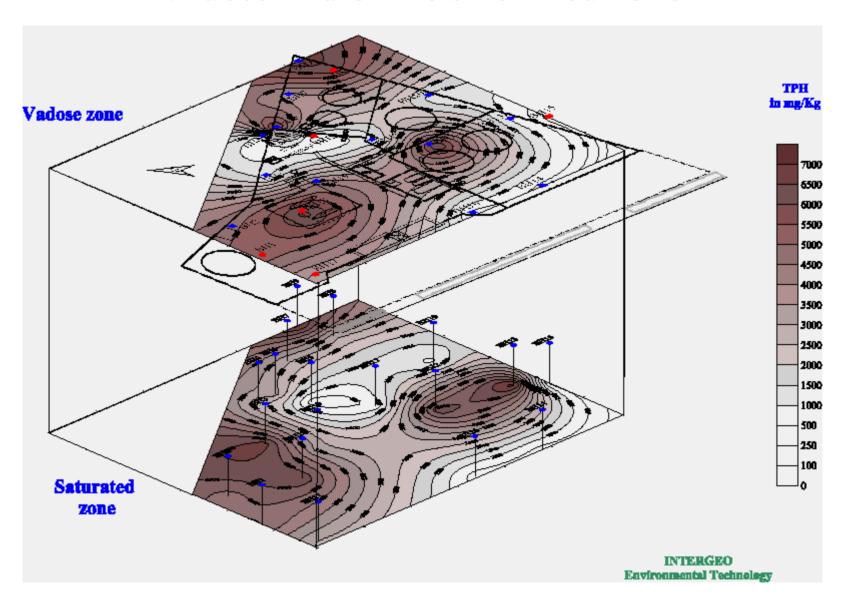
Distribution of TPH concentration in the soil of the vadose and of the saturated zone

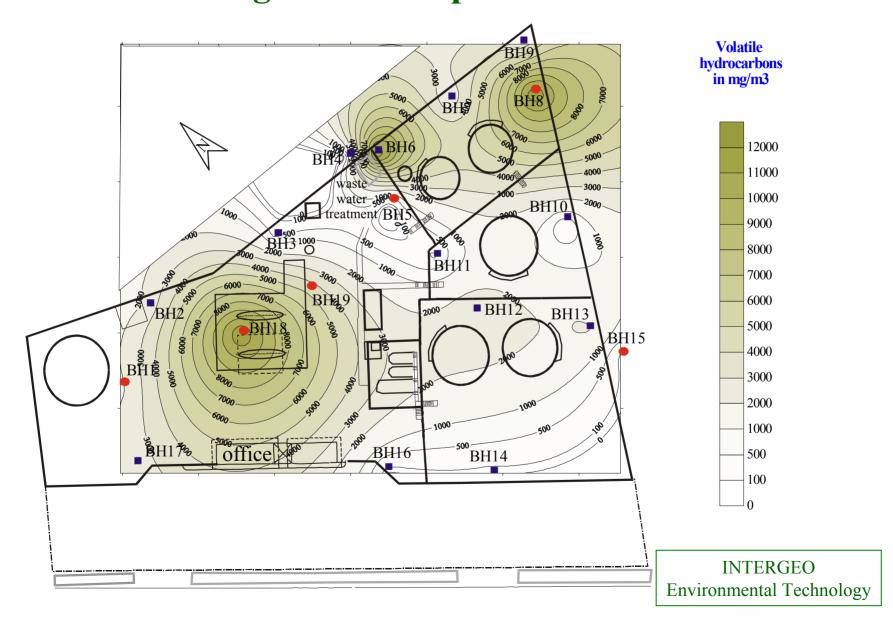
Distribution of volatile hydrocarbon concentration in the soil-gas at the depot terminal

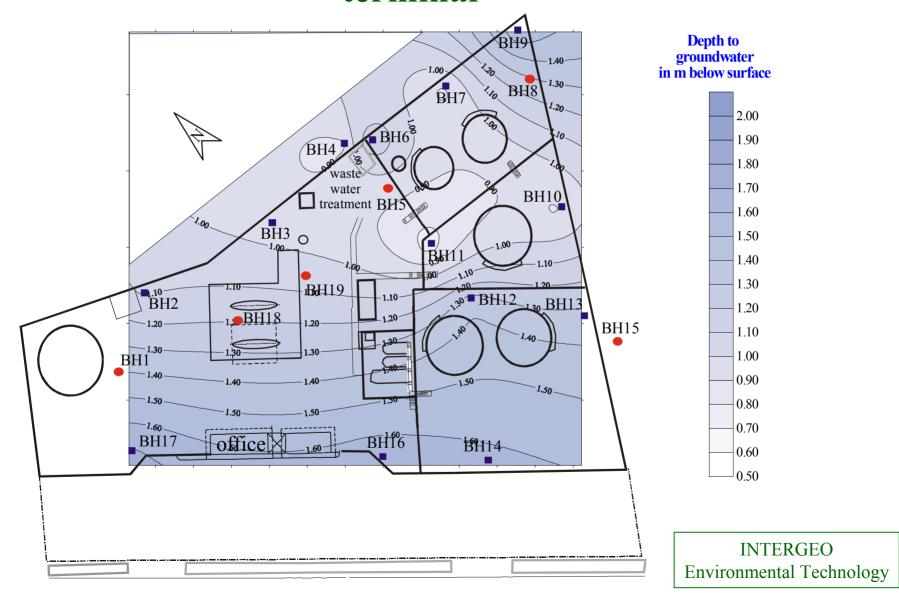
Depth to the groundwater at the site of the depot terminal

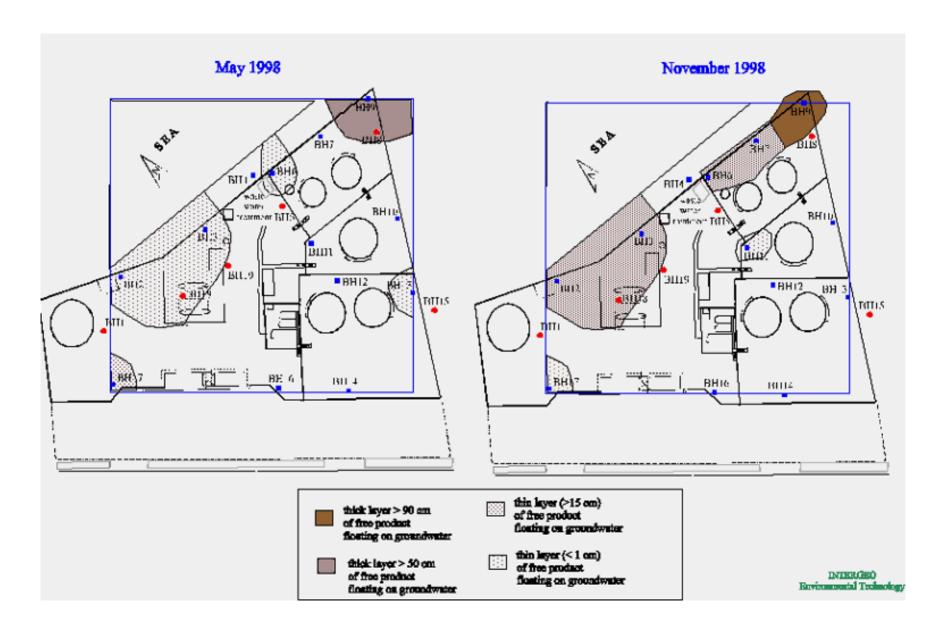
Estimated extent of floating free product on groundwater at the depot terminal (May '98-Nov '98)

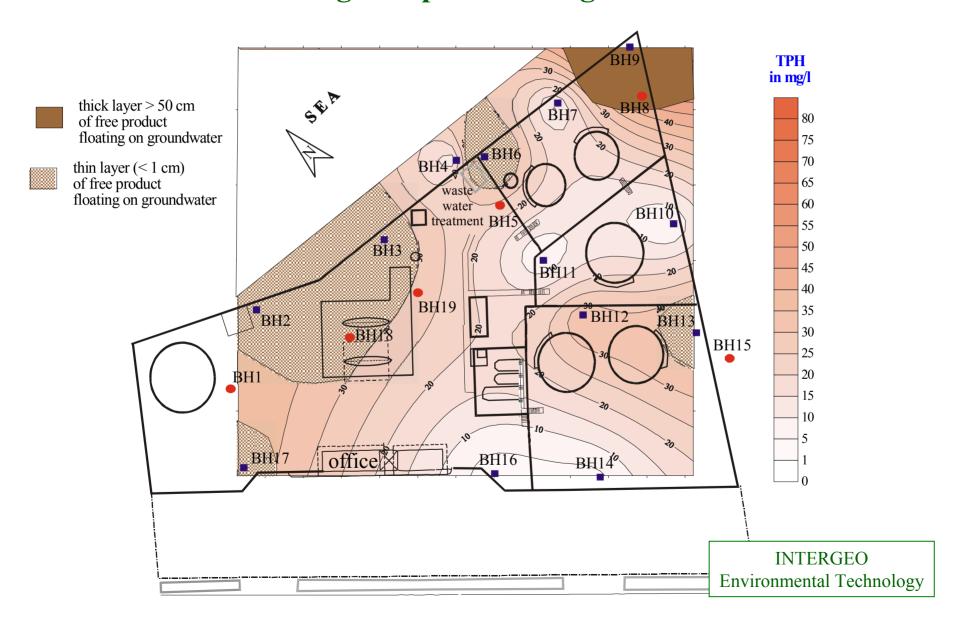
Distribution of TPH concentration in groundwater & estimated extent of floating free product on groundwater table

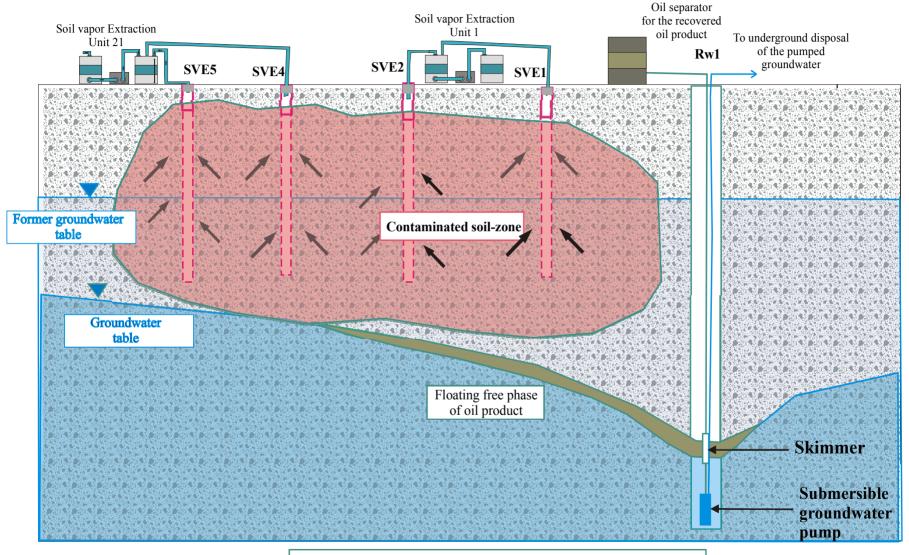
Initial concept of the proposed decontamination technique for the subsurface in the installation

SVE1 : Soi Vapor Recovery well : Groundwater Abstraction well + Oil Product recovery well

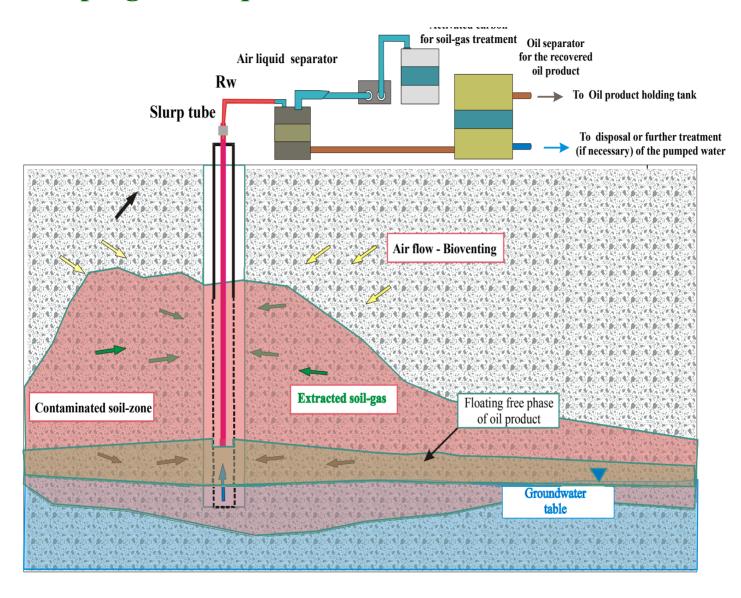
Bioslurping technique for the subsurface in the installation

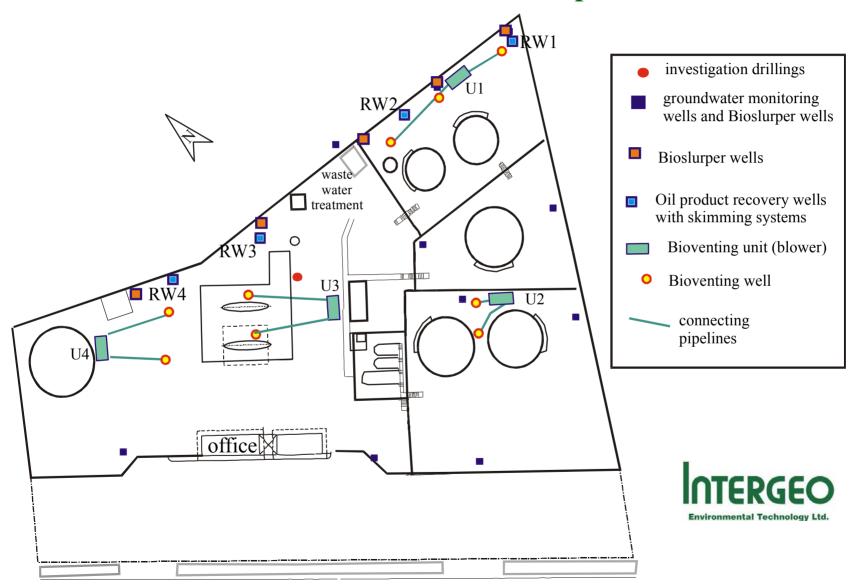
Applied soil and groundwater Decontamination measures at Depot terminal

Decontamination measures in the Depot Terminal

For the unsaturated soil:

Implementation of the in situ method of "Bioventing" in 4 areas within the installation For the groundwater:

- 1) Installation of Skimming system for free product recovery [at least four (4) recovery wells]
- 2) Implementation of Bioslurping technique in 5 monitoring wells

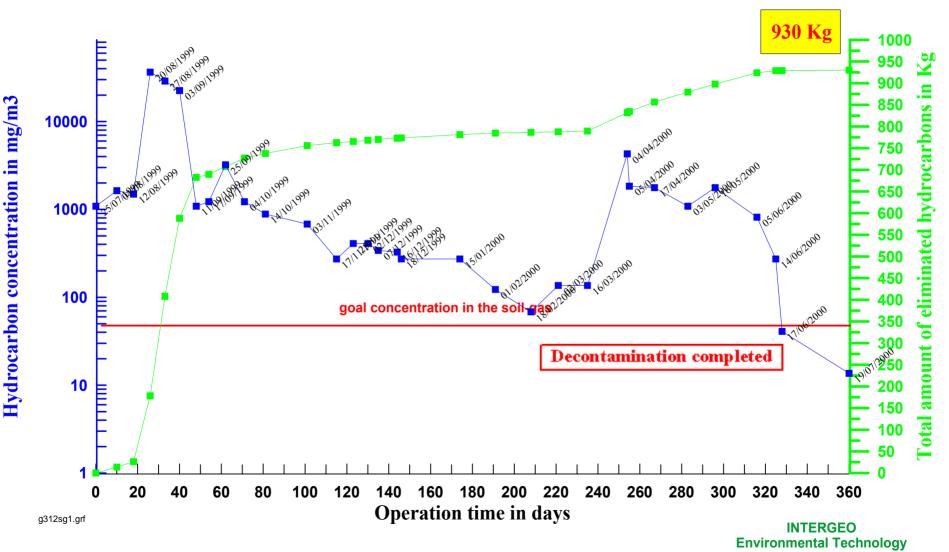
Progress of soil decontamination procedure Operation time of SVE unit 1: 25/7/1999-19/7/2000 at the Depot terminal

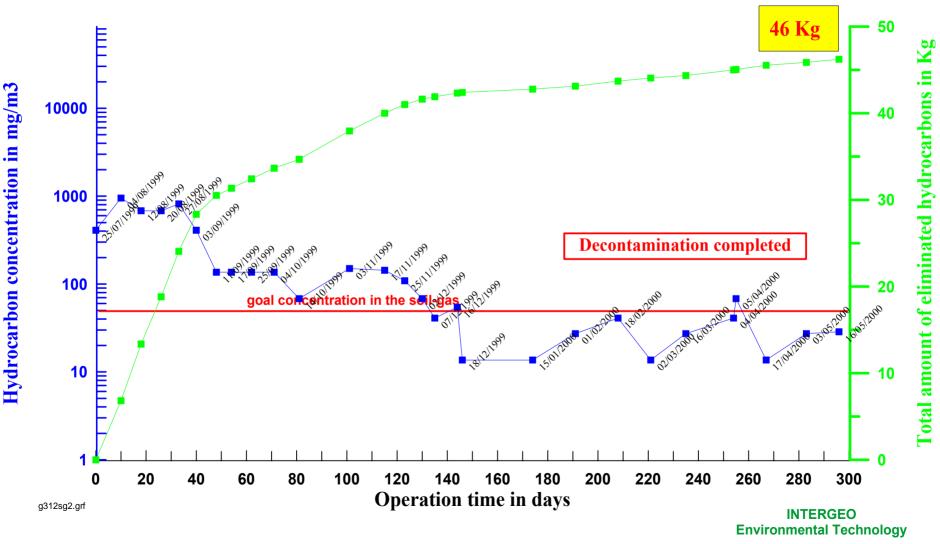
Progress of soil decontamination procedure Operation time of SVE unit 2: 25/7/1999-17/5/2000 at the Depot terminal

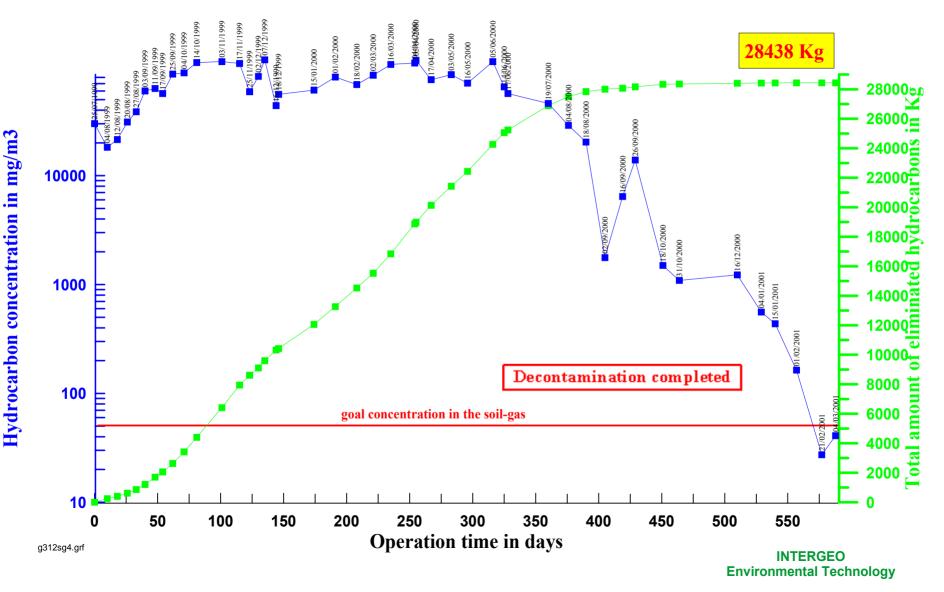
Progress of soil decontamination procedure Operation time of SVE unit 4: 25/7/1999-4/3/2001 at an installation

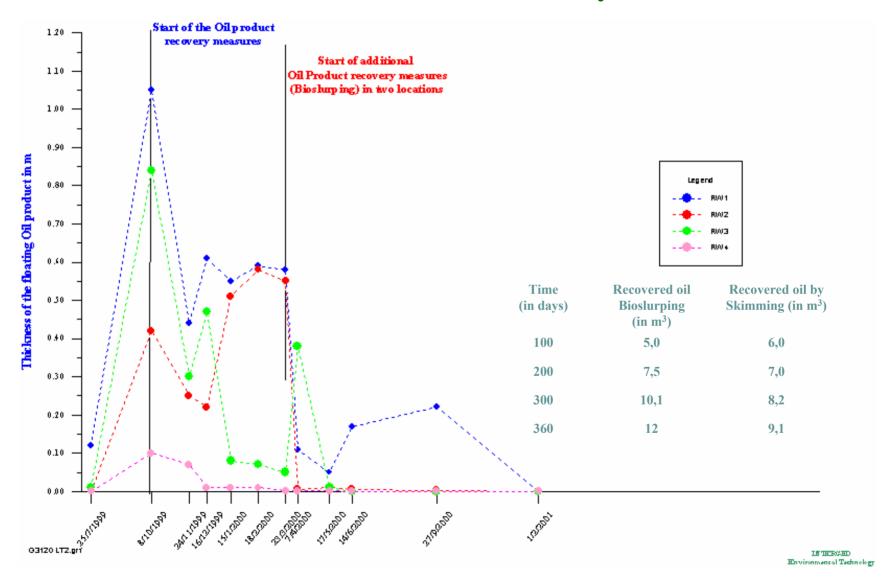
Progress of the oil product floating on the groundwater - Measurements in the recovery wells

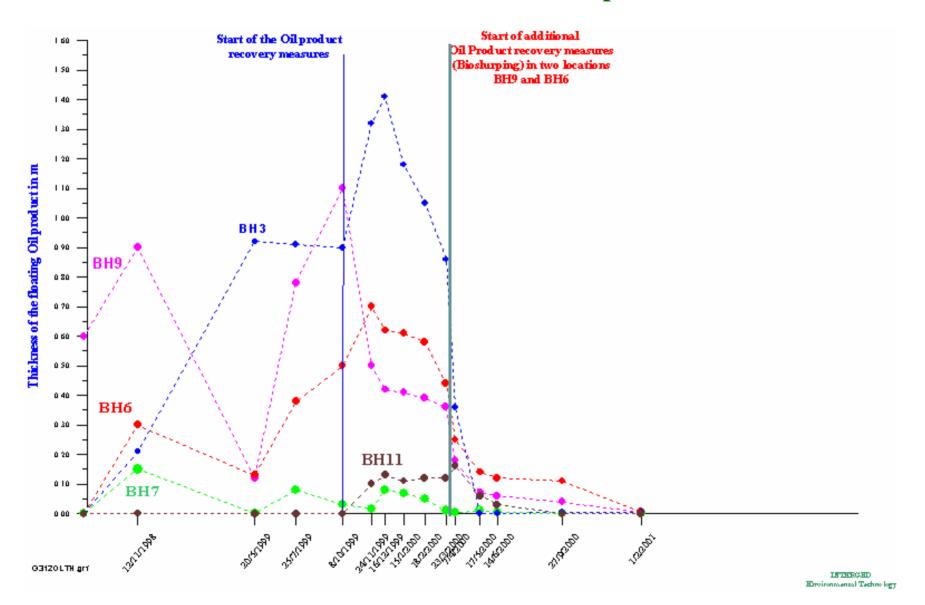
Thickness of the oil product floating on the groundwater - Measurements in the Bioslurper wells
