Lessons Learned Applying Multiple Remediation Technologies at Air Force Plant 4

FRTR Presents...Evolution of Subsurface Remediation: Lessons Learned from Technical Challenges to Achieving Cleanup Goals - Part 2

Air Force Plant 4

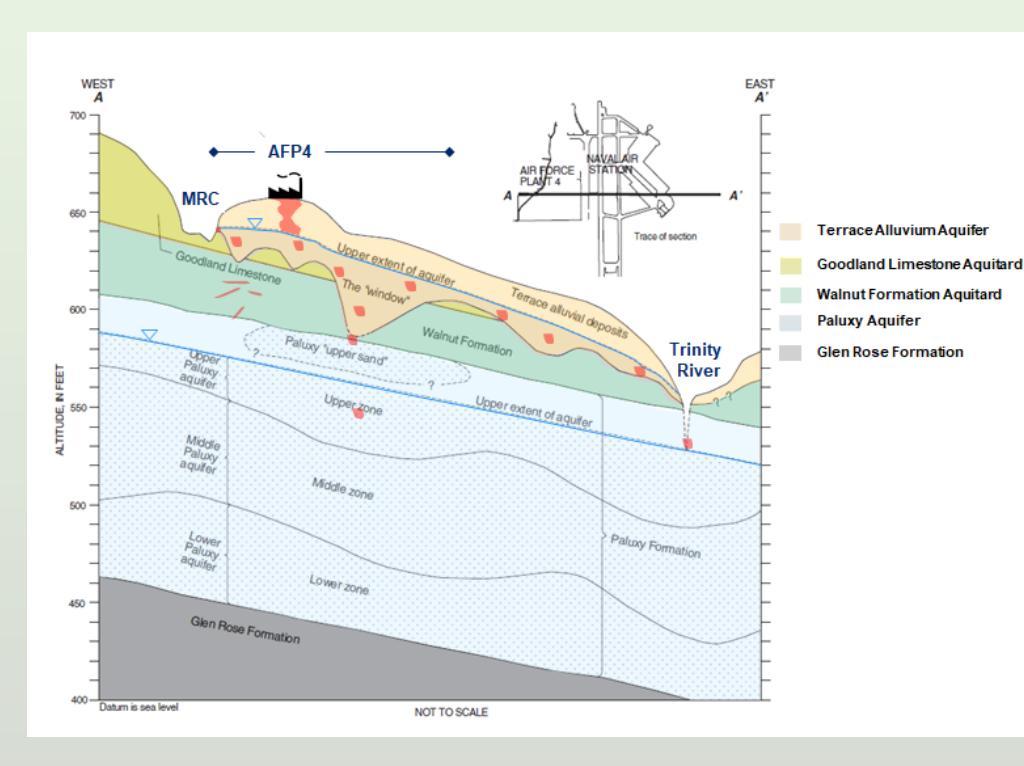
Hydrogeologic Setting

- Groundwater divide along Bldg 5
 - Eastward West Fork of the Trinity River
 - Westward flow to Meandering Road Creek (MRC)

- Terrace alluvial deposits
- Goodland Limestone
- Walnut Formation
- Paluxy Formation
 - Upper, middle and lower zones
- Glen Rose Formation

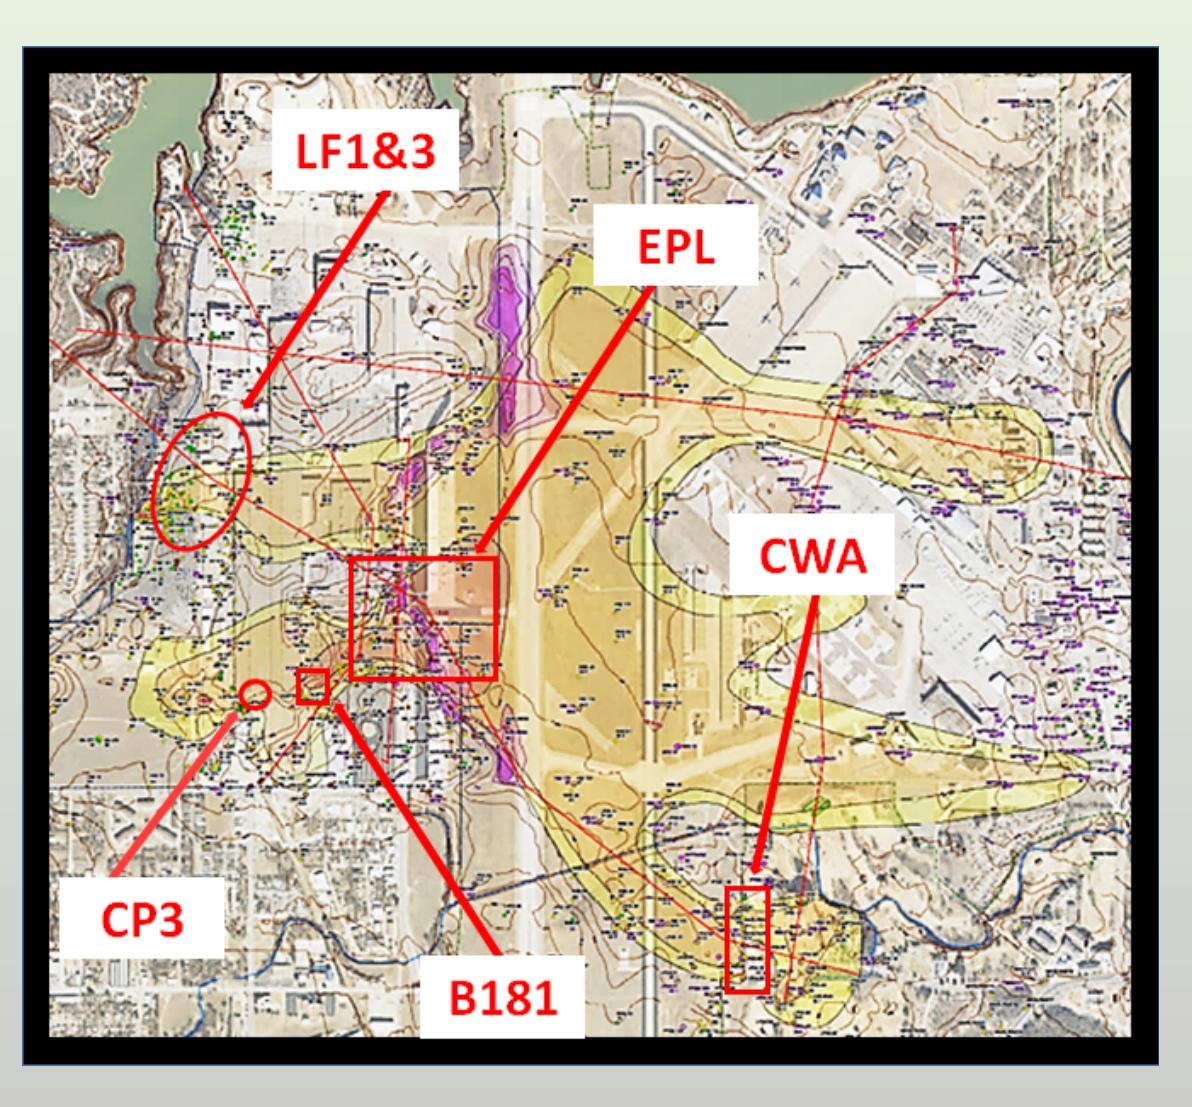
TCE Plume Areas of Concern

- Building 181 (B181)
 - Source of eastern plume
- East Parking Lot (EPL)
 - Dissolved-phase plume
- Carswell Area (CWA)
 - Southern Lobe of the EPL Plume
- Landfill 1 and Landfill 3 (LF1&3)
 - DNAPL source and dissolved-phase plume
- Chrome Pit 3 (CP3)
 - Chrome waste disposal pit
 - Separate TCE source from B181

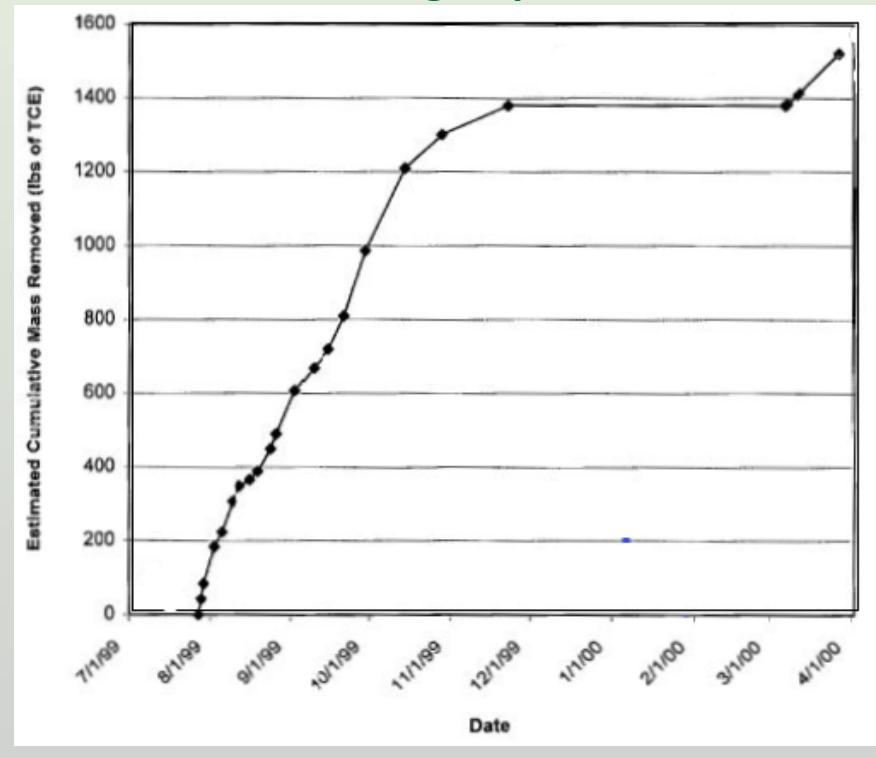
Cumulative TCE removal from August 1999 through April 2000

- Pilot test in 1993, full scale in 1999
- Operation from 1993 to 2002
- Removal rates started high and became asymptotic by 2000
- ~ 1,500 lbs of TCE were removed through SVE as of April 2000
- System augmented with ERH to facilitate volatilization and increase the TCE removal rate

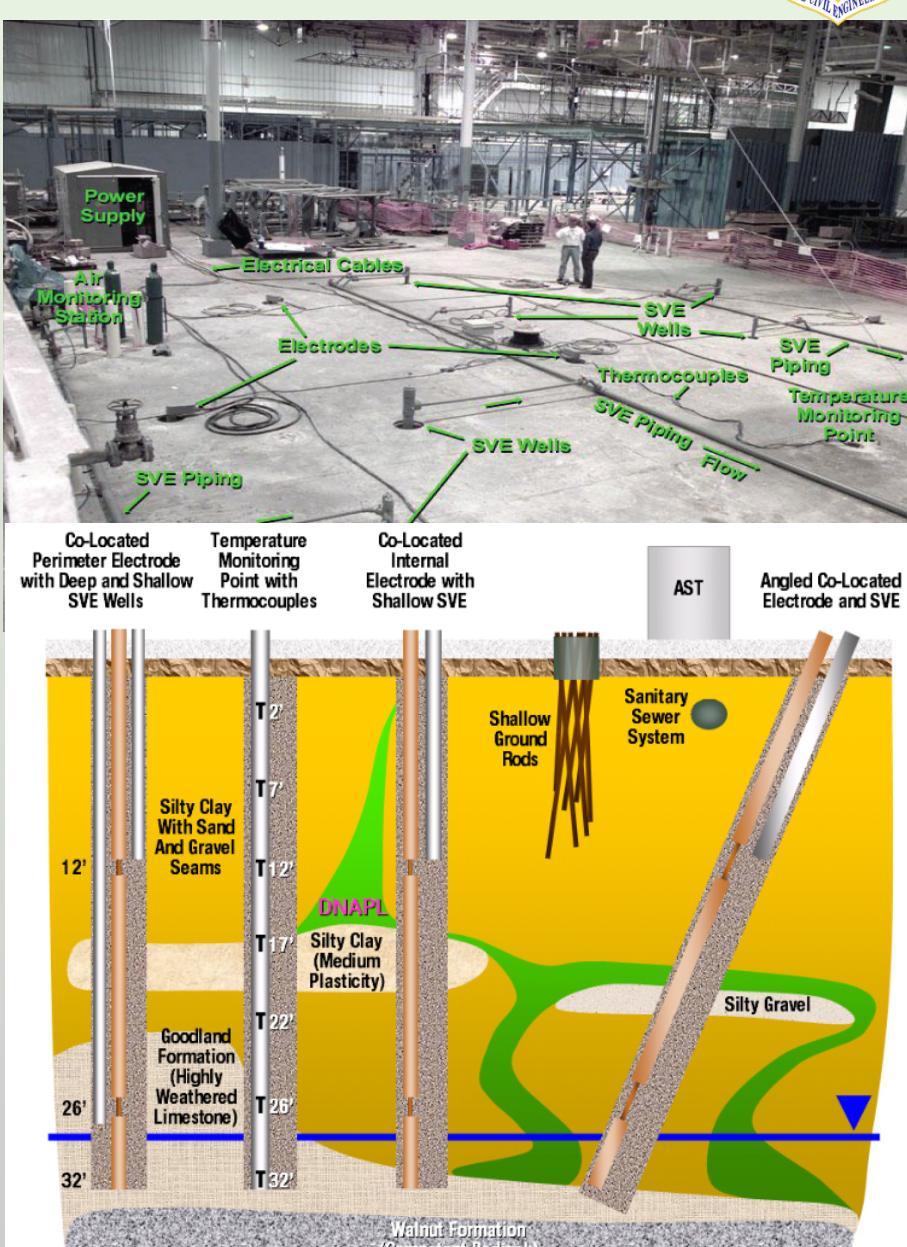
B181 ERH Layout and Operation

- 6-phase heating
- Pilot tested for 13 weeks
- Scaled up to cover ~ 22,000 ft²
 - (200 ft × 140 ft)
- Design Summary
 - 73 electrodes placed to 35 ft bgs
 - 10 TMPs at 7 discrete depths
 - 81 groundwater sampling points
 - ~150 soil-vapor locations
- Larger-scale system operated for ~8 months
 - 5/13/02 to 12/19/02
 - Heated GW to ~90°C

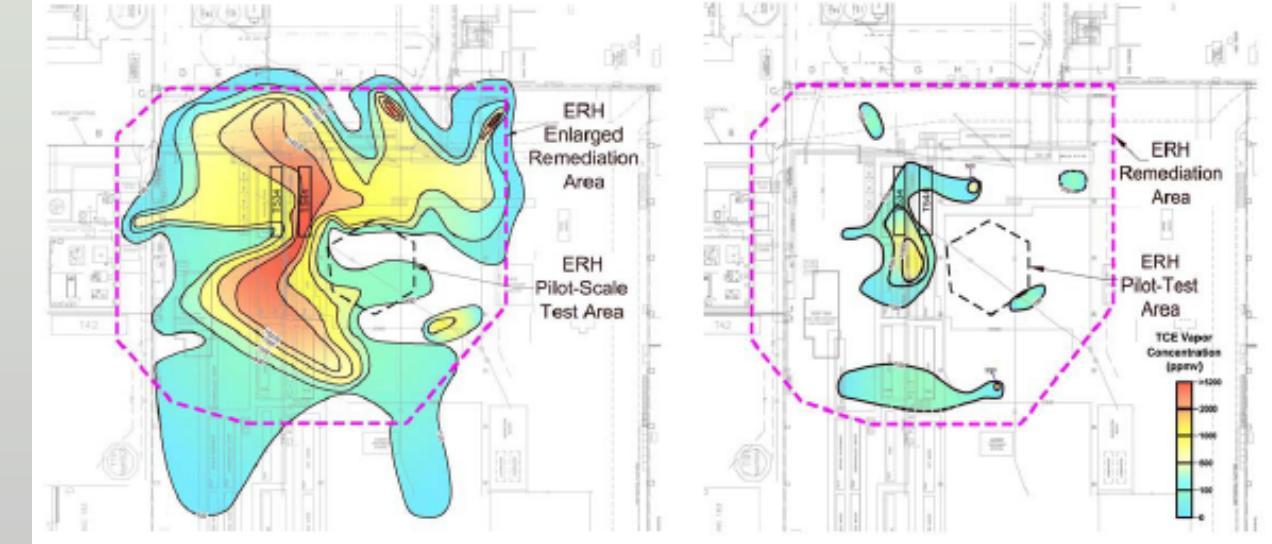
ERH Performance Assessment

- Total TCE mass removed (1,417 lbs)
- Soil-vapor concentrations:
 - Mean SV TCE concentration was reduced by 93%
 - Max conc. decreased from > 5,200 to 1,358 ppmv
 - Vapor plume greater than 100 ppmv reduced in size
- Groundwater TCE concentrations:
 - Mean GW TCE concentration reduced by 87% (33.2 to 4.3 mg/L)
 - 353% increase in average chloride concentration
- Follow-on includes ISCO (hot spot) and EISB
 - Note: TCE concentration rebounded and was measured at 16,400 μg/L in 1/18

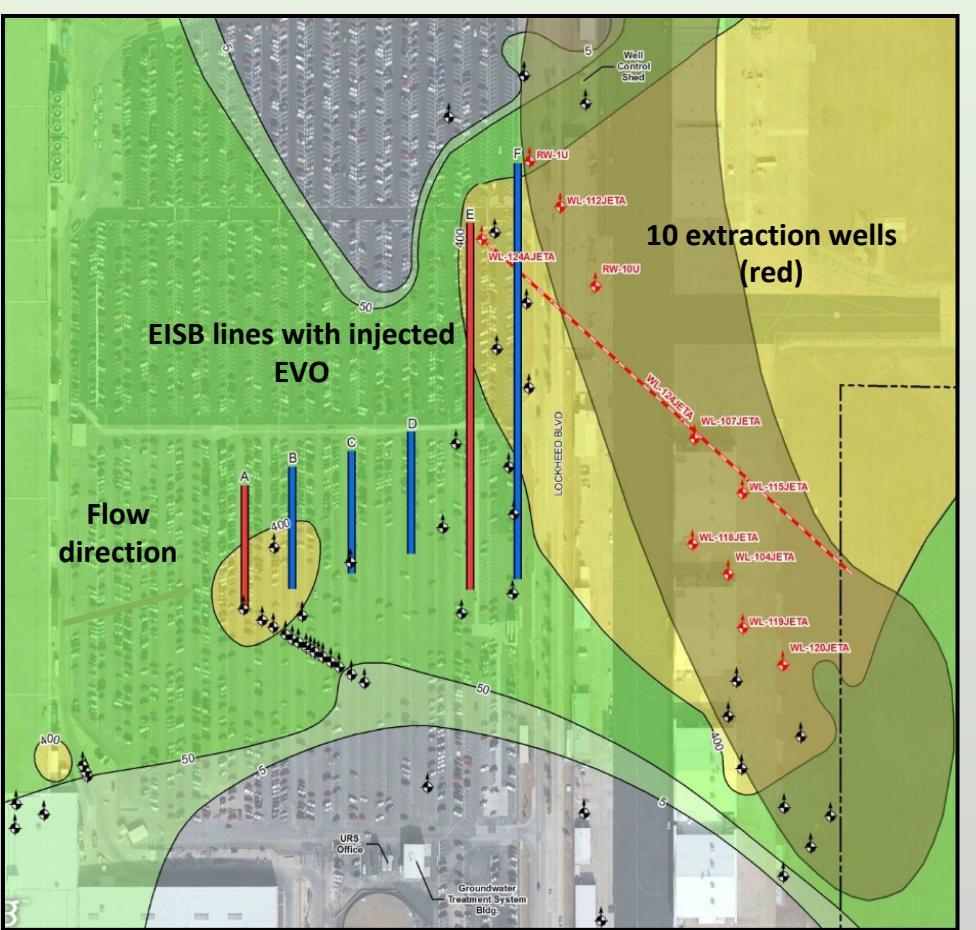
EPL Systems Layouts

- Pump and treat
 - Installed in 1993 with 7 extraction wells
 - Expanded to 51 extraction wells in 1999
 - Down to 50 extraction wells in 2011
 - Down to 10 extraction wells in 2013
 - 8 extraction wells in 2014
 - System shutdown in 2015
 - EISB continues

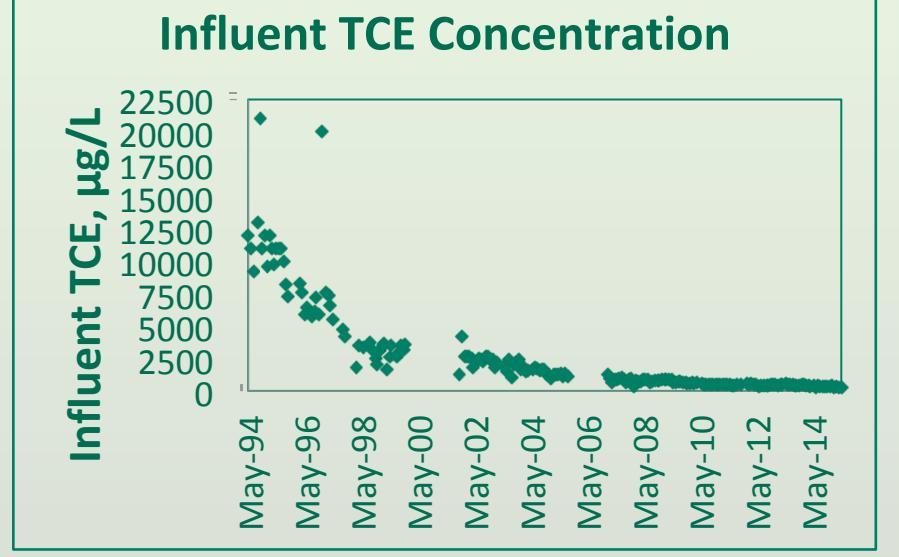
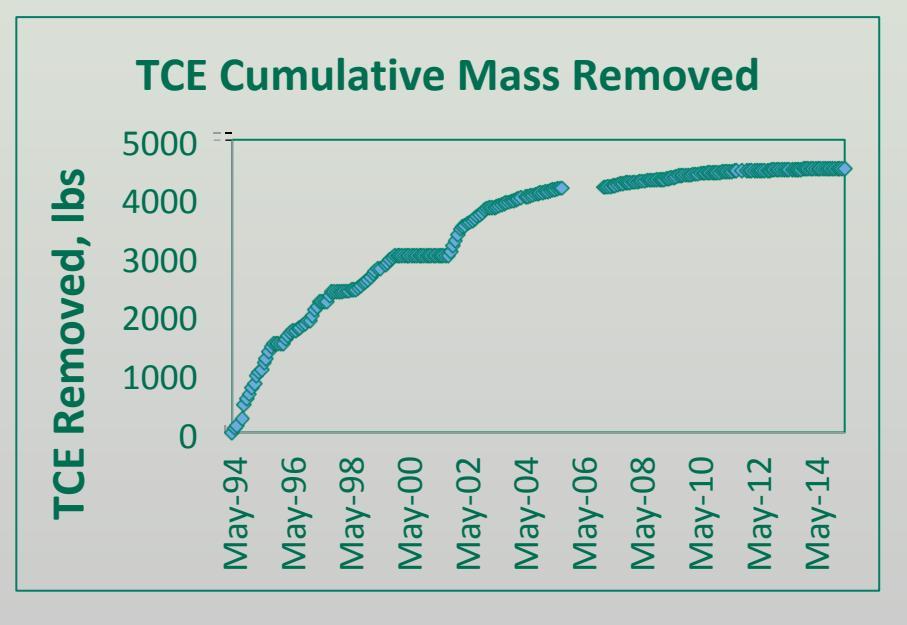
EPL P&T Performance

- P&T operated ~25 years
- Design for 150 gpm, ~50 gpm max achieved
- Initial influent TCE concentrations ~10,000 to 15,000 μg/L
- Below 5,000 μg/L in ~ 3 years
- Asymptotic at ~400 µg/L for ~7 to 8 years
- Overall TCE mass removed estimated at ~4,500 lbs

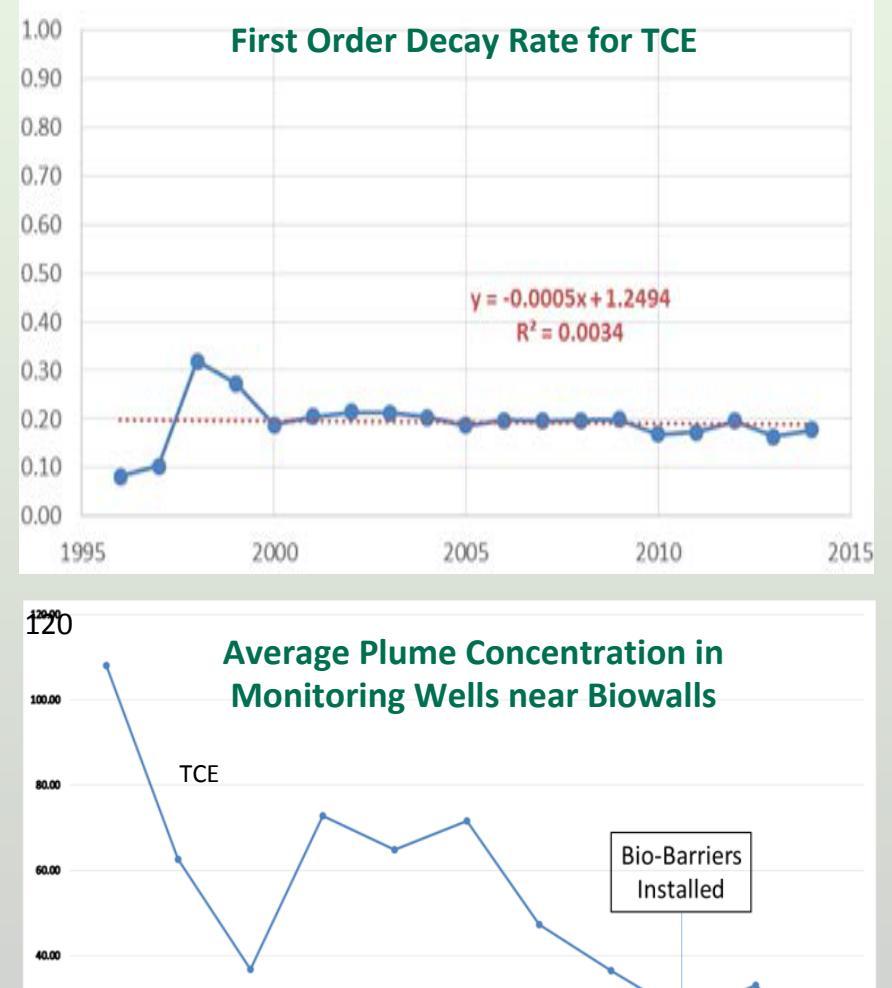
OTIE Overall Performance Analysis (EPL)

- Uniform decay rate regardless of remedial actions (P&T, biowalls, MNA)
- Engineered remedies have no greater impact than natural attenuation on plume mass
- Back diffusion mass flux may overwhelm mass removed by engineered systems

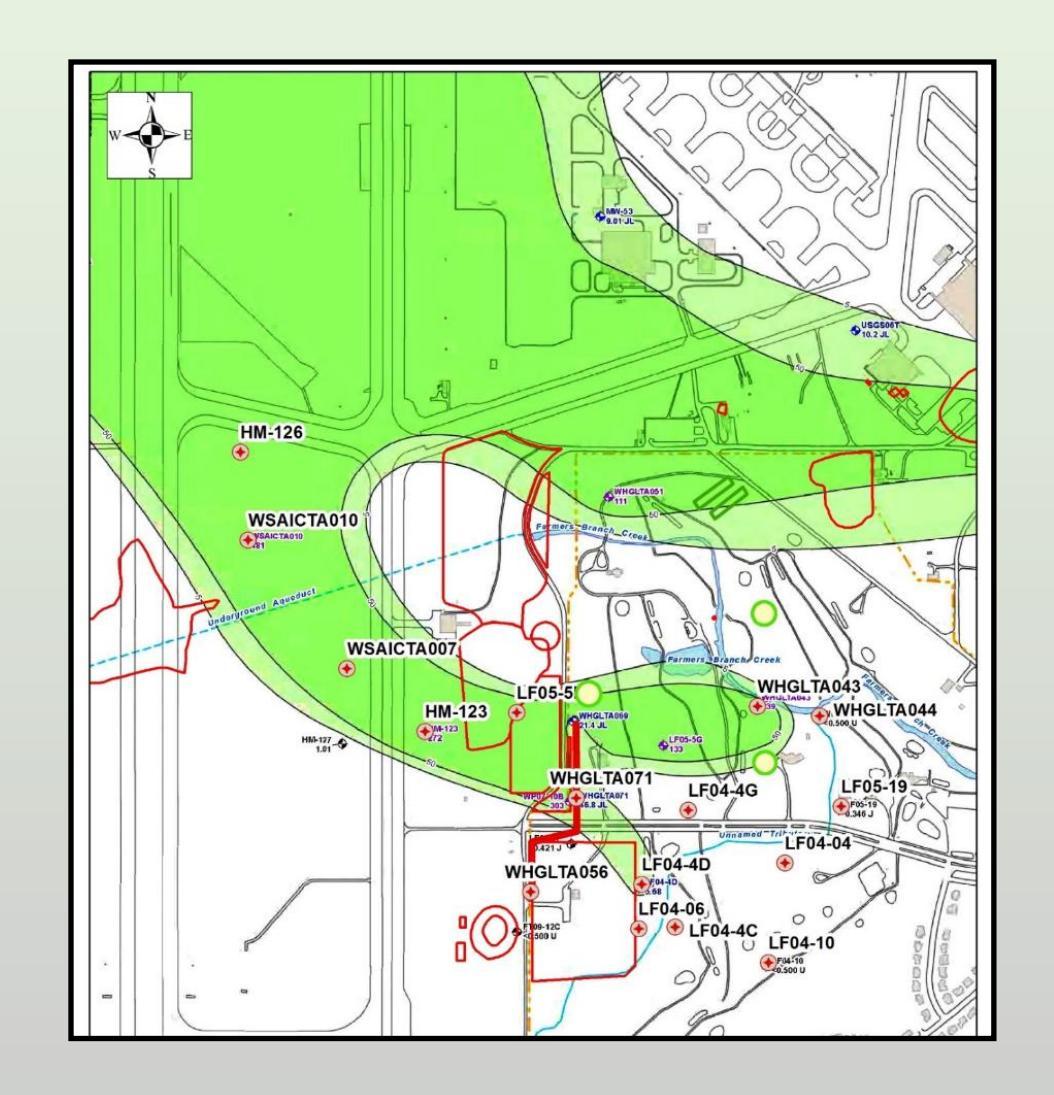
CWA Systems Layouts

• ZVI PRB

- Designed to prevent further migration of TCE beyond installation boundary
- 1,170 foot long, 2 foot wide, 35 foot deep
- 50-50 mix of iron filings and sand
- Construction Completion on September 15, 2006

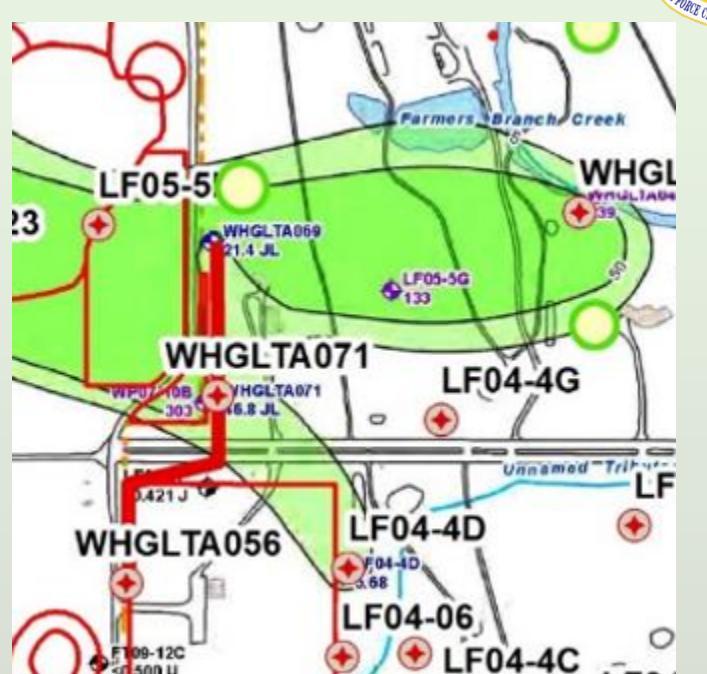
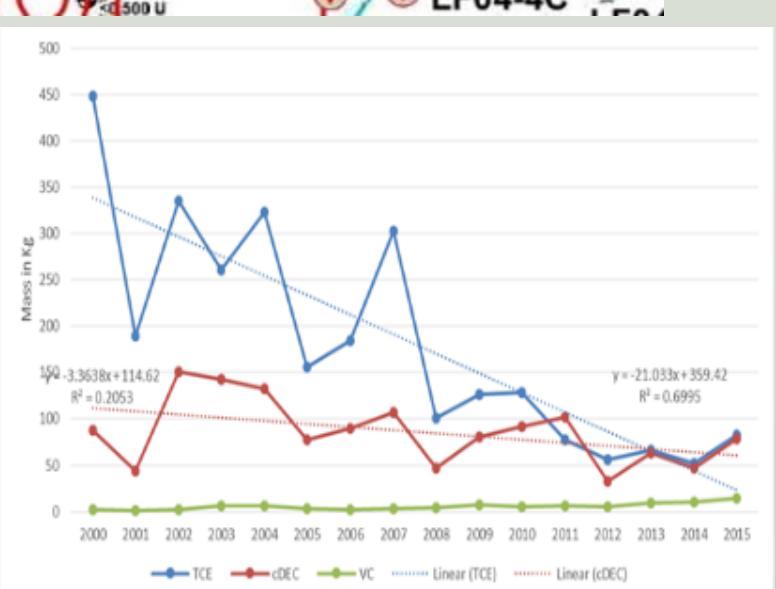
CWA PRB Assessment

- PRB performance Assessment
 - Adversely effected GW flow pattern; violating design constraints
 - ZVI has lost its effectiveness
 - No method to effectively rejuvenate
 - Conversion to biobarrier
 - Downgradient VC concentrations increasing
 - Benefit for TCE degradation is not sustainable for long-term effectiveness

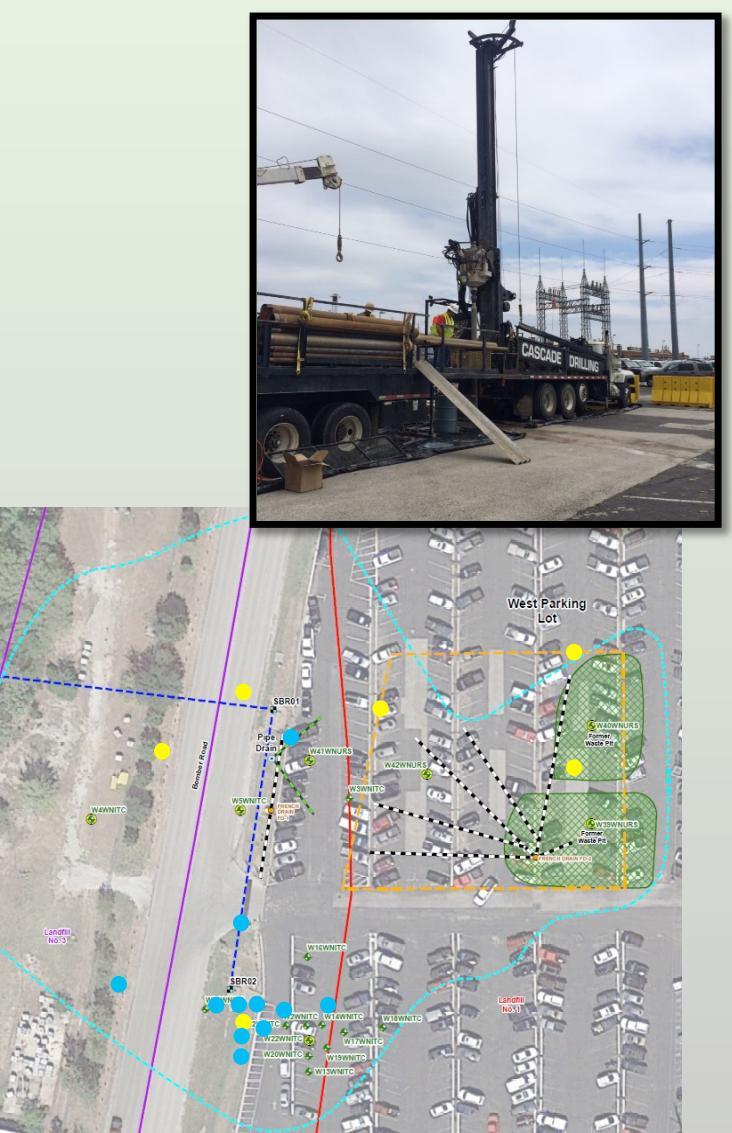
LF1 DNAPL Recovery

- Determine practicability of removing mass through DNAPL extraction wells
- Installed 4 new extraction wells in the Walnut Formation
 - Recover DNAPL via pumping or bailing
 - Frequency based on how quickly product accumulates in the well
- Monitor DNAPL thickness in neighboring Walnut wells monthly to determine how recovery is affecting surrounding area

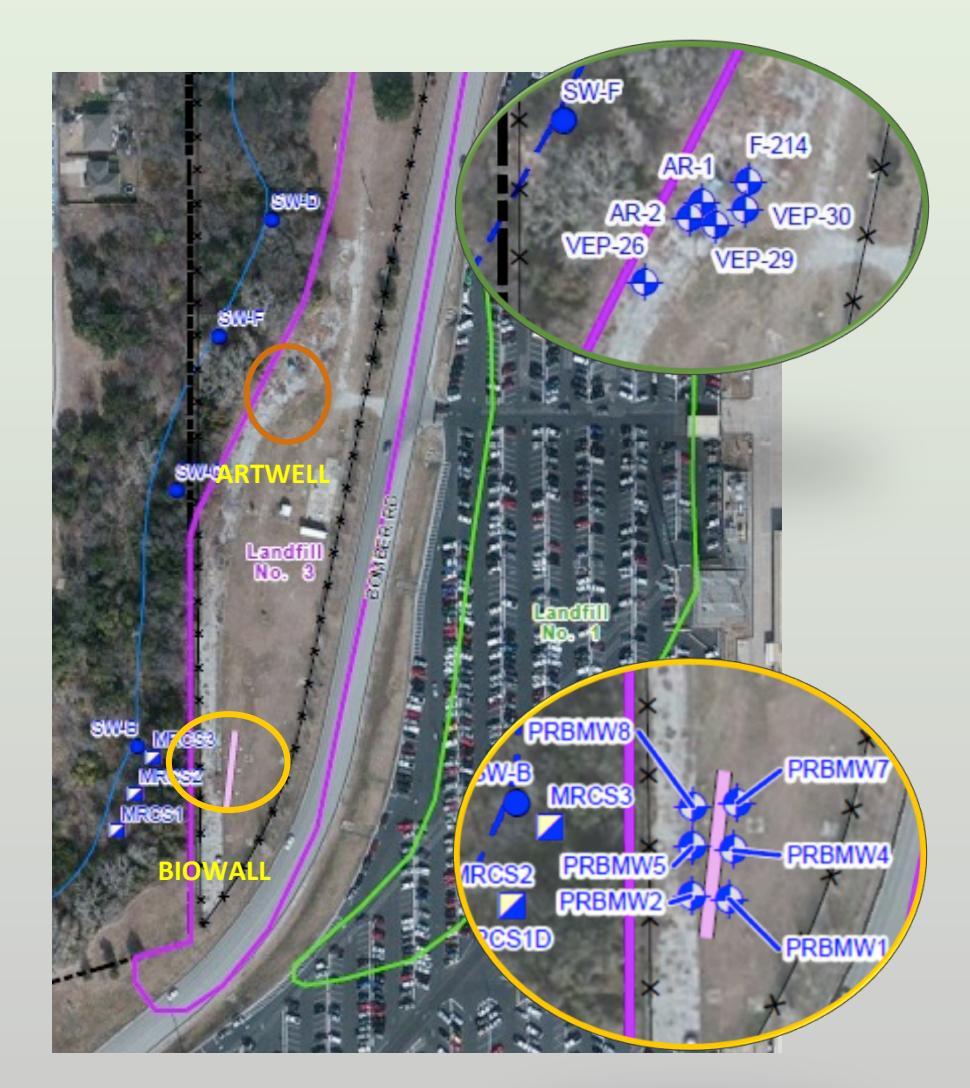
LF3 EISB Pilot Study

- Inject biostimulants into the biowall and ART well area to reduce LF3 groundwater cVOC concentrations
- Implementation Overview
 - First injections performed May -October 2013
 - EHC-L (food)
 - KB-1 (bacteria)
 - Second injections performed March - September 2015
 - EHC-L (food)
 - EHC (food + ZVI)
