Technology Overview Using Case Studies of Alternative Landfill Technologies and Associated Regulatory Topics

March 2003

Prepared by
Interstate Technology & Regulatory Council
Alternative Landfill Technologies Team

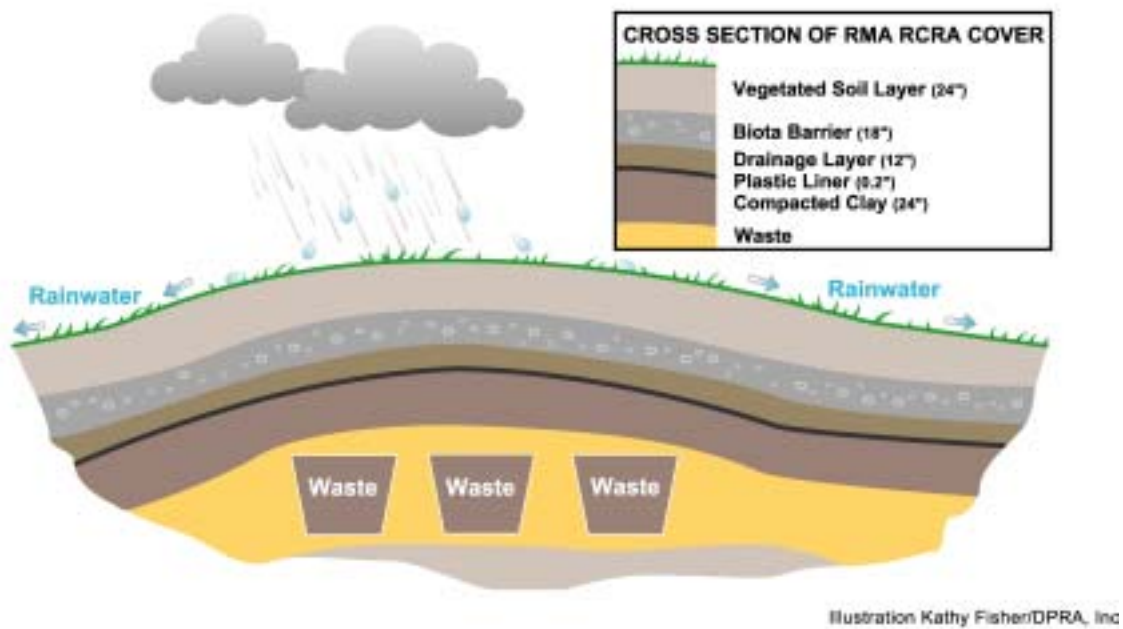
Figure 2-1. Cross section of RMA RCRA cover.

If the RCRA Demonstration Project failed to demonstrate equivalency, a prescriptive RCRA Subtitle C cap would be constructed. A comparison of the two cover systems at RMA is exhibited in Figs. 2-1 and 2-2.

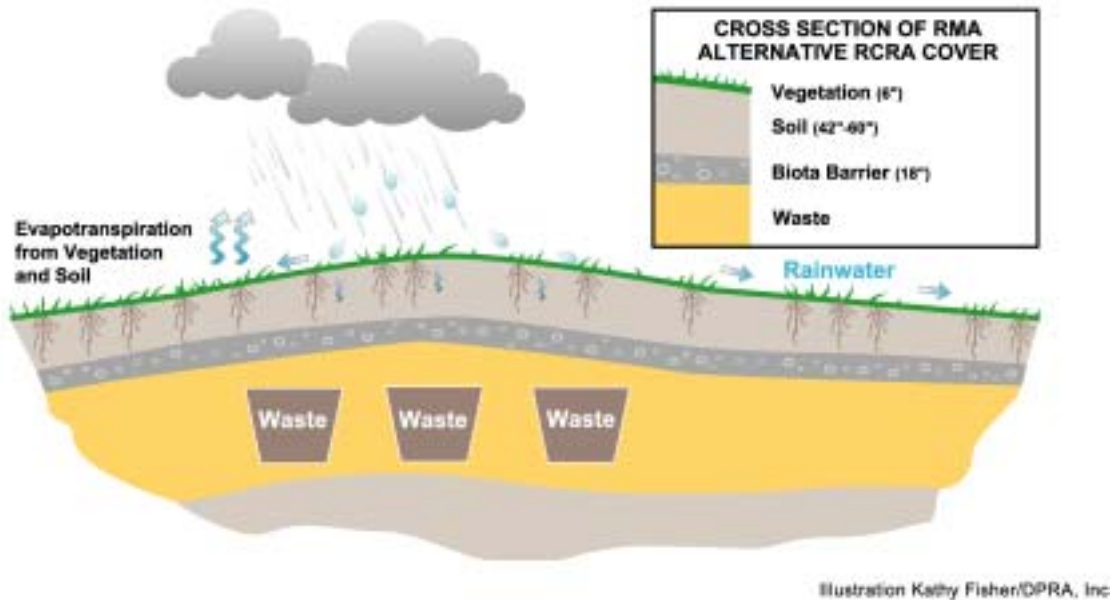
Figure 2-2. Cross section of RMA alternative RCRA cover.

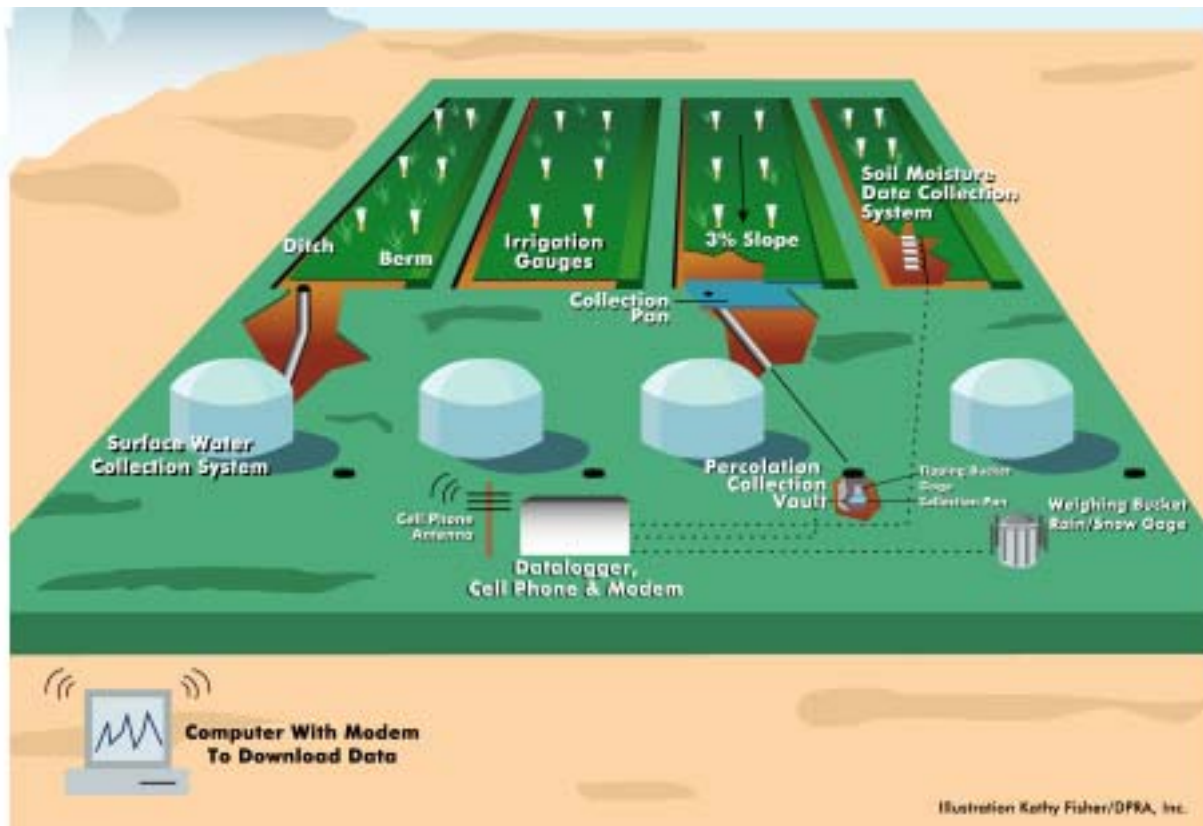
Figure 2-3. RCRA-Equivalent Cover Demonstration Project monitoring instrumentation.

After construction of the field demonstration, vegetation was allowed to establish over a three-year period. Beginning September 1, 2000, a one-year test period was conducted to determine if the test covers could meet the performance criterion of having no more than 1.3 mm of percolation during the test year. Natural precipitation was supplemented with irrigation to achieve wet conditions during the test year. Weekly inspections were conducted throughout the vegetation establishment period and the test year to check the condition of the field demonstration, as well as to collect and evaluate monitoring data. The monitored items include those displayed in Fig. 2-3 and described below:

- **Soil Moisture Data**—Soil moisture probes were placed in the test cover profile to monitor soil moisture conditions. A set of eight probes was placed on each of three covers, while three sets were placed on the fourth cover for a total of 48 soil moisture probes. The probes were wired to a data collector allowing data to be accessed remotely.

- **Precipitation Data**—A weighing bucket precipitation gage was installed near the test covers to provide measurement of natural precipitation. Data can be accessed remotely, or obtained from direct readings of the gage chart paper.

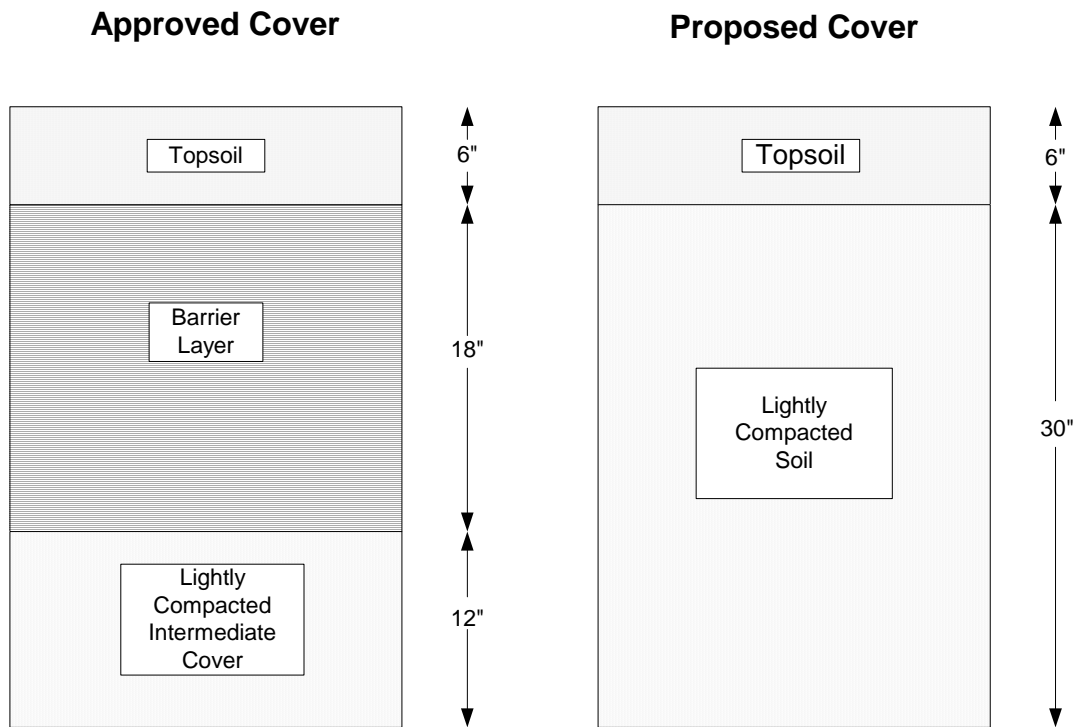
Figure 3-1. Soil cover design comparison.

The alternative cover system is known variously as an “evapotranspiration (ET) cover,” a “monolithic cover,” or a “sponge cap.” Fig. 3-1 depicts the two systems considered in this project.

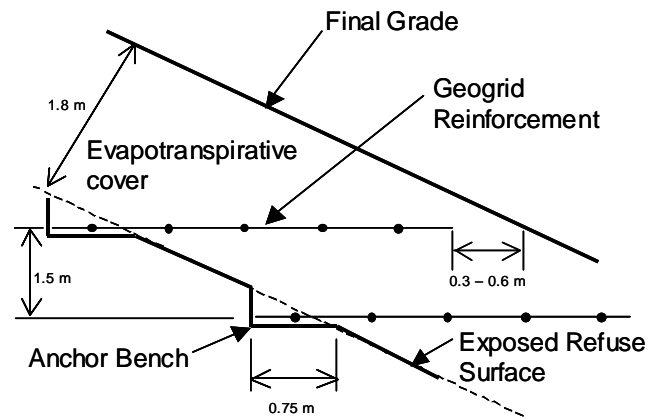
Figure 4-1. Typical reinforcement detail for horizontal reinforcement anchored into solid waste (from Zornberg et al. 2001).

After evaluating various alternatives, geogrid reinforcement were used for veneer stability of the north slope. Stability analyses showed that for most available cover materials, compacted to practically achievable levels of relative compaction on a 1.5:1 slope, the minimum static and seismic stability criteria were not met. Veneer geogrid reinforcement with horizontally placed geogrids was then selected as the most appropriate and cost-effective method for stabilizing the north slope cover (Zornberg et al. 2001). The veneer reinforcement consisted of polypropylene uniaxial geogrids, installed at 1.5-meter vertical intervals for slopes steeper than 1.8:1 and at 3-meter vertical intervals for slopes between 2:1 and 1.8:1. The geogrid panels were embedded a minimum of 0.75 meters into the exposed refuse slope face from which the preexisting cover had been stripped. The geogrid panels were curtailed approximately 0.3–0.6 meters away from the finished surface of the slope cover to permit surface construction, operation, and maintenance activities on the slope face without the risk of exposing or snagging the geogrid. Fig. 4-1 shows the typical veneer reinforcement detail selected based on the shear strength of the soils used in construction.

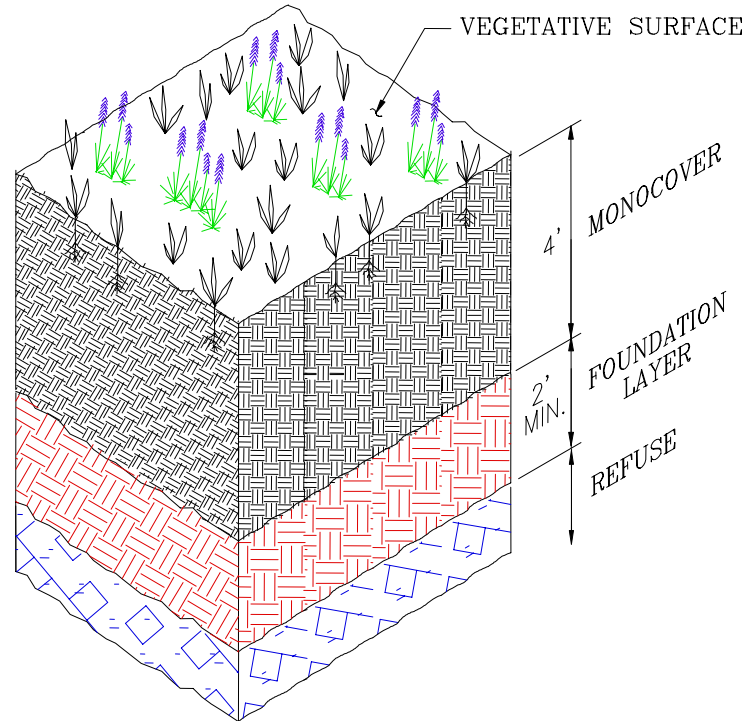
Figure 4-2. Schematic view of the evapotranspirative cover system.

Fig. 4-2 shows a schematic view of the cover cross section. The design of the final cover system at the OII Superfund site was also constrained by requirements involving shear strength, resistance to erosion, shrinkage potential, and ability to sustain vegetation. Erosion calculations

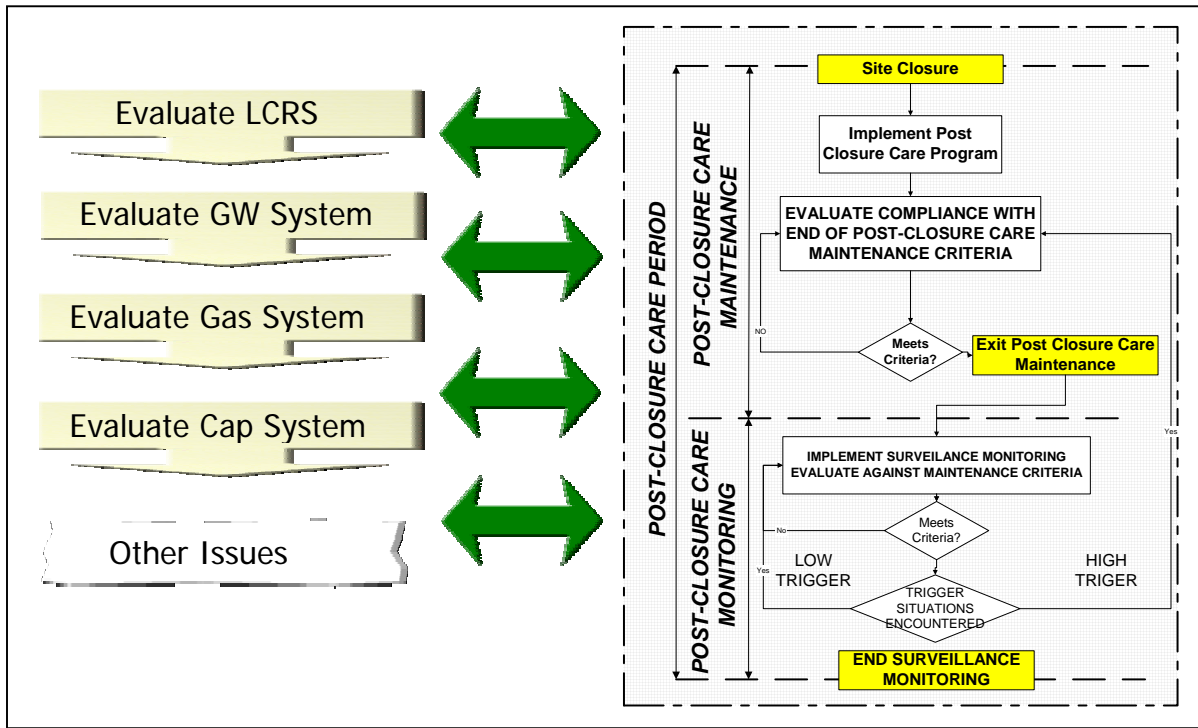
Figure 8-1. Postclosure care logic diagram.

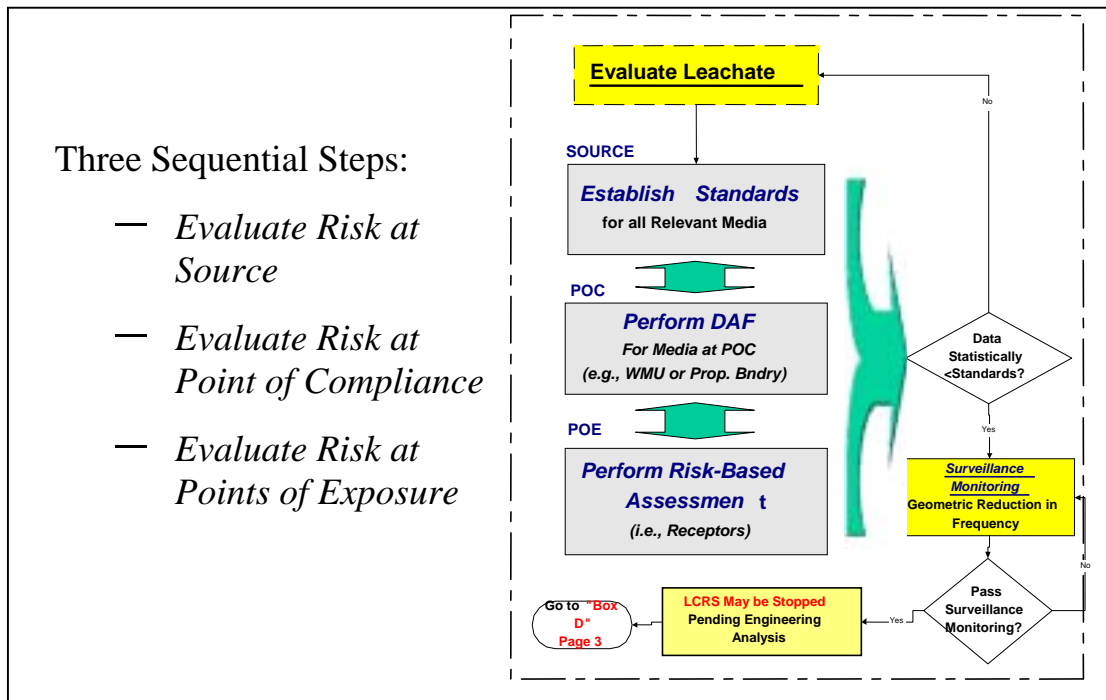
Figure 8-2. Leachate collection and recovery system logic diagram.

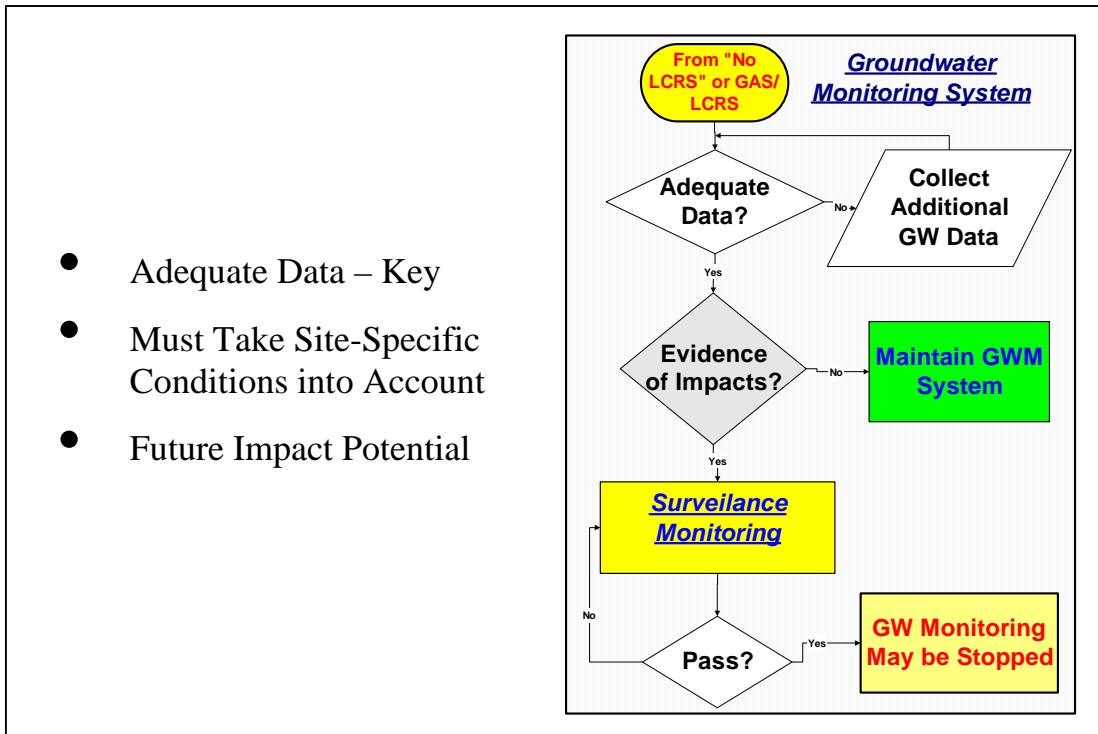
Figure 8-3. Groundwater monitoring logic diagram.

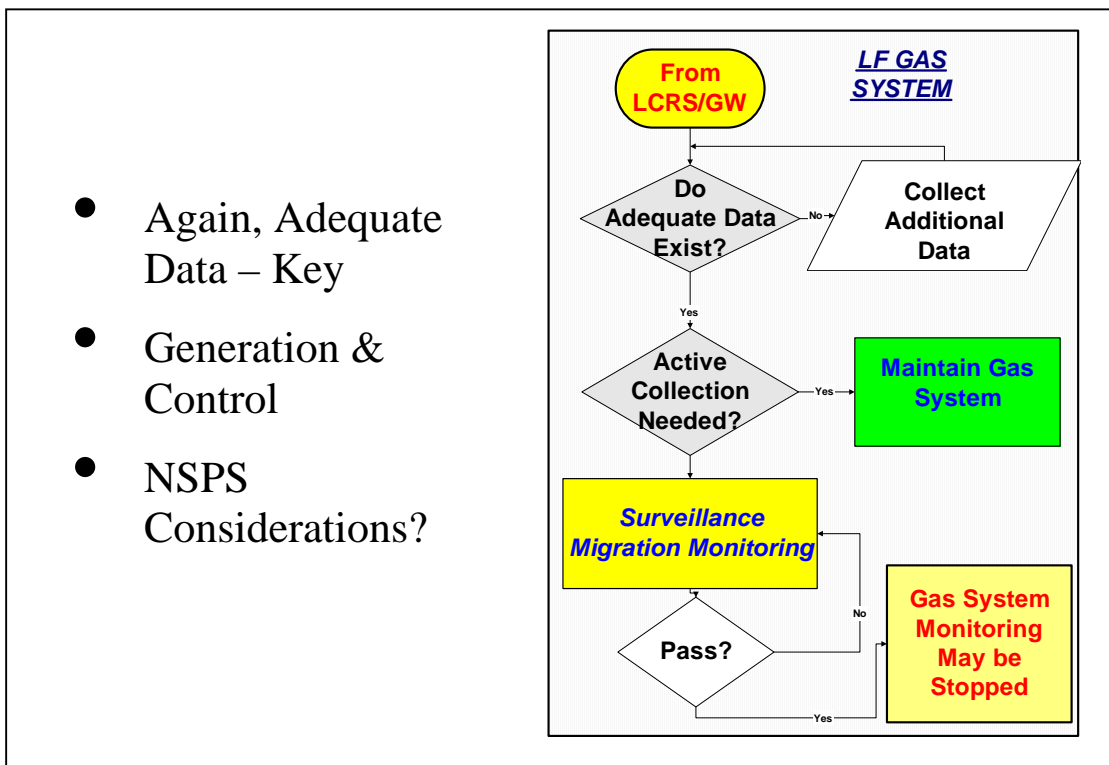
Figure 8-4. Landfill gas logic diagram.

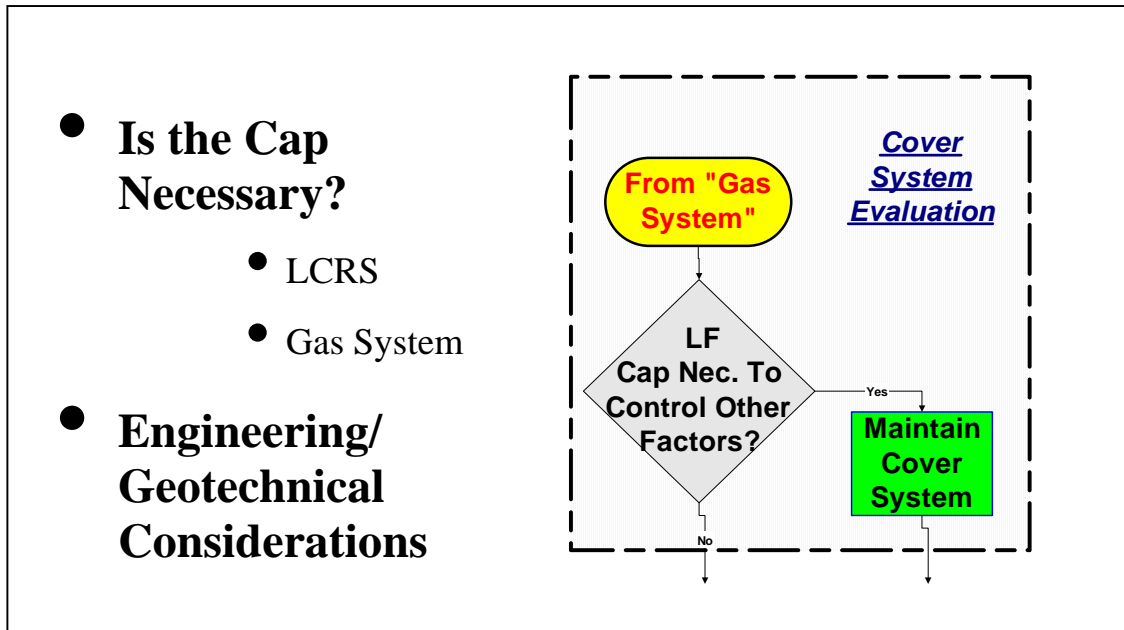
Figure 8-5. Cover system logic diagram.

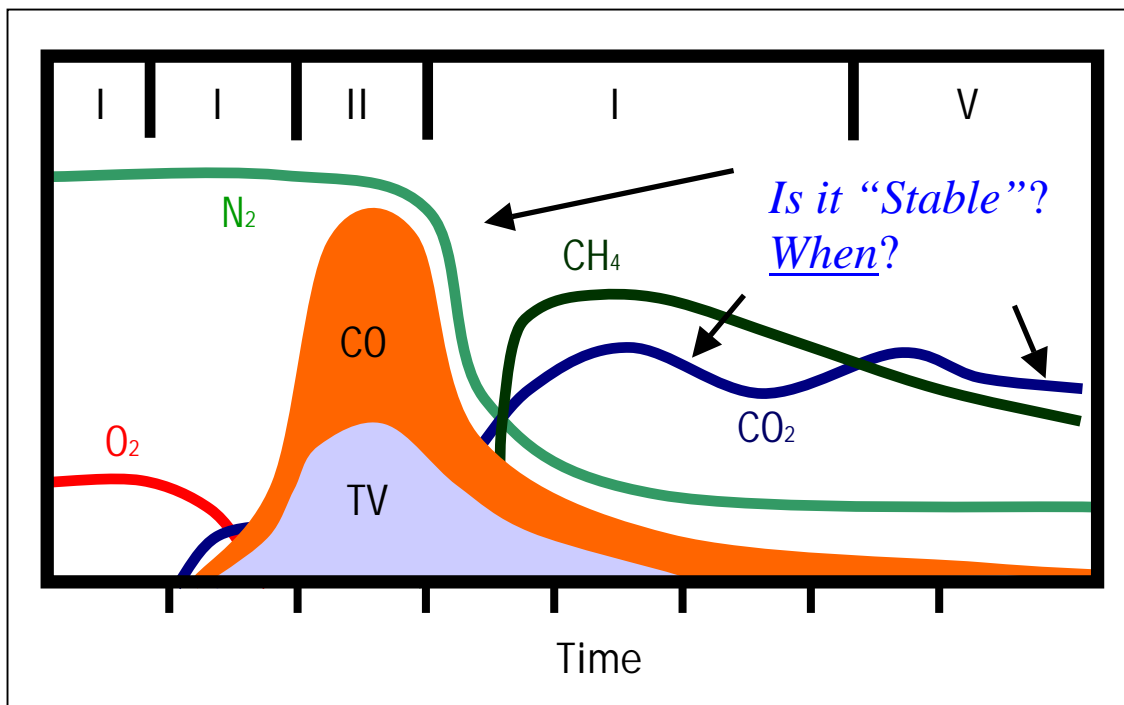
Figure 8-6. Typical landfill degradation phases of MSW and stability.

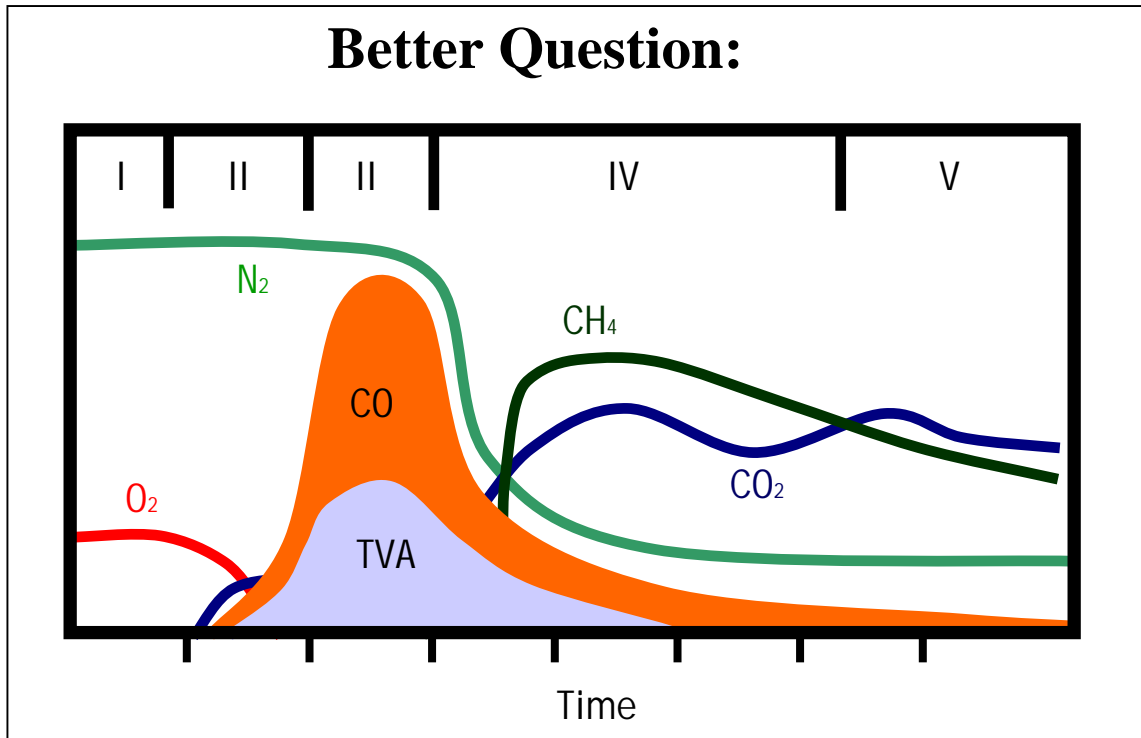
Figure 8-7. Typical degradation phases of MSW and risk.

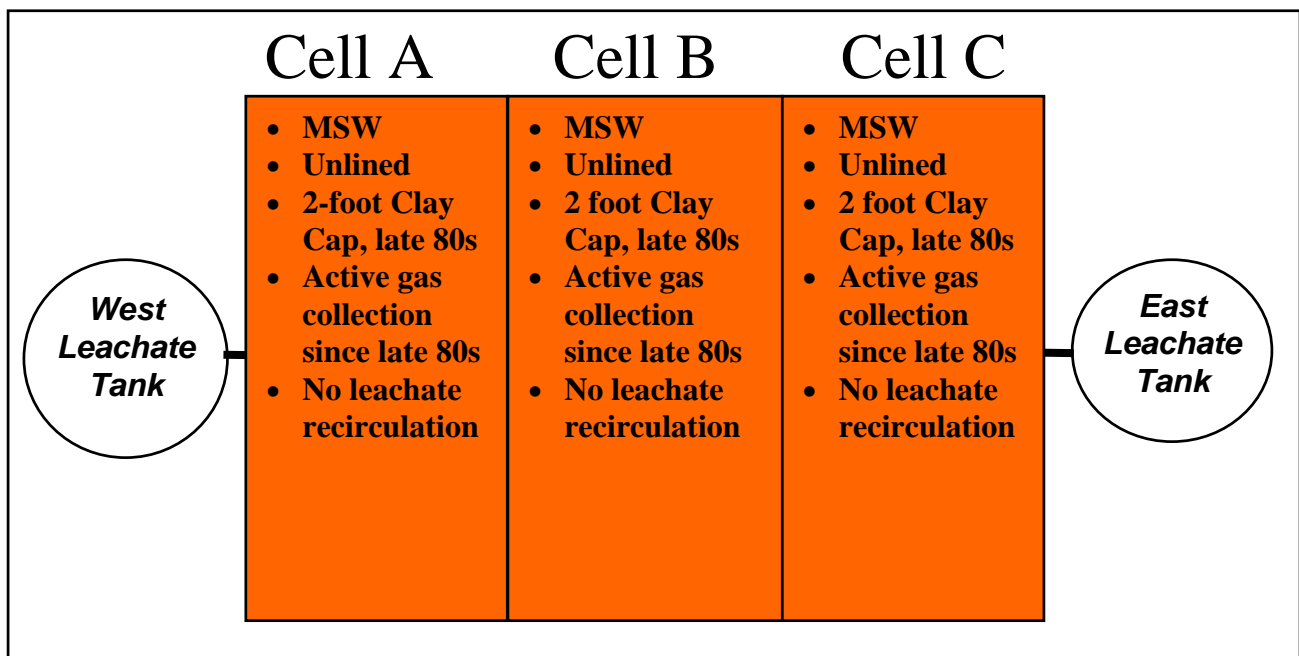
Figure 8-8. Case Study I—New York landfill.

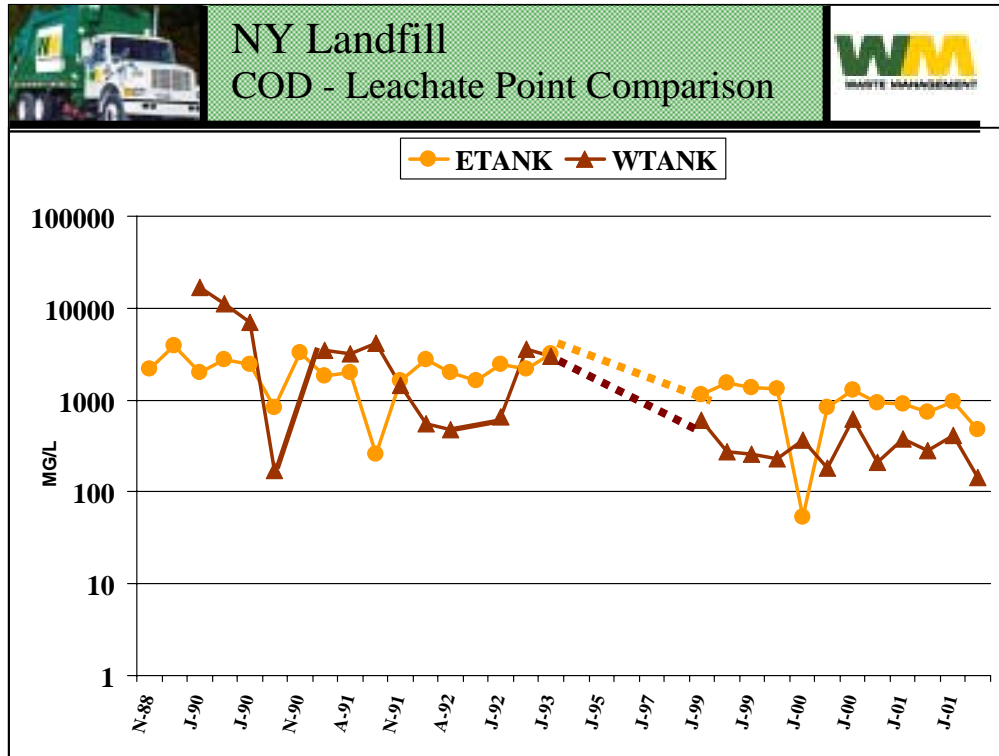
Figure 8-9. COD leachate point comparisons.

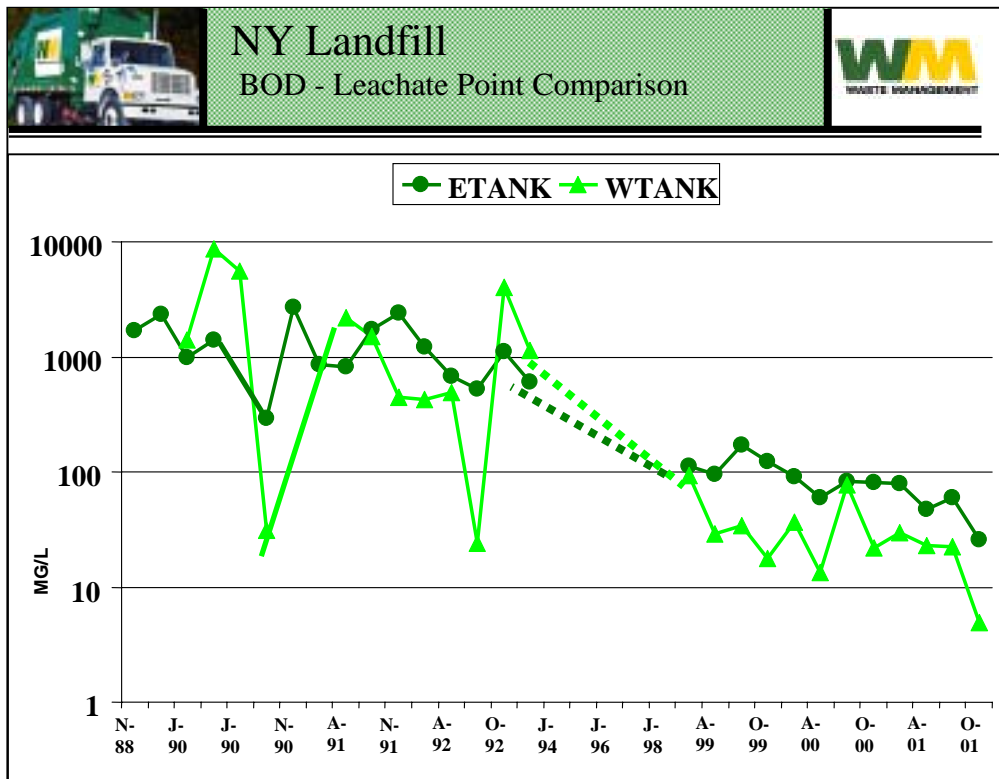
Figure 8-10. BOD leachate point comparisons.

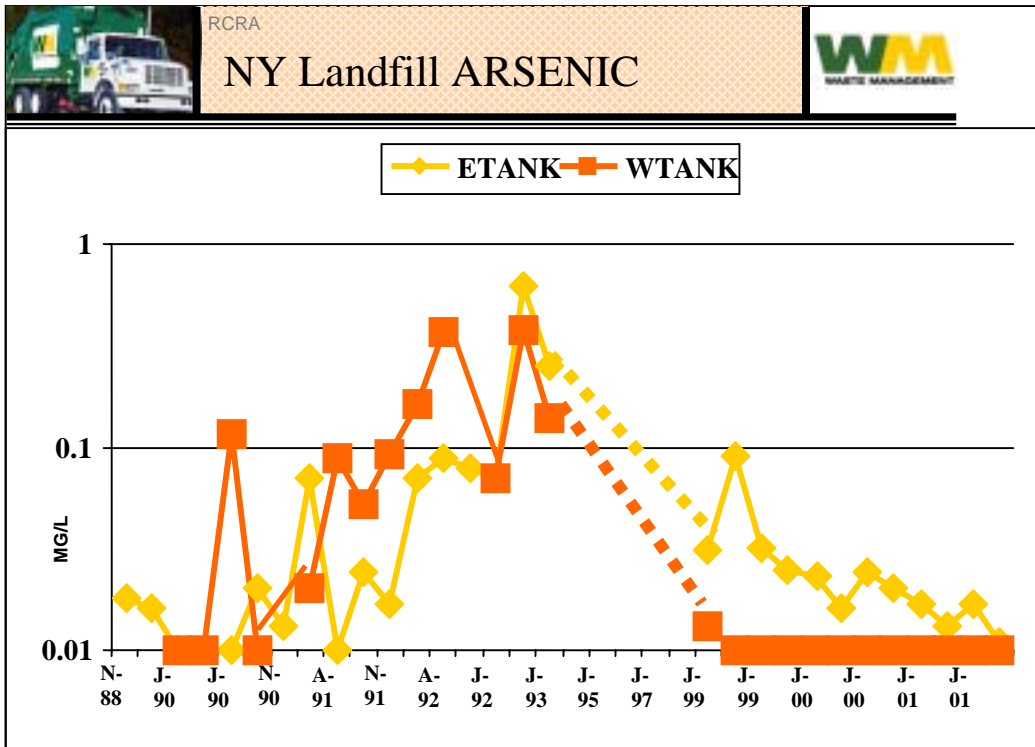
Figure 8-11. Arsenic vs. time.

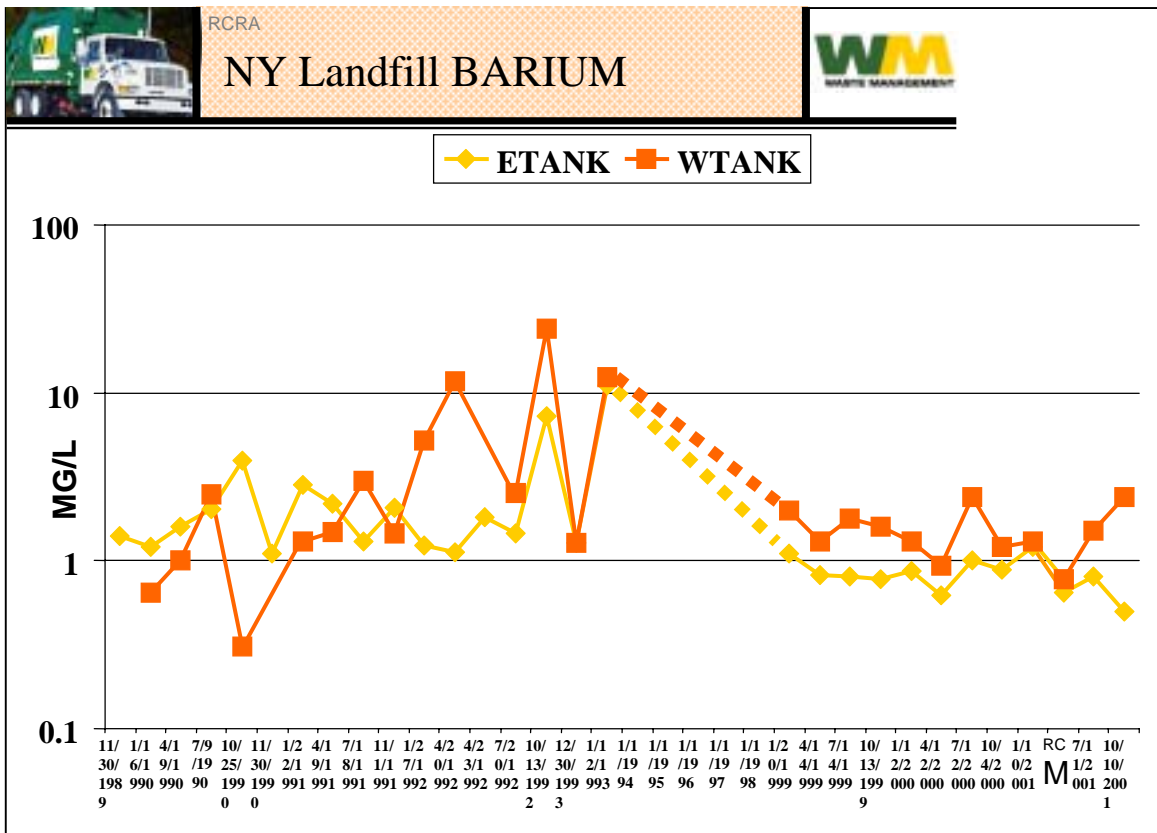
Figure 8-12. Barium vs. time.

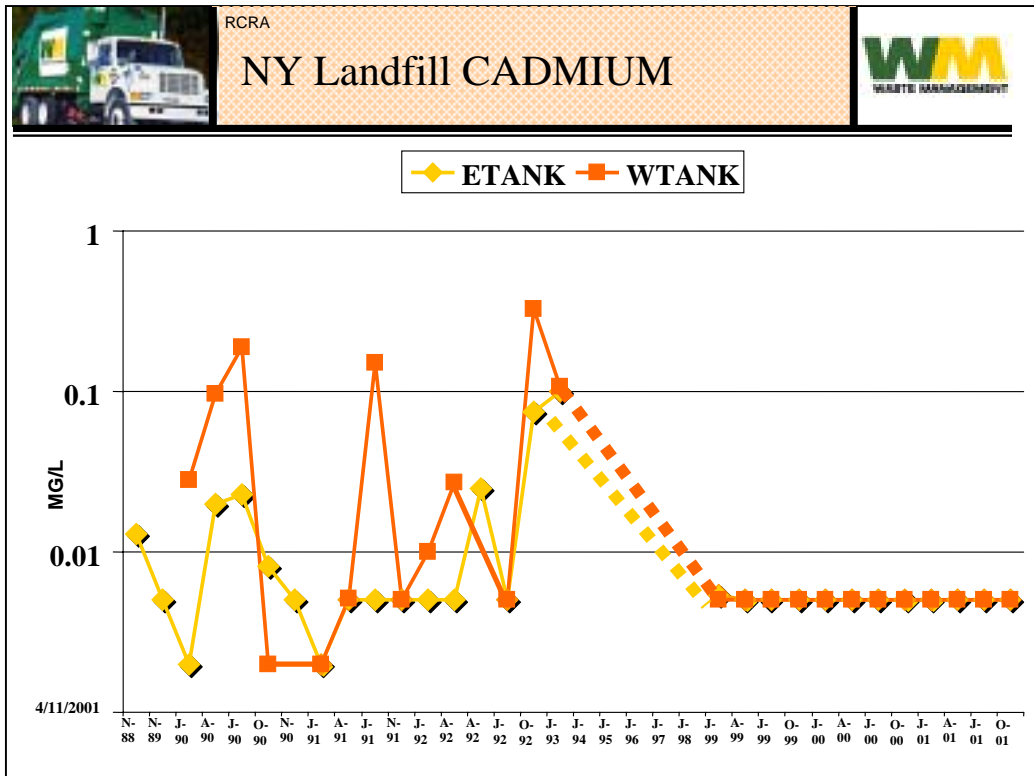
Figure 8-13. Cadmium vs. time.

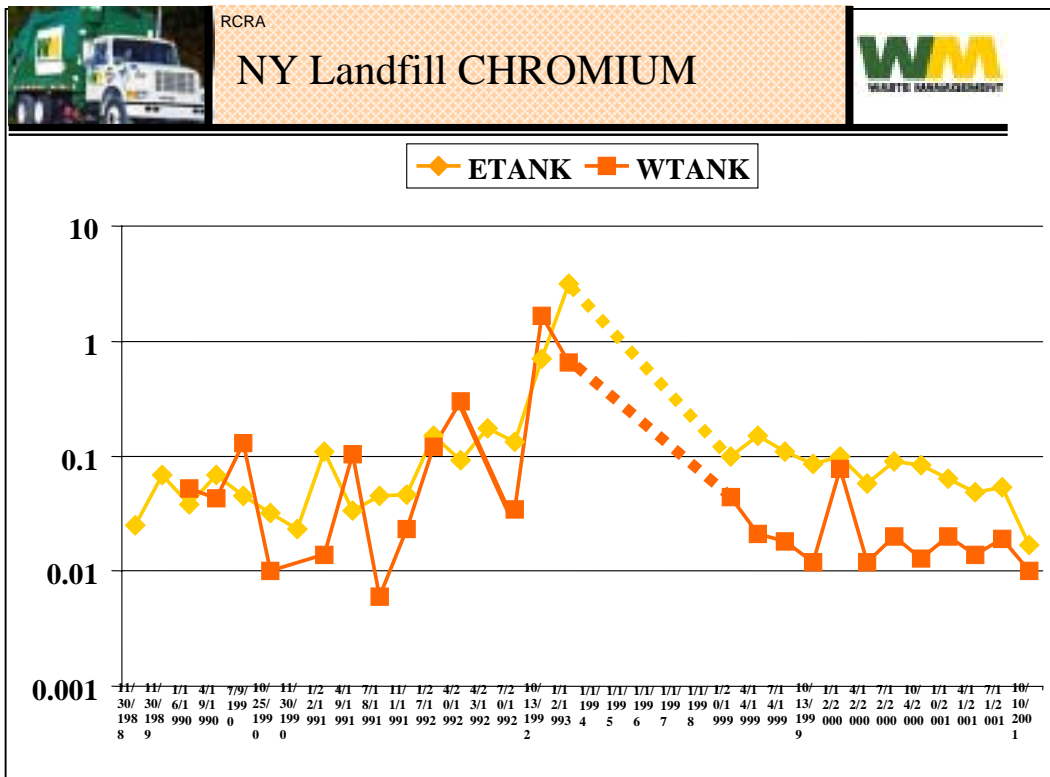
Figure 8-14. Chromium vs. time.

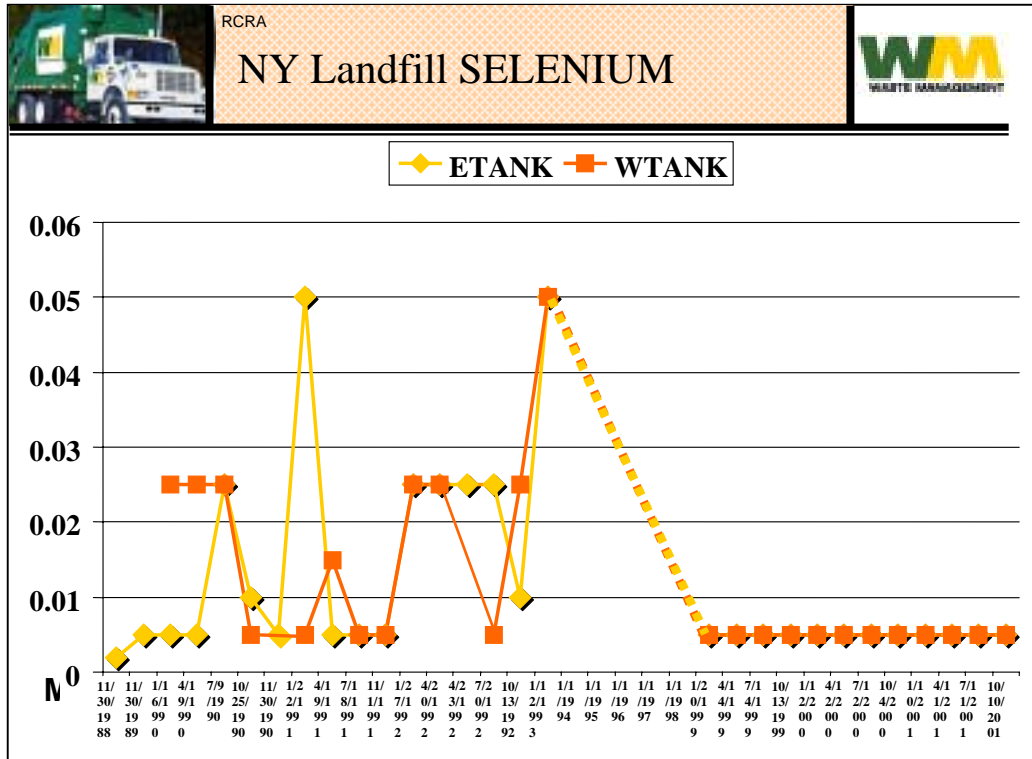
Figure 8-15. Selenium vs. time.

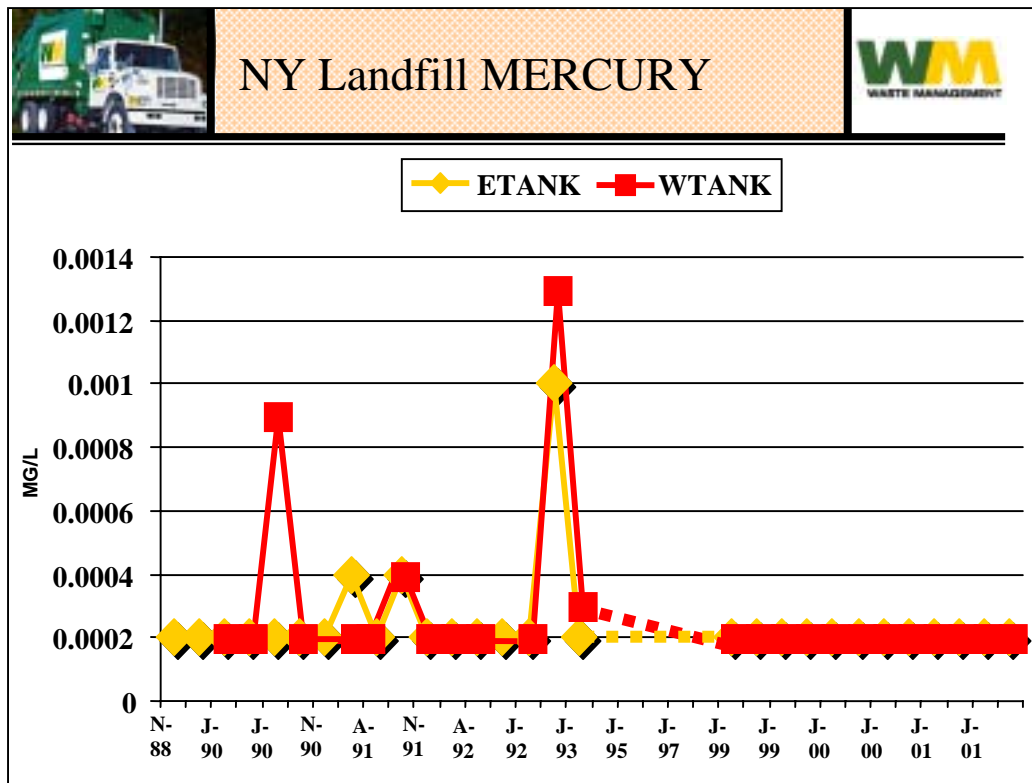
Figure 8-16. Mercury vs. time.

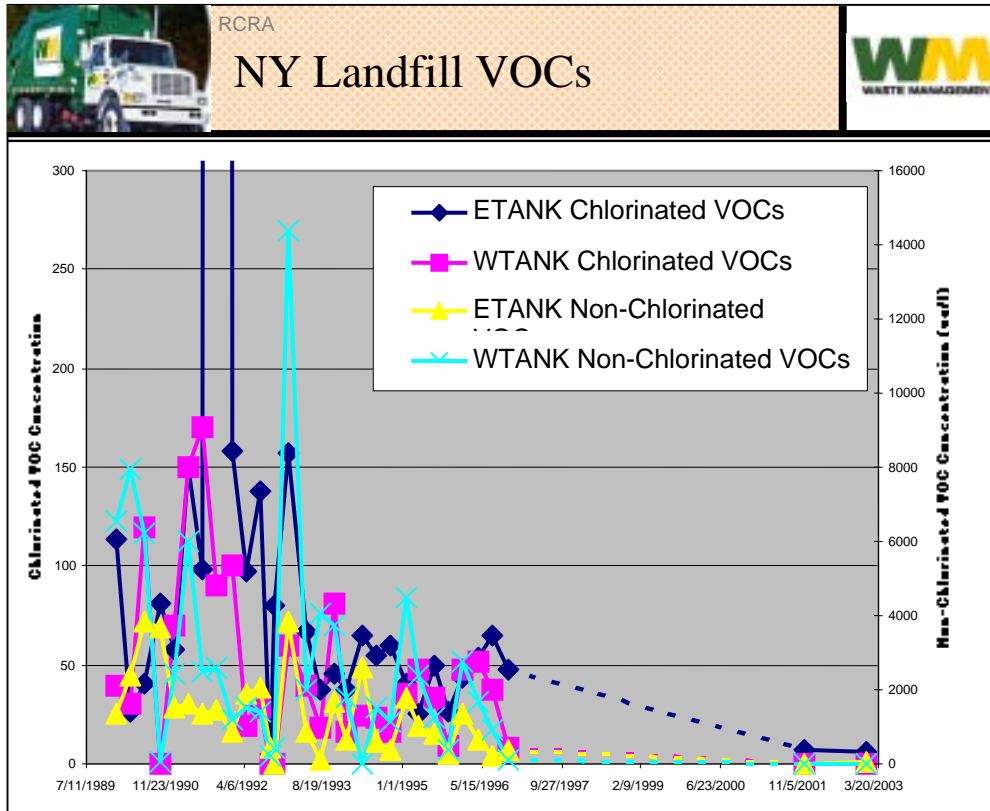
Figure 8-17. VOCs vs. time.

- Profile closed MSW landfill leachate with time
 - BOD/COD < 0.1
 - VOCs have data gaps, but last two sampling events detected only a few VOCs but below their respective MCLs
 - Flat or decreasing trends for indicators
 - Metals below MCLs
- Evaluate Leachate Characteristics by Time Series Plots*

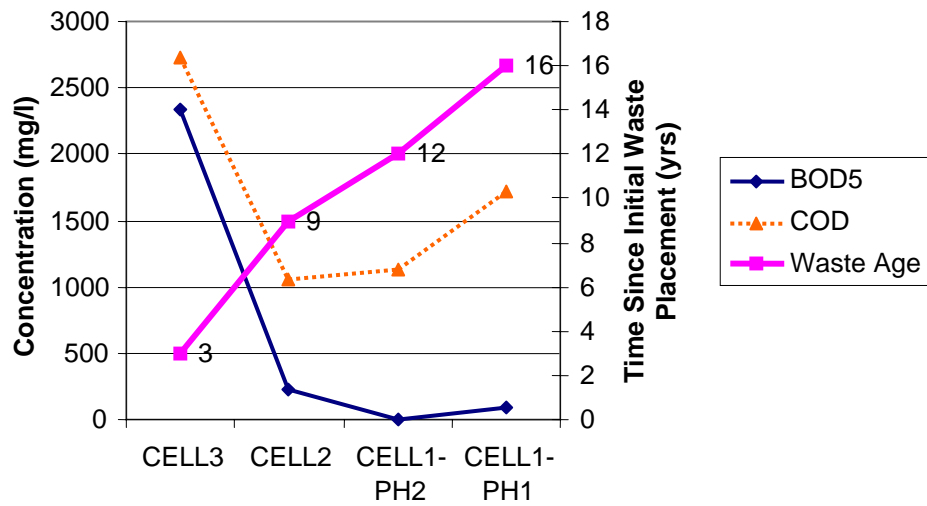
Figure 8-20. Comparison of leachate quality and waste age—BOD/COD.

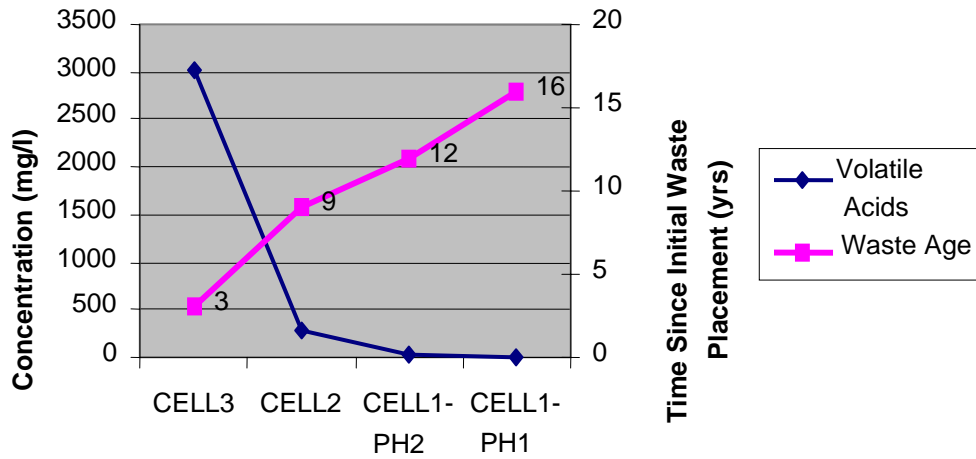
Figure 8-21. Comparison of leachate quality and waste age—volatile acids.

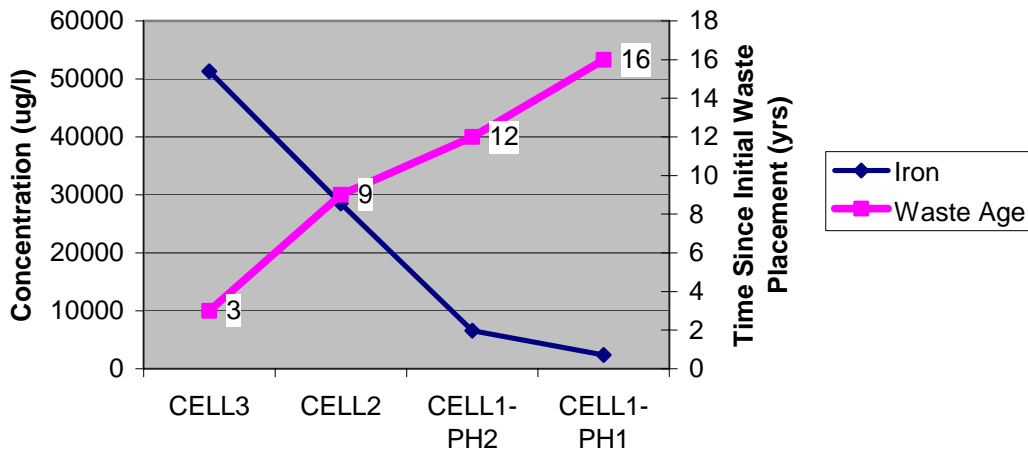
Figure 8-22. Comparison of leachate quality and waste age—iron.

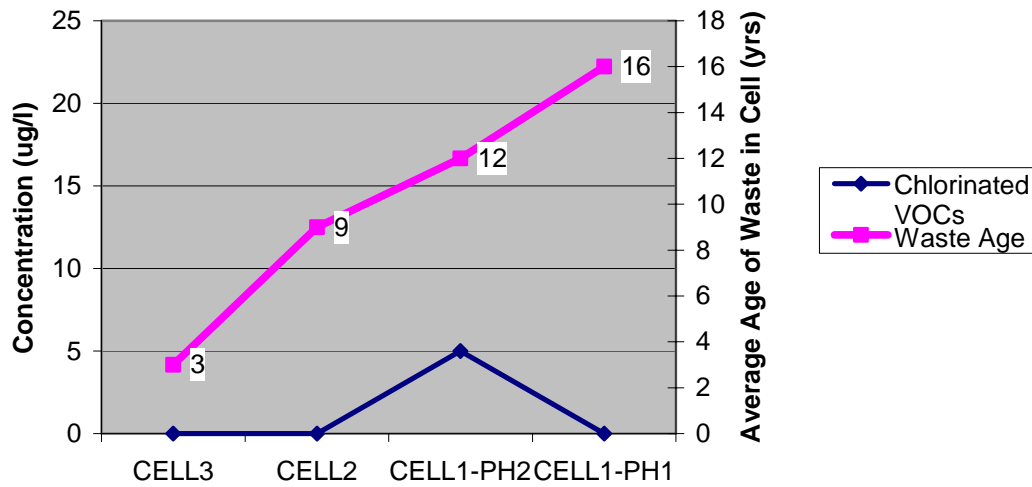
Figure 8-23. Comparison of leachate quality and waste age—VOCs.
