Technology Overview Using Case Studies of Alternative Landfill Technologies and Associated Regulatory Topics

March 2003

Prepared by
Interstate Technology & Regulatory Council
Alternative Landfill Technologies Team

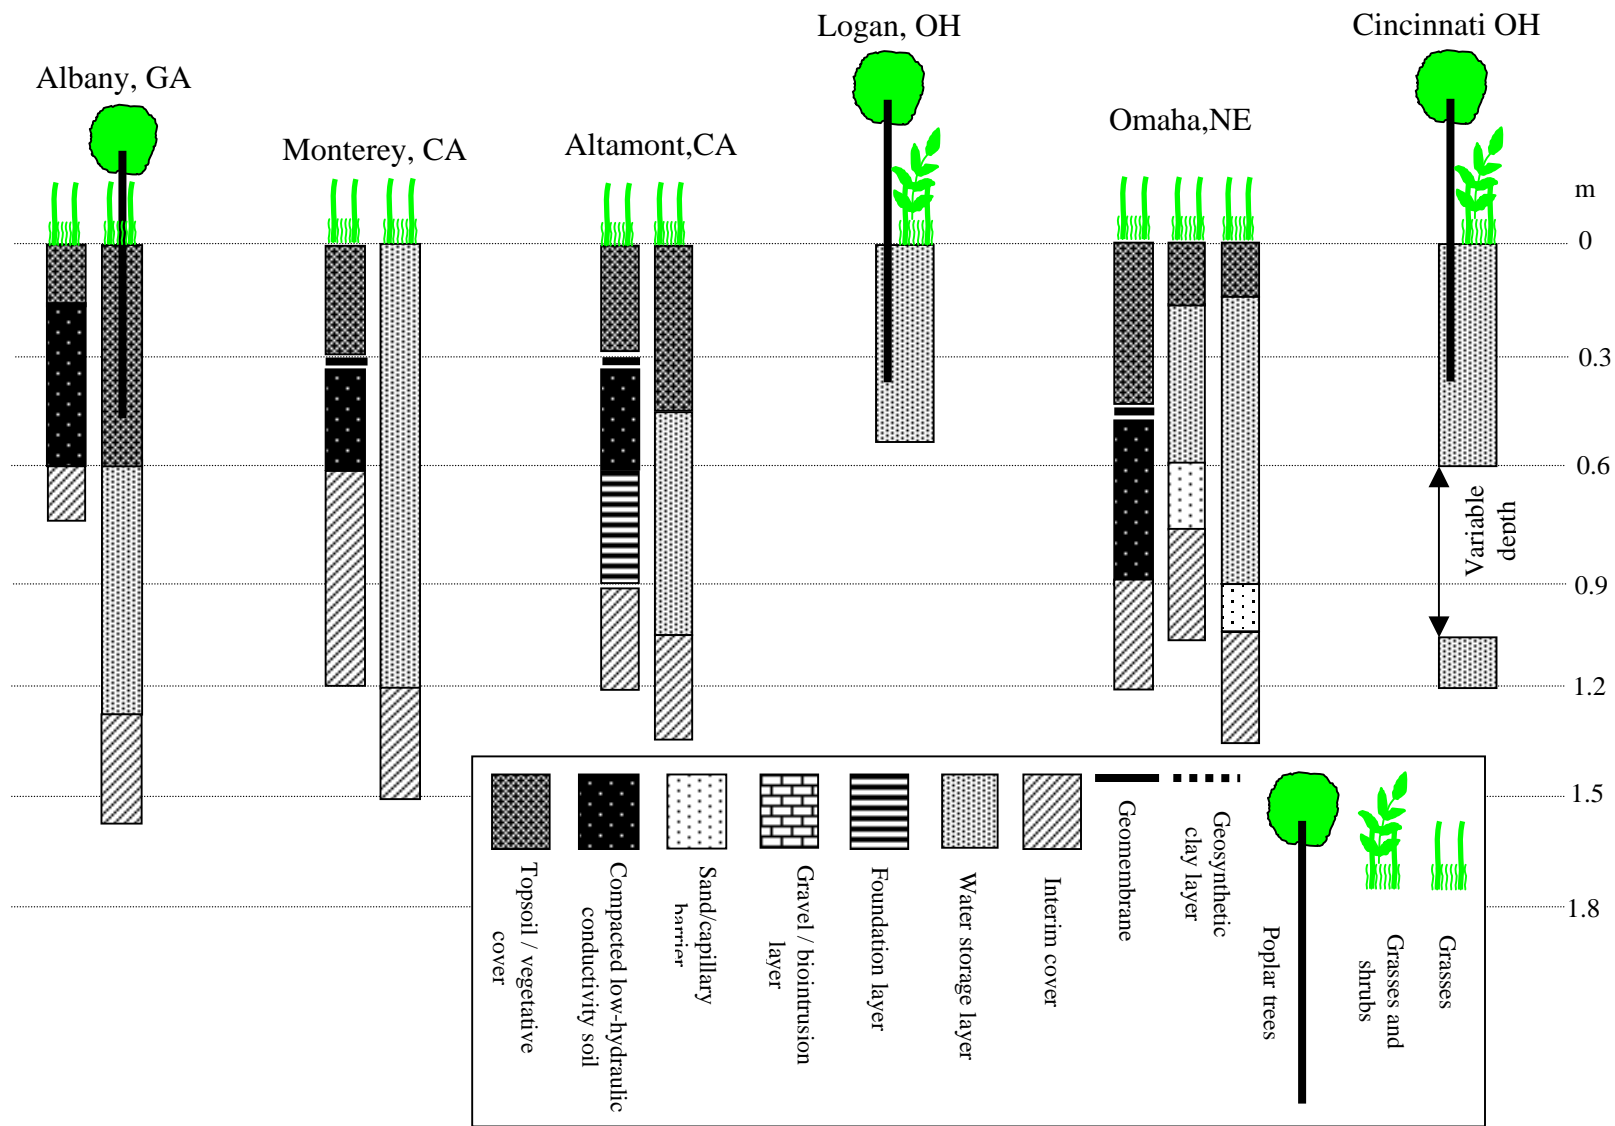
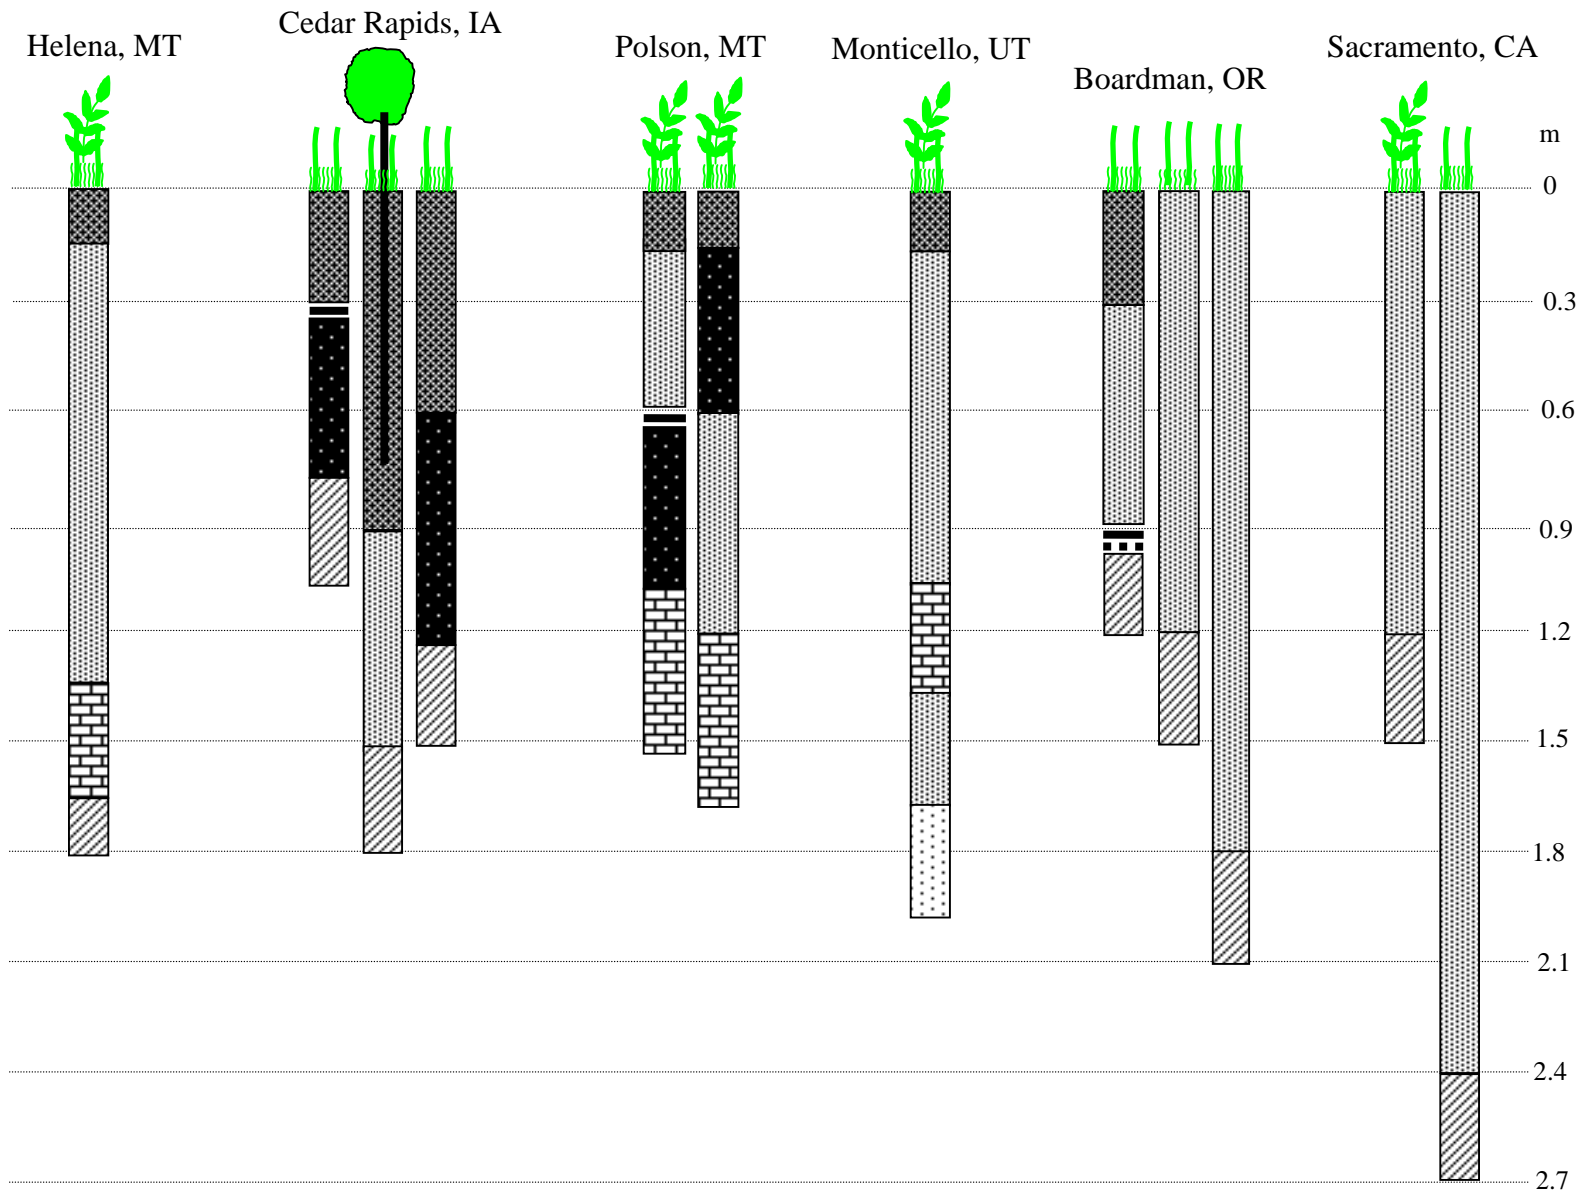
Figure 9-2. ACAP cover design profiles.

Figure 9-2. ACAP cover design profiles (continued).

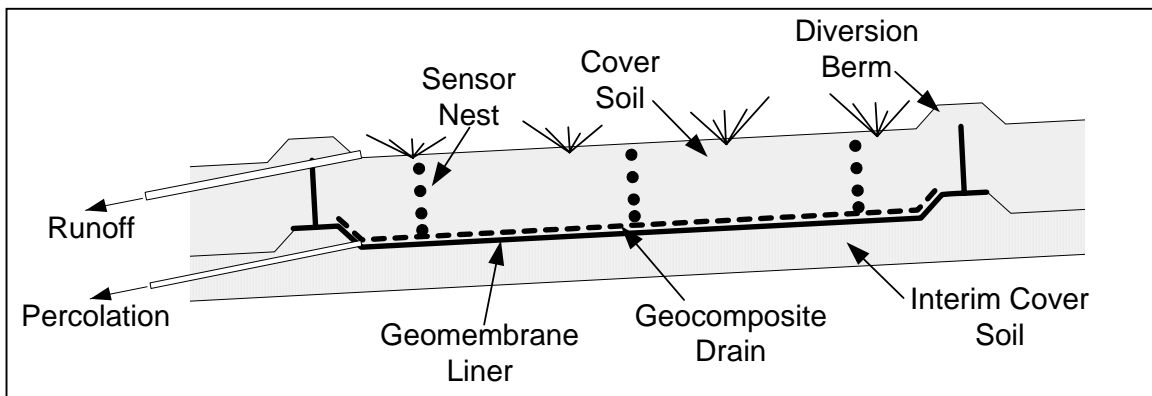
Figure 9-3. Schematic of ACAP drainage lysimeter.

The primary feature of ACAP is the evaluation of cover designs in large (10 × 20 m) drainage lysimeters (Fig. 9-3). These field facilities offer excellent ability to quantify the components of the near-surface water budget and are described in the Test Section Installation Instructions (Benson et al. 1999) and the ACAP Construction Summary (Phase II Report) both available on the ACAP Web site (www.acap.dri.edu). Construction of the ACAP test facilities was completed in the fall of 2000. Flux monitoring is scheduled to proceed for 5 years. Data are collected daily for all sites.
