NARPM Presents...Vapor Intrusion Issues at the Hill Air Force Base
Sponsored by: EPA Office of Superfund Remediation and Technology
Innovation

**CASE STUDY
VAPOR INTRUSION
HILL AIR FORCE BASE, UT
Other Federal Agency Lead**

OVERVIEW OF HILL AFB VAPOR INTRUSION PROGRAM

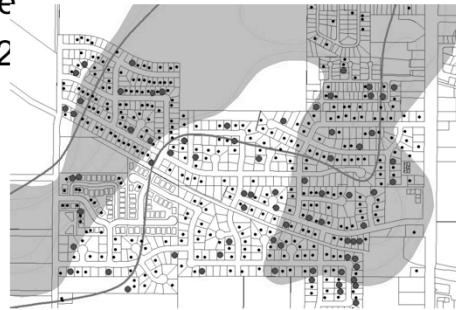
■ Indoor source study

- Try to find a non-groundwater source

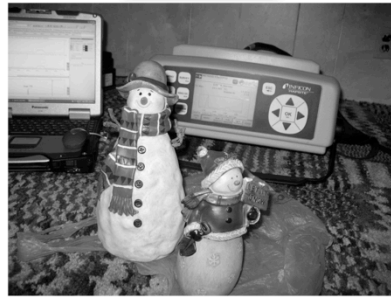
1,2-DCA study (cont'd)

- Initial indoor source study identified 1,2-DCA in a molded plastic decoration
 - Confirmed with laboratory emission rate testing (Doucette et al., 2010)
- Portable GC/MS – molded plastics are a significant source
 - Molded plastic decorations emitting 1,2-DCA have been identified in many (>20) homes.
