Responsible/Safe Shoreline Recovery and Dredging Operations

Paul Greene
USACE Baltimore District
Explosive Safety Chief
M2S2 Explosives Safety Webinar
21 August 2014

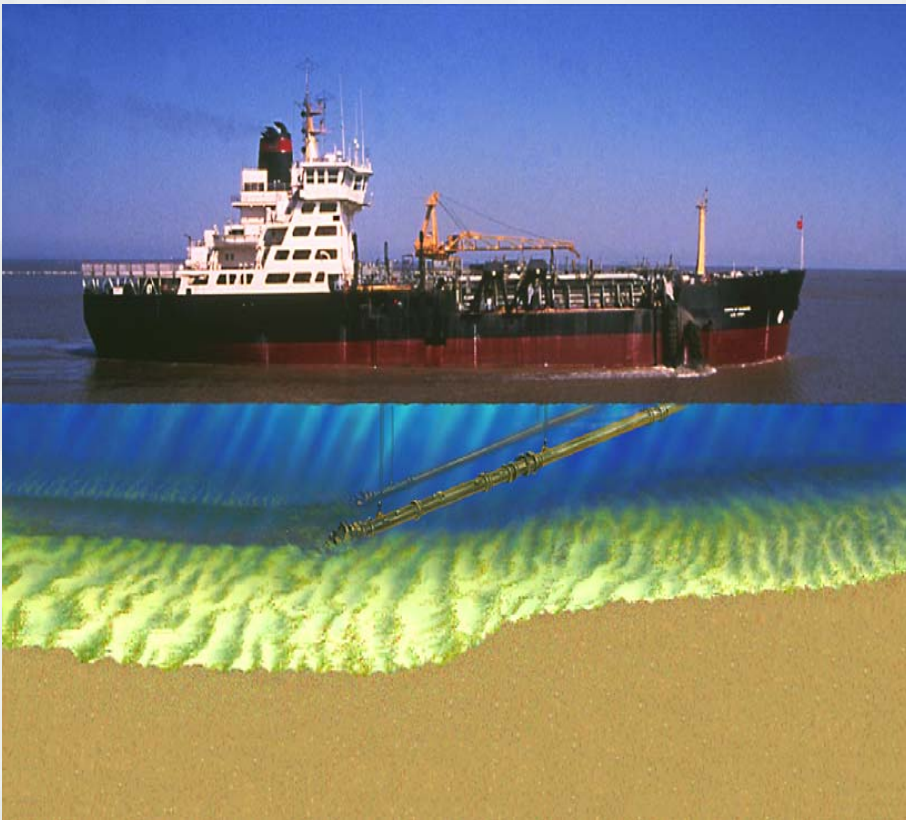
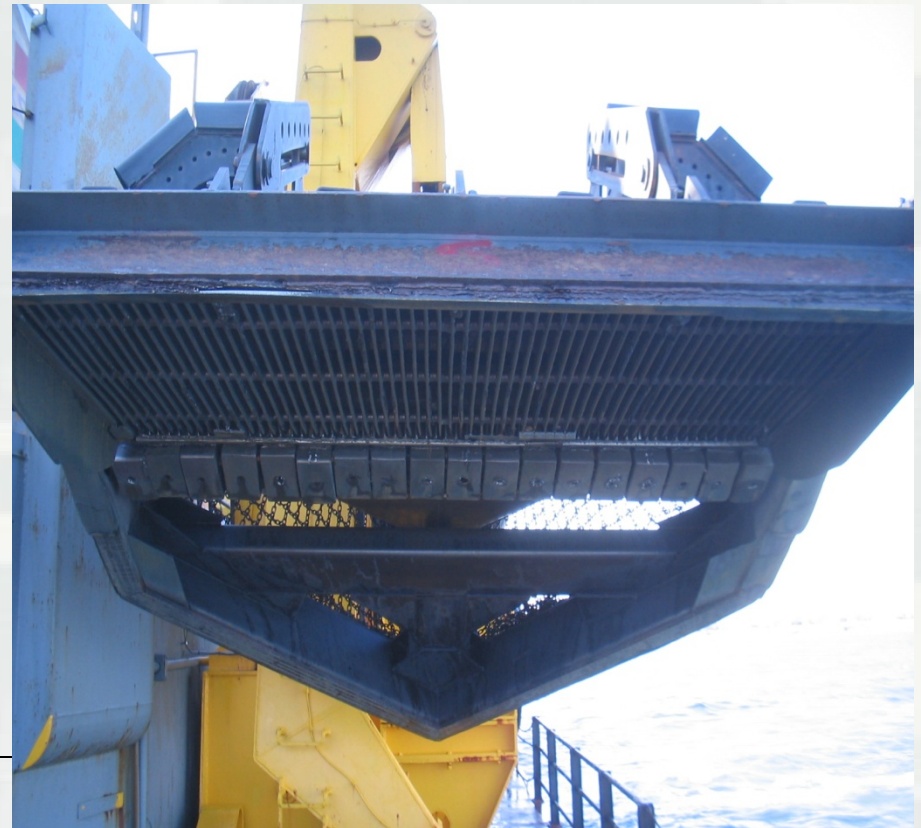
Dredging Operations at SEA

- Intakes on Dredging Operations

- 1.25 inch screens on hopper dredge intakes (37mm about 1.4" diameter)
- .75 inch screens on outflow basket
- MEC training for dredge and beach crews
- MEC training for USACE personnel

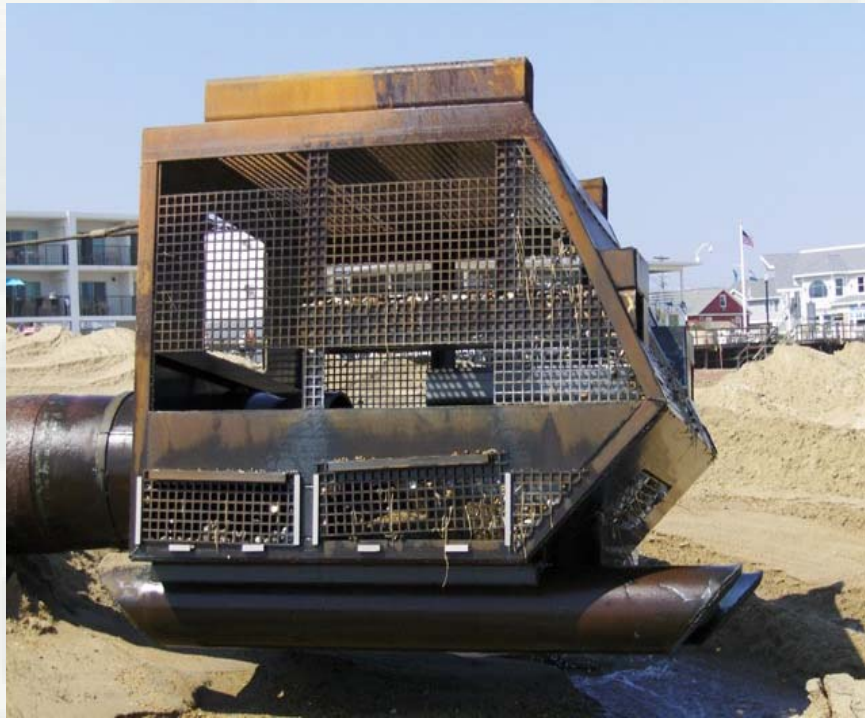
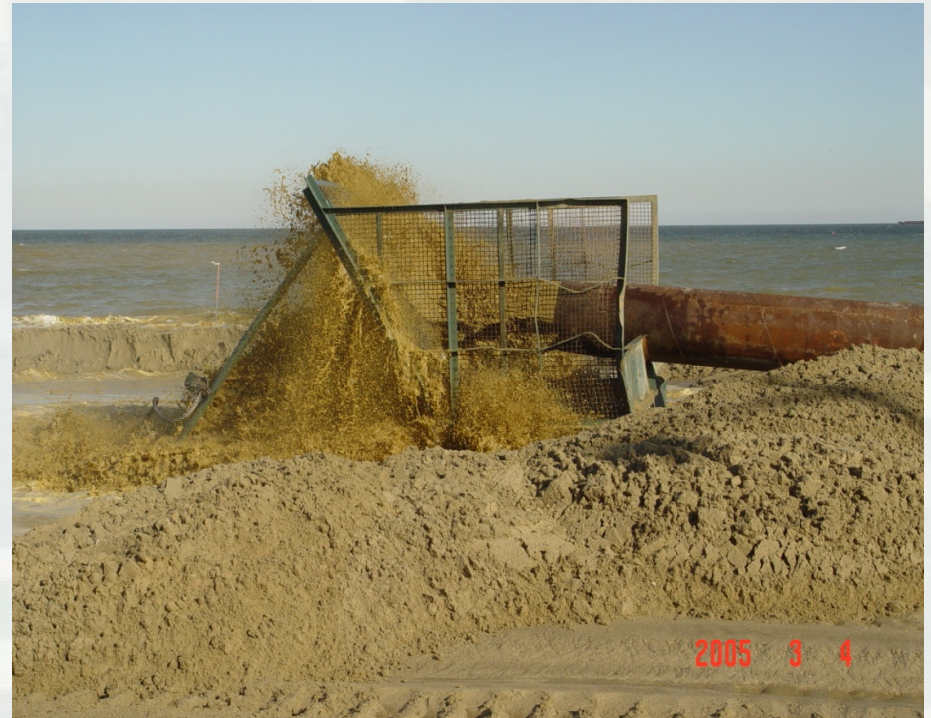
Dredging Operations on shore

Screens on Shore
