SUMMARY October 2011

The West Branch Susquehanna

A WATERSHED IN RECOVERY

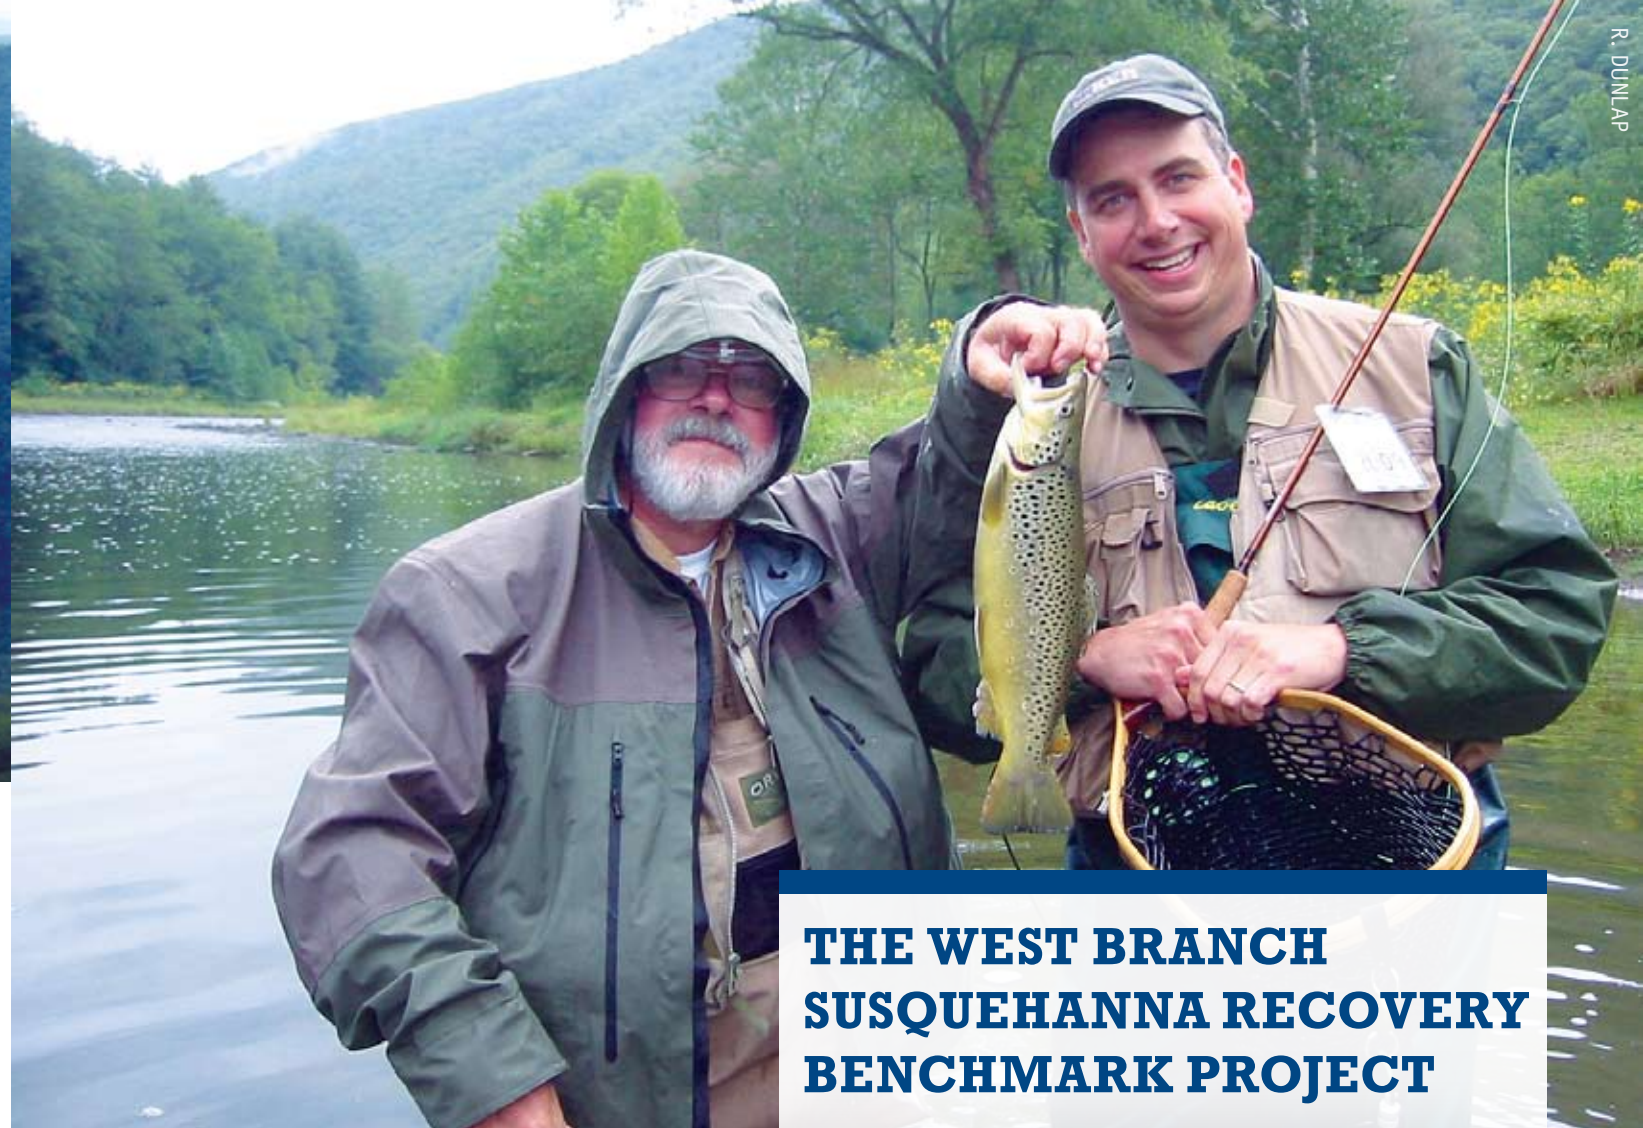
White Oak AMD discharge near Madera, Clearfield County

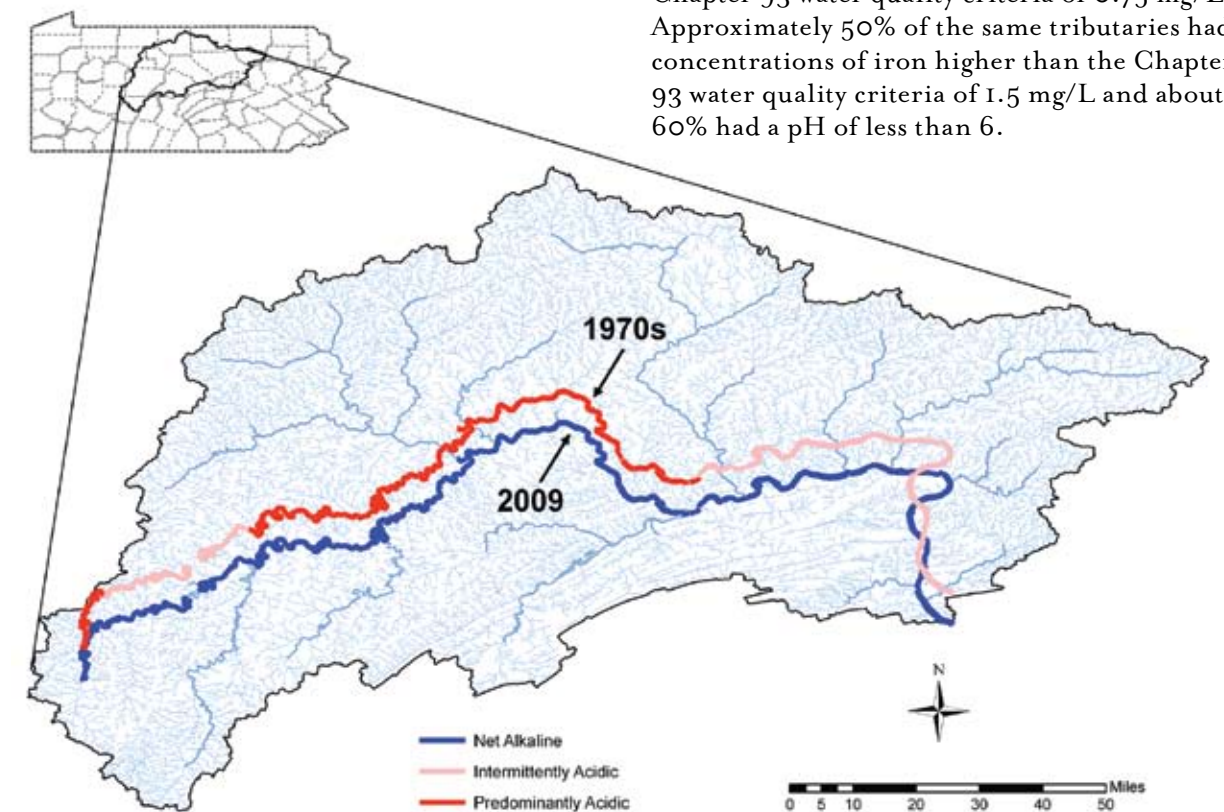
Map compares predominantly acidic river in the early 1970s to a near net alkaline condition in 2009.

Water quality today in the West Branch Susquehanna River and many of its tributaries is significantly better than it was according to a study conducted in the early 1970s and even when compared to the 1984 USGS study which focused on the river and its tributaries between Curwensville and Renovo. The project documented that the pH of the river has increased significantly from its headwaters downstream to Lock Haven. Concentrations of acidity, iron, and aluminum have also been greatly reduced. In the 1970s, the river was predominantly or intermittently acidic and in 2009 it displayed a near net alkaline condition despite the continued contribution of acidity from more than 40 tributaries.

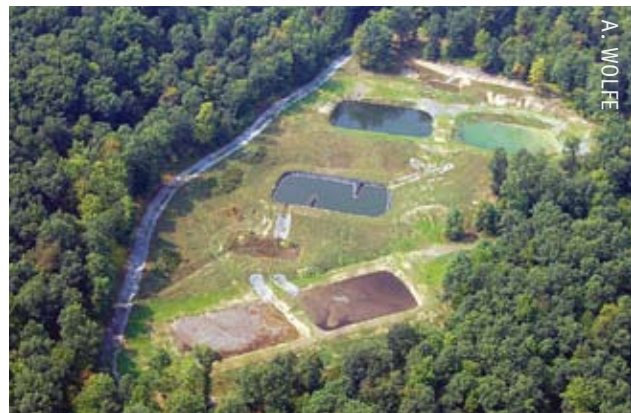
More than 7,000 acres of AMD-producing abandoned mine lands were remined in the West Branch Susquehanna reducing the amount of pollution generated.

Remining, which is the extraction of remaining coal reserves from previously mined areas by surface mining, often results in producing permanent water quality benefits for abandoned mine environments. It was concluded that remining also had a role in the acidity decrease observed between 1984 and 2009 at several sites where remining occurred during that timeframe. For instance, it was estimated that remining was most likely responsible for anywhere from 9 to 22% of the acidity decrease observed for the river at Karthaus, as well as 7 to 11% of the acidity decrease observed for Clearfield Creek.

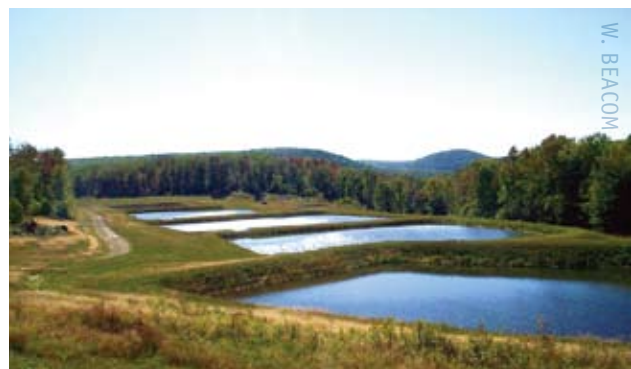
Middle Branch passive treatment system

On the other side of the scale, it was estimated that natural attenuation only accounted for just over 12% of the acidity decrease observed for Laurel Run. However, decades and centuries, in some instances, would be necessary to restore a stream by natural attenuation alone. One case in point would be Middle Branch – it would take 116 years for natural attenuation to achieve the same low levels of acidity currently measured in the stream that are a result of a passive AMD treatment system.

Finally, passive and active AMD treatment systems have played a key role in the improvement of water quality documented throughout the watershed. While data characterizing many of the treatment systems across the watershed were not readily available so that quantifying their cumulative effect on water quality improvement was not possible, individual examples point to the importance of water treatment toward overall water quality improvement. For example, multiple passive treatment systems and an active treatment facility have resulted in the return of a wild trout fishery to Babb Creek and the delisting of approximately 14 miles of Babb Creek and 5 miles of Pine Creek from Pennsylvania's list of impaired streams. A passive treatment system in the Sterling Run watershed resulted in the delisting of just over 12 miles of Sterling Run and the return of native brook trout to the stream. Additionally, Middle Branch in the lower Kettle Creek watershed is currently being sampled in consideration of delisting and water quality has improved enough that native brook trout have returned.
