FINAL REPORT

Direct Push Chemical Sensors for DNAPL

ESTCP Project: ER-0109

JANUARY 2007

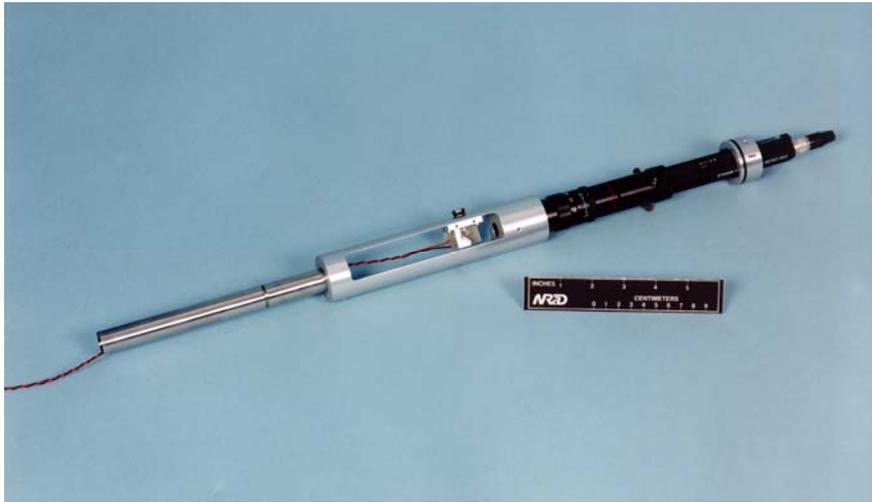
Figure 18. . Photograph of downhole video imaging system probe. Soil in contact with the sapphire window is illuminated with scattered light from white LEDs. The soil is imaged through a lens system coupled to a color CCD camera. The video signal is returned to the surface where it can be viewed in real-time and recorded using a video recorder or stored digitally.
