# FINAL REPORT

Field Demonstration of a Novel Biotreatment Process for Perchlorate Reduction in Groundwater

## ESTCP Project ER-200636

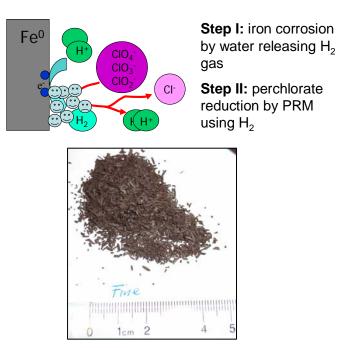
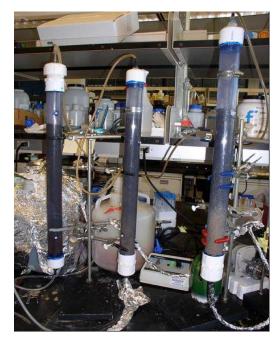
**Figure 1.2** Schematic description of perchlorate biotreatment using ZVI and perchlorate reducing microorganisms (PRM) (top left) and picture of laboratory flow through bioreactor systems (right) consisting of a packed bed of ZVI through which the contaminated water flows upwards. Bottom left picture shows fine (unused) ZVI (bar scale in cm).

We have recently shown that ZVI can be coupled with perchlorate-reducing microorganisms (PRM) to degrade perchlorate without the need for external hydrogen gas addition or organic carbon source (Yu et al., 2006, Yu et al., 2007). Extensive batch and column experiments were conducted in the laboratory prior to this project to prove the concept and determine the applicability of perchlorate reduction supported by ZVI. The schematic description of the zero-valent iron/autotrophic perchlorate reducing microorganisms process is shown in Figure 1.2. The advantage of this novel approach lies in that:

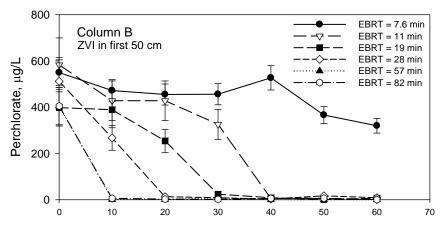
**Figure 2.1** Typical results from the laboratory flow through bioreactors. Here, the effect of flow rate on the axial perchlorate concentration profile is shown. Influent  $ClO_4^- = 400$  to  $600 \ \mu g \ L^{-1}$ . EBRT is the empty bed retention time. The actual retention time of the groundwater in the system is shorter.

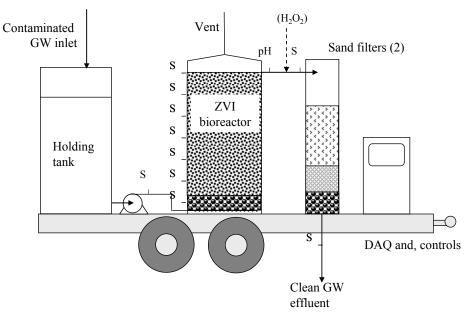
**Figure 2.2** Schematic of the trailer mounted pilot demonstration system (not to scale, controls not shown). S = sampling port. Homogeneous distribution of the water at the bottom of the bioreactor is achieved via a network of perforated pipes. Backflush for the sand filters not shown. As mentioned in the text, pre-treatment of the contaminated water to remove dissolved oxygen was implemented after the startup of the system, but is not shown on the schematic.

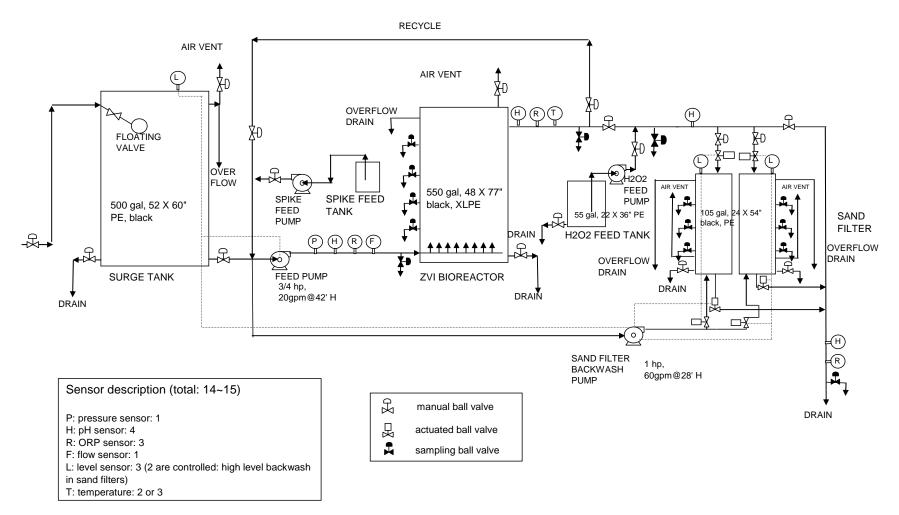
Figure 2.3 Flowsheet and instrumentation of the demonstration system (not to scale).

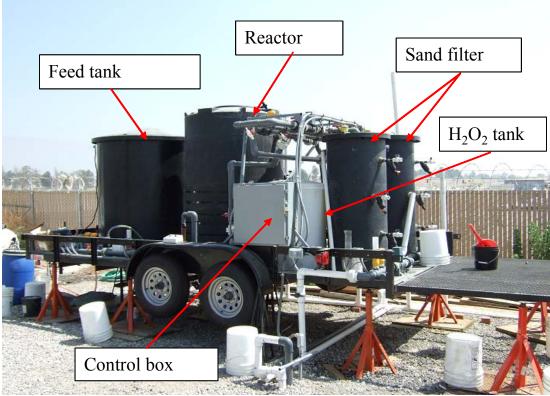
**Figure 2.4** Picture of the demonstration system at the Rialto well #2 site. Membrane degassing pre-treatment not shown.

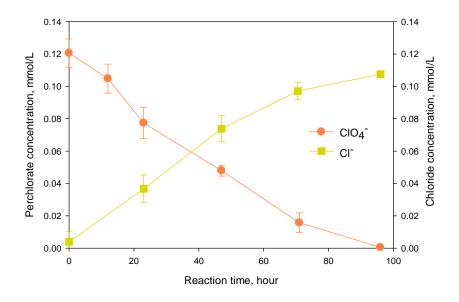
**Figure 3.1** Perchlorate reduction (in a shake flask) by perchlorate reducing bacteria and stoichiometric release of chloride.

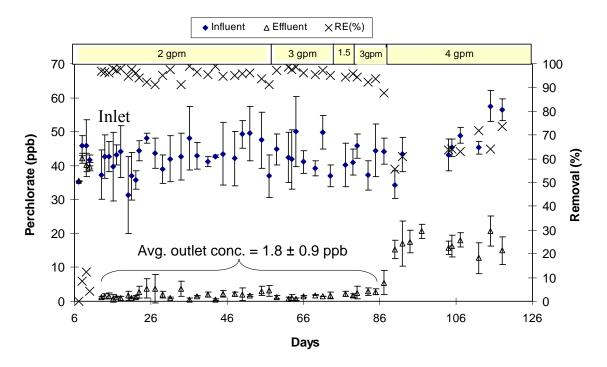
Figure 5.1 Perchlorate inlet and outlet concentrations over the first 4 months of operation.

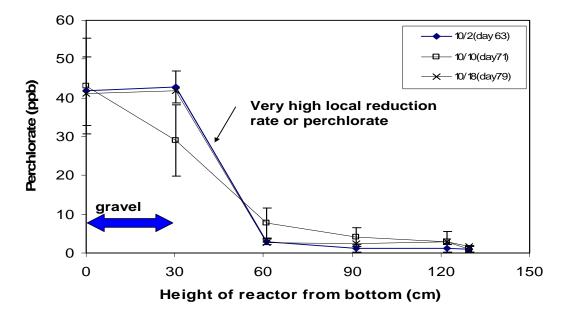
Figure 5.2 Perchlorate concentration profiles in the ZVI bioreactor at selected dates.

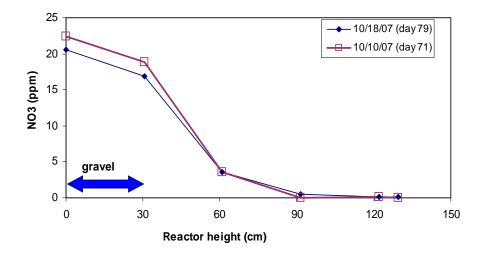
Figure 5.3 Nitrate concentration profiles in the ZVI bioreactor at selected dates.

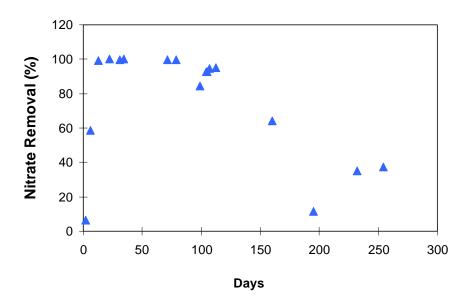
Figure 5.4 Nitrate removal over the duration of the field demonstration.

perchlorate and nitrate in the laboratory [Yu et al., 2007]. Overall nitrate removal was high as reported in Figure 5.4 and remained high for well over 100 days. Problems that developed with the reactor and nitrate removal after 130 days will be discussed later in the next section.

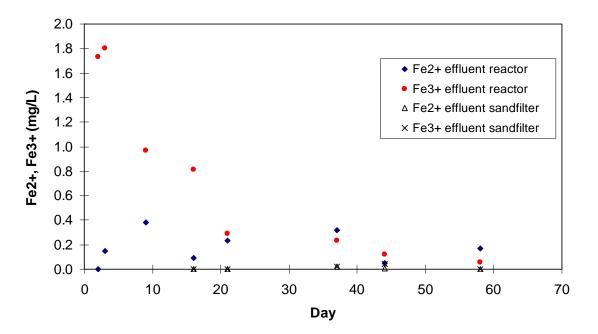
Figure 5.5 Iron species in the effluents of the reactor and sand filters.

The concentrations of  $Fe^{2+}$  and  $Fe^{3+}$  after the sand filters (Figure 5.5) reflect the fact that the sand filters were very efficient at removing iron. The low iron concentrations in the sand filter effluent meant that no hydrogen peroxide was needed to oxidize  $Fe^{2+}$ . Spontaneous oxidation was sufficient. Turbidity measurements (not shown) ranged from 30 to 50 NTU in the reactor effluent and were always less than 4 NTU in the sand filter effluent.

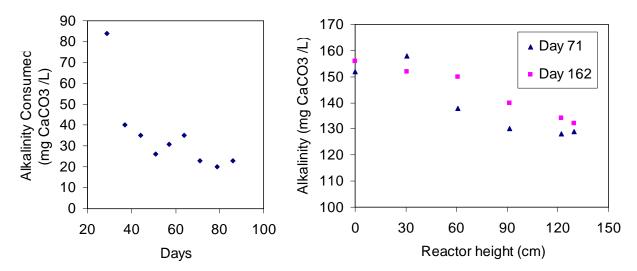
**Figure 5.6** Evolution of the alkalinity consumed over time (left) and alkalinity concentration profiles (right) in the ZVI bioreactor at selected dates. Note that the first 30 cm are packed with gravel for proper liquid distribution.

Alkalinity data are reported in Figure 5.6. No measurements were made during the first 28 days. Consumption of alkalinity is primarily by precipitation of carbonates with iron, as will be

discussed later in Section 5.2.2, although some alkalinity is expected to be taken up by autotrophic bacteria, for cell growth. Figure 5.6 shows that during the initial bicarbonate feeding period, a high rate of alkalinity consumption was observed. Profiles along the height show that alkalinity decreased quasi linearly with penetration along the reactor. Note that the alkalinity profile of day 162 was obtained well after significant performance problems were observed with the bioreactor, but that the profile was essentially identical to this observed while the bioreactor was performing well. This indicates that the main process for alkalinity uptake is most probably abiotic.

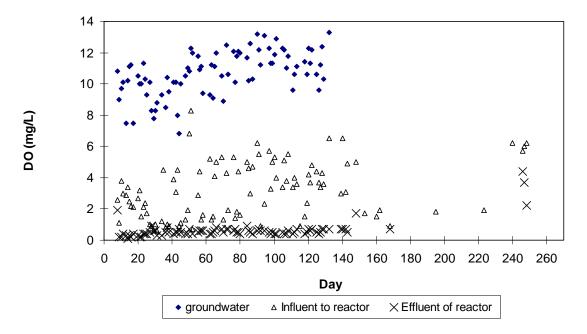
**Figure 5.7** Evolution of the dissolved oxygen. On day 150, the degassing membrane module was installed on the influent feed.

Dissolved oxygen concentrations are reported in Figure 5.7. The data illustrate the fact that the well water was oversaturated with oxygen and that the ZVI pre-treatment system was effective at removing some of the influent DO, but that it could not consistently maintain an effluent DO below 2 ppm. The high variability of the DO fed to the ZVI bioreactor is due to the batch loading of fresh ZVI and removal of used ZVI in the pre-treatment system. Note that the bioreactor effluent DO was always below 1 ppm. On Day 150, the ZVI pre-treatment was replaced by the membrane degasser and low influent DO were consistently obtained. We did note that the membrane degasser required periodical rinsing with a mild acid solution, probably to remove precipitated carbonates.

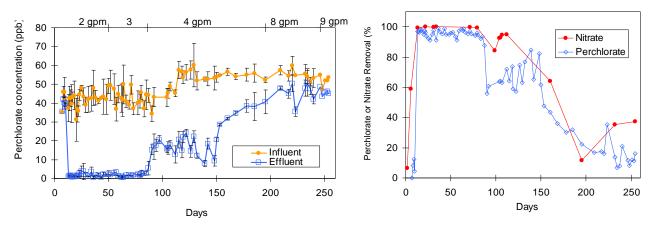
**Figure 5.8** Perchlorate inlet and outlet concentrations (left) and comparison of nitrate and perchlorate removal over time (right).

After about 80 days of operation, an increase in the perchlorate effluent concentration was observed and treatment performance deteriorated. Within about a week, the outlet perchlorate concentration increased to 12-18 ppb (see e.g., Figure 5.1), corresponding to a removal of 60-70% only (Figure 5.8). Careful examination of Figure 5.8 reveals that the upset was very sudden and that perchlorate removal reached a temporary steady value of 60-70% until day 150, after which it gradually decreased further to removals around 10%. Despite less frequent analysis for nitrate, a slightly different trend was detected for the removal of nitrate. Possibly, nitrate removal was not greatly affected until after about day 100, after which removal gradually decreased until about day 200.

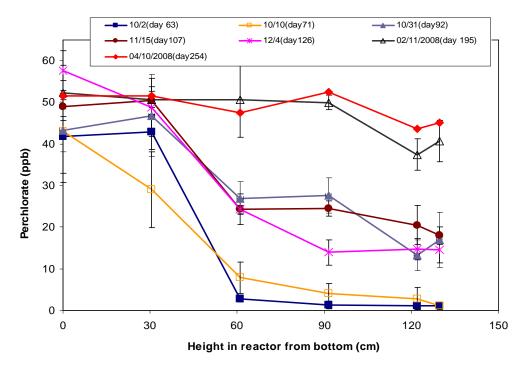
**Figure 5.9** Perchlorate concentration profiles in the ZVI bioreactor at selected dates. Note that the first 30 cm are packed with gravel for proper liquid distribution.

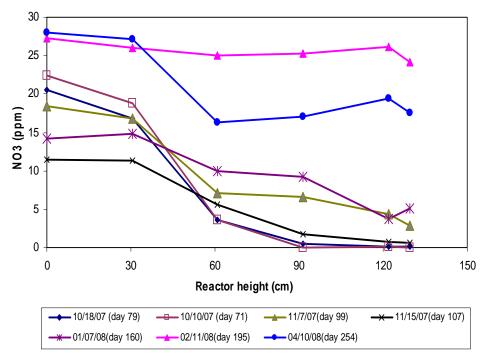
**Figure 5.10** Nitrate concentration profiles in the ZVI bioreactor at selected dates. Note that the first 30 cm are packed with gravel for proper liquid distribution.

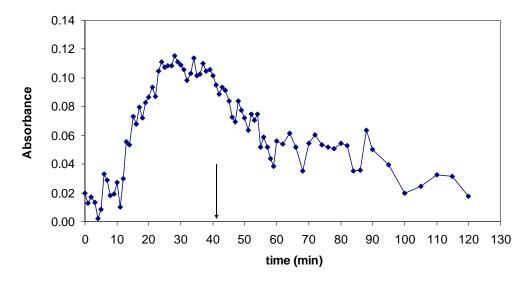
**Figure 5.11** Tracer residence time distribution in the ZVI bioreactor on day 145. The arrow shows the mean residence time of 41 min, while the theoretical bed residence time was 60 min (80 min EBRT and original porosity of 75%). Thus there was some reduction of the bed porosity or some short-circuiting occurring in the system.

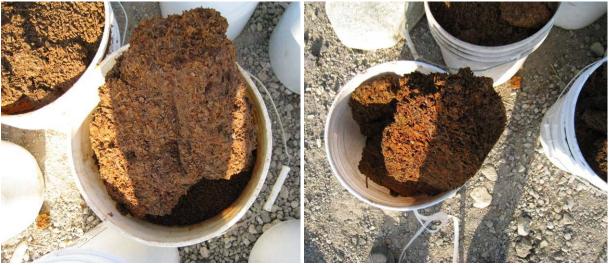
**Figure 5.12** Pictures of large blocks of ZVI taken out of the reactor when it was dismantled showing the solid structure of the ZVI bed.

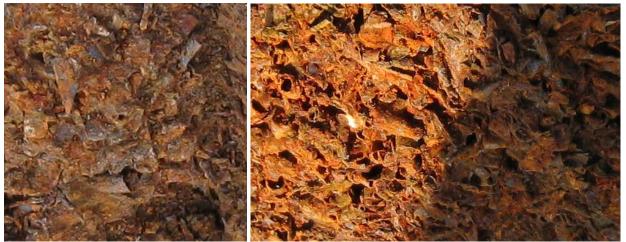
**Figure 5.13** Close views of ZVI taken out of the reactor when it was dismantled showing the heavy deposits of iron corrosion products and quasi total loss of porosity.

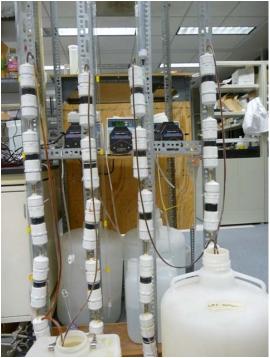
**Figure 5.14** Picture of the column setup used for the determination of the effect of carbonate on the hydraulic properties of the ZVI bed.

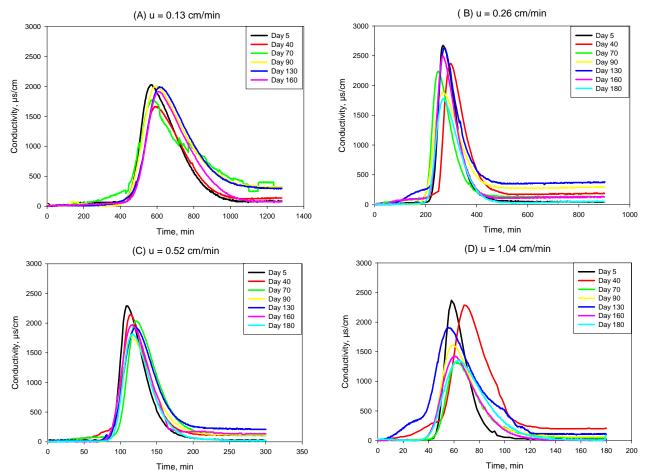
Figure 5.15 Tracer responses obtained over time in columns A-D operating at different flows.

The shape of the effluent tracer signals were symmetrical and fairly consistent over time over the first 190 days for all 4 columns (Figure 5.15). This indicates homogenous flow and constant residence time distribution occurred over time under these conditions. This is further illustrated in Figure 5.16 in which the experimentally determined residence times are reported. Figure 5.15 shows Column D had some variability in the residence time distribution as ZVI aged but this was not reflected in the actual value of the residence time as is shown in Figure 5.16. Detailed Examination of Figure 5.15 shows that the tracer response peak was broadened over time, which is due to the development of heterogeneities over time in the ZVI bed. This finding suggests that ZVI beds operated at high velocities are more susceptible to experience hydraulic changes than column operated at lower water velocities.

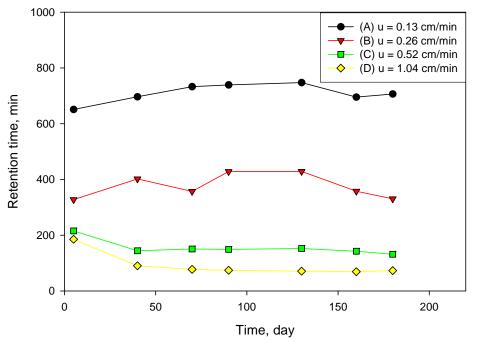
Figure 5.16 Experimentally determined mean residence time of in the different columns.

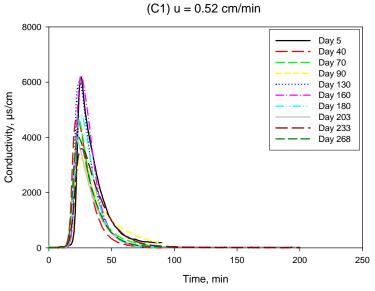
Figure 5.17 Tracer effluent concentration after column C1 during the entire experiment.

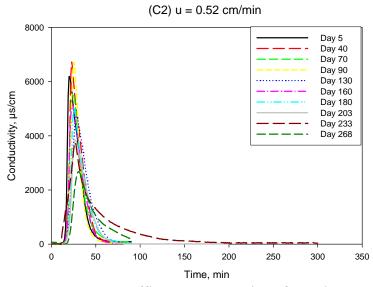
Figure 5.18 Tracer effluent concentration after column C2 during the entire experiment.

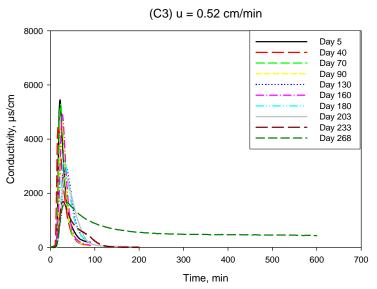
**Figure 5.19** Tracer effluent concentration after column C3 during the entire experiment. 6 mM NaHCO<sub>3</sub> were fed after day 192.

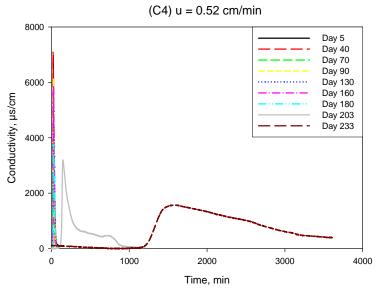
**Figure 5.20** Tracer effluent concentration after column C4 during the entire experiment. 12 mM NaHCO<sub>3</sub> were fed after day 192. Delayed tracer output after day 200 reflects lower flow and lower permeability in that column.

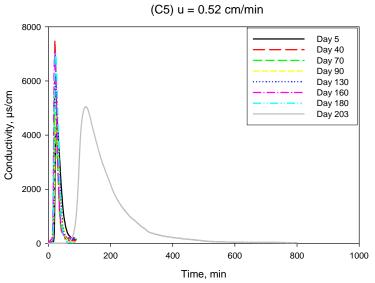
**Figure 5.21** Tracer effluent concentration after column C5 during the entire experiment. 24 mM NaHCO<sub>3</sub> were fed after day 192. Delayed tracer output after day 200 reflects lower flow and lower permeability in that column.

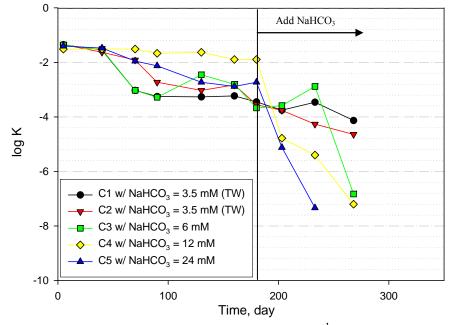
**Figure 5.23** Hydraulic conductivity K (in cm s<sup>-1</sup>) of the different ZVI bed segments over the entire experiment. The first 192 days, tap water (TW) was fed sequentially to C1-C5. After 192

In all cases, the trend in the presence of additional NaHCO<sub>3</sub> is clear with very important decreases (2 to 4 orders of magnitude) in the hydraulic conductivity compared to the controls. C5 which was fed the highest concentration of NaHCO<sub>3</sub> was plugged first, followed by C4 and then by C3. Thus, it appears that there may be a direct relationship between the NaHCO<sub>3</sub> loading and the time to plugging. Interestingly, despite a gradual decrease in their hydraulic conductivity, C1 and C2 did not experience plugging during the experiment.

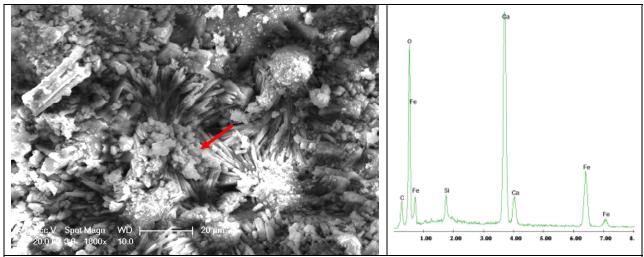
**Figure 5.24** SEM image (left) of ZVI in C5 at a height of 0 cm. The right shows the and EDX spectrum (x axis in keV) of the spot indicated by the red arrow on the SEM image. Note that the x axis was truncated to improve readability but no peaks were observed above 8 keV.

The distribution of the precipitates was clearly changing with the depth in the column. At increasing penetration depth, calcium decreased while the intensity of iron increased, probably as a result of both the availability of calcium and of the redox conditions. Most of the calcium carbonate (long rod shape) accumulated at the entrance of the reactor resulting a thick deposit layer, even possibly "gluing" ZVI particles together and is suspected to be a major contributor to the loss of hydraulic conductivity. Green rusts (GRs) are layered Fe(II)-Fe(III) hydroxi-salts that are often detected in environmental systems with alternating redox conditions and is often the products of both aerobic and anaerobic corrosion (Legrand et al., 2004). Green rusts have also been reported to be the result of the biological reduction of ferric oxihydroxides by dissimilatory iron-reducing bacteria (DIRB) (Fredrickson et al., 1998; Ona-Nguema et al., 2002). Oxidizing species such as dissolved oxygen and nitrate are known to play an important role in the formation and subsequent reaction of such corrosion products. It is not clear whether these were indeed the formation mechanisms involved in the tested system. The detection of large amount of calcium carbonate at the top (L=13 cm) of the column was a surprise as calcium was thought to have been depleted in the first few cm. A possible reason for the calcium presence at that height may be calcium carried by preferential flow after significant heterogeneities developed in the ZVI bed.

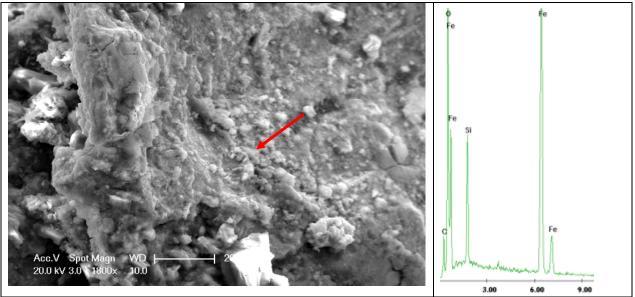
**Figure 5.28** SEM image (left) and EDX spectrum (right, x axis in keV) of ZVI in C5 at a height of 9 cm. Possible dominant species are green rusts, and iron oxides

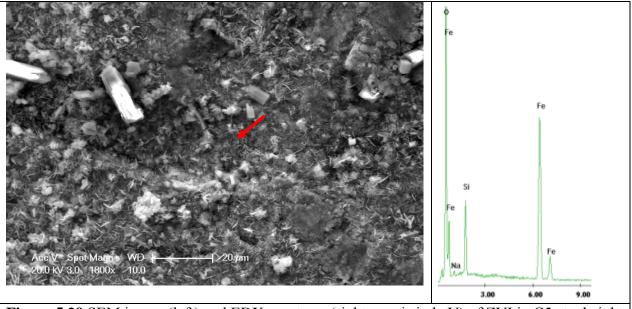
**Figure 5.29** SEM image (left) and EDX spectrum (right, x axis in keV) of ZVI in C5 at a height of 11 cm.

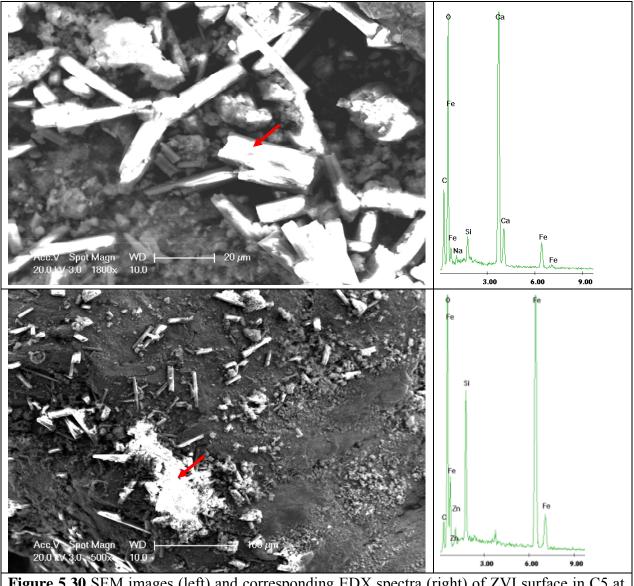
**Figure 5.30** SEM images (left) and corresponding EDX spectra (right) of ZVI surface in C5 at a height of 13 cm. Note the lower magnification for the bottom image and the large difference in iron and calcium peaks.

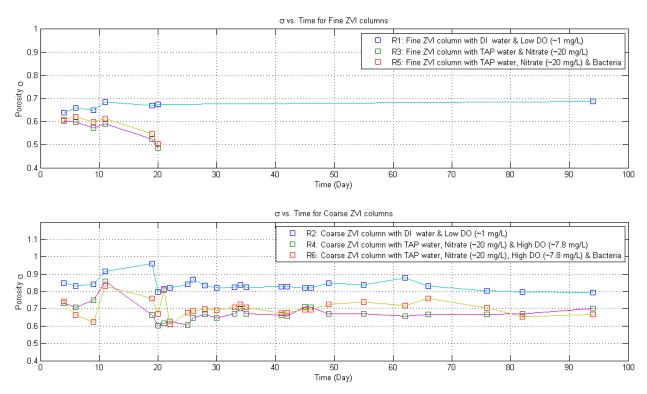
Figure 5.32 Porosity determined by tracer injection over time for the six ZVI reactors.

Over time, nitrate reduction was observed in R3 and R4. The most likely explanation for this is that some bacterial contamination occurred in these reactors, resulting in denitrification. Also, removal of nitrate in R5 and R6 decreased after 40 days and stabilized to about 5 mg  $L^{-1}$  removed. There was no difference between R5 and R6, packed with fine and coarse ZVI respectively. This would suggest that denitrification was not limited by the surface available for bacterial attachment or ZVI surface area for corrosion and hydrogen production. This conclusion is in contradiction with the fact that denitrification rate decreased over time in both reactors. An alternative explanation could be that short circuits and heterogeneous conditions established in the ZVI bed, although this was not observed in residence time distribution determinations discussed for Figure 5.32.

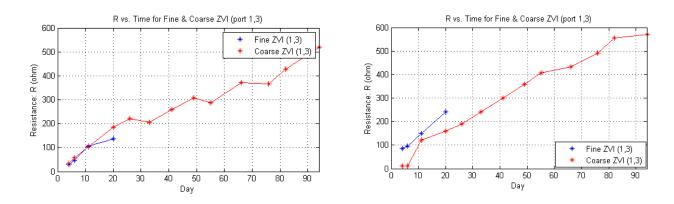
**Figure 5.33** Electrical resistance of selected ZVI reactors: left R3 (labeled fine) and R4 (coarse), and right R5 (fine) and R6 (coarse). R1 and R2 not shown.

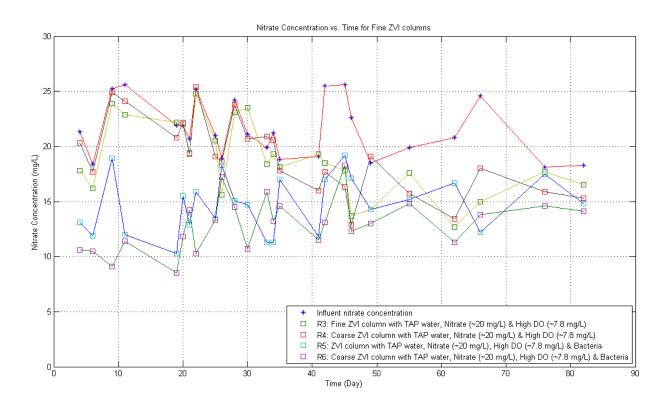
**Figure 5.34** Nitrate concentrations in the influent and effluent of the ZVI reactor. R1 and R2 which had no spiked nitrate are not shown.

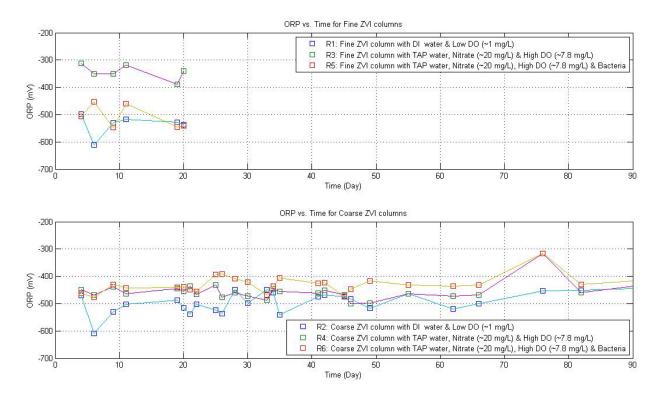
Figure 5.35 ORP in the effluent of the ZVI reactors.

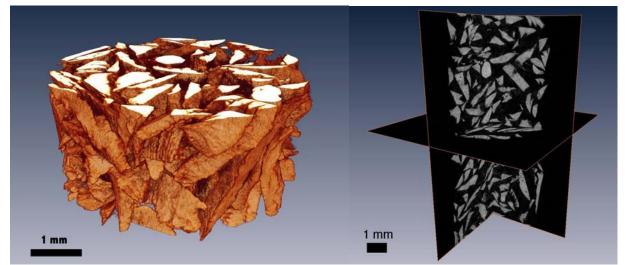
**Figure 5.36** Micro-CT of a section of a coarse ZVI bed showing (left) the complex 3D path the water must take through the bed. Right: orthogonal sections of that bed.

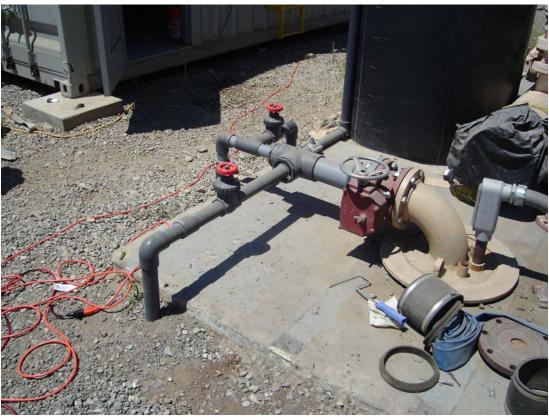
Well #2 and splitting of the feed line to the different demonstration projects.

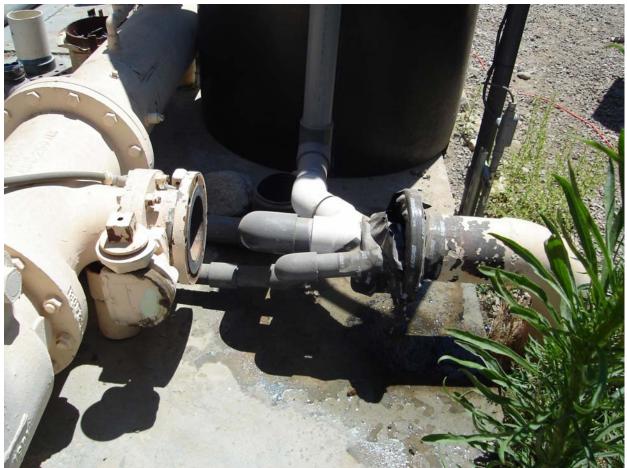
Discharge of the effluent of the different demonstration project to a common line leading to the catch basin.

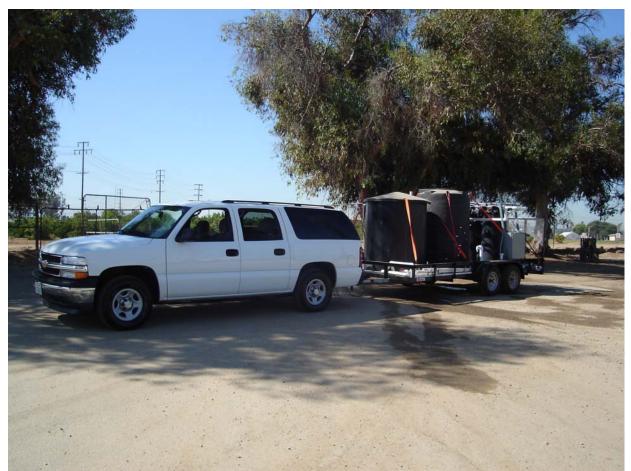
The ZVI bioreactor on its trailer ready for mobilization. ZVI was loaded into the system at the site.
