MEMORANDUM

Date: May 15, 2009

Subject: Summary/Update Regarding Site Conceptual Model
Kearsarge Metallurgical Corporation Superfund Site, Conway, New Hampshire

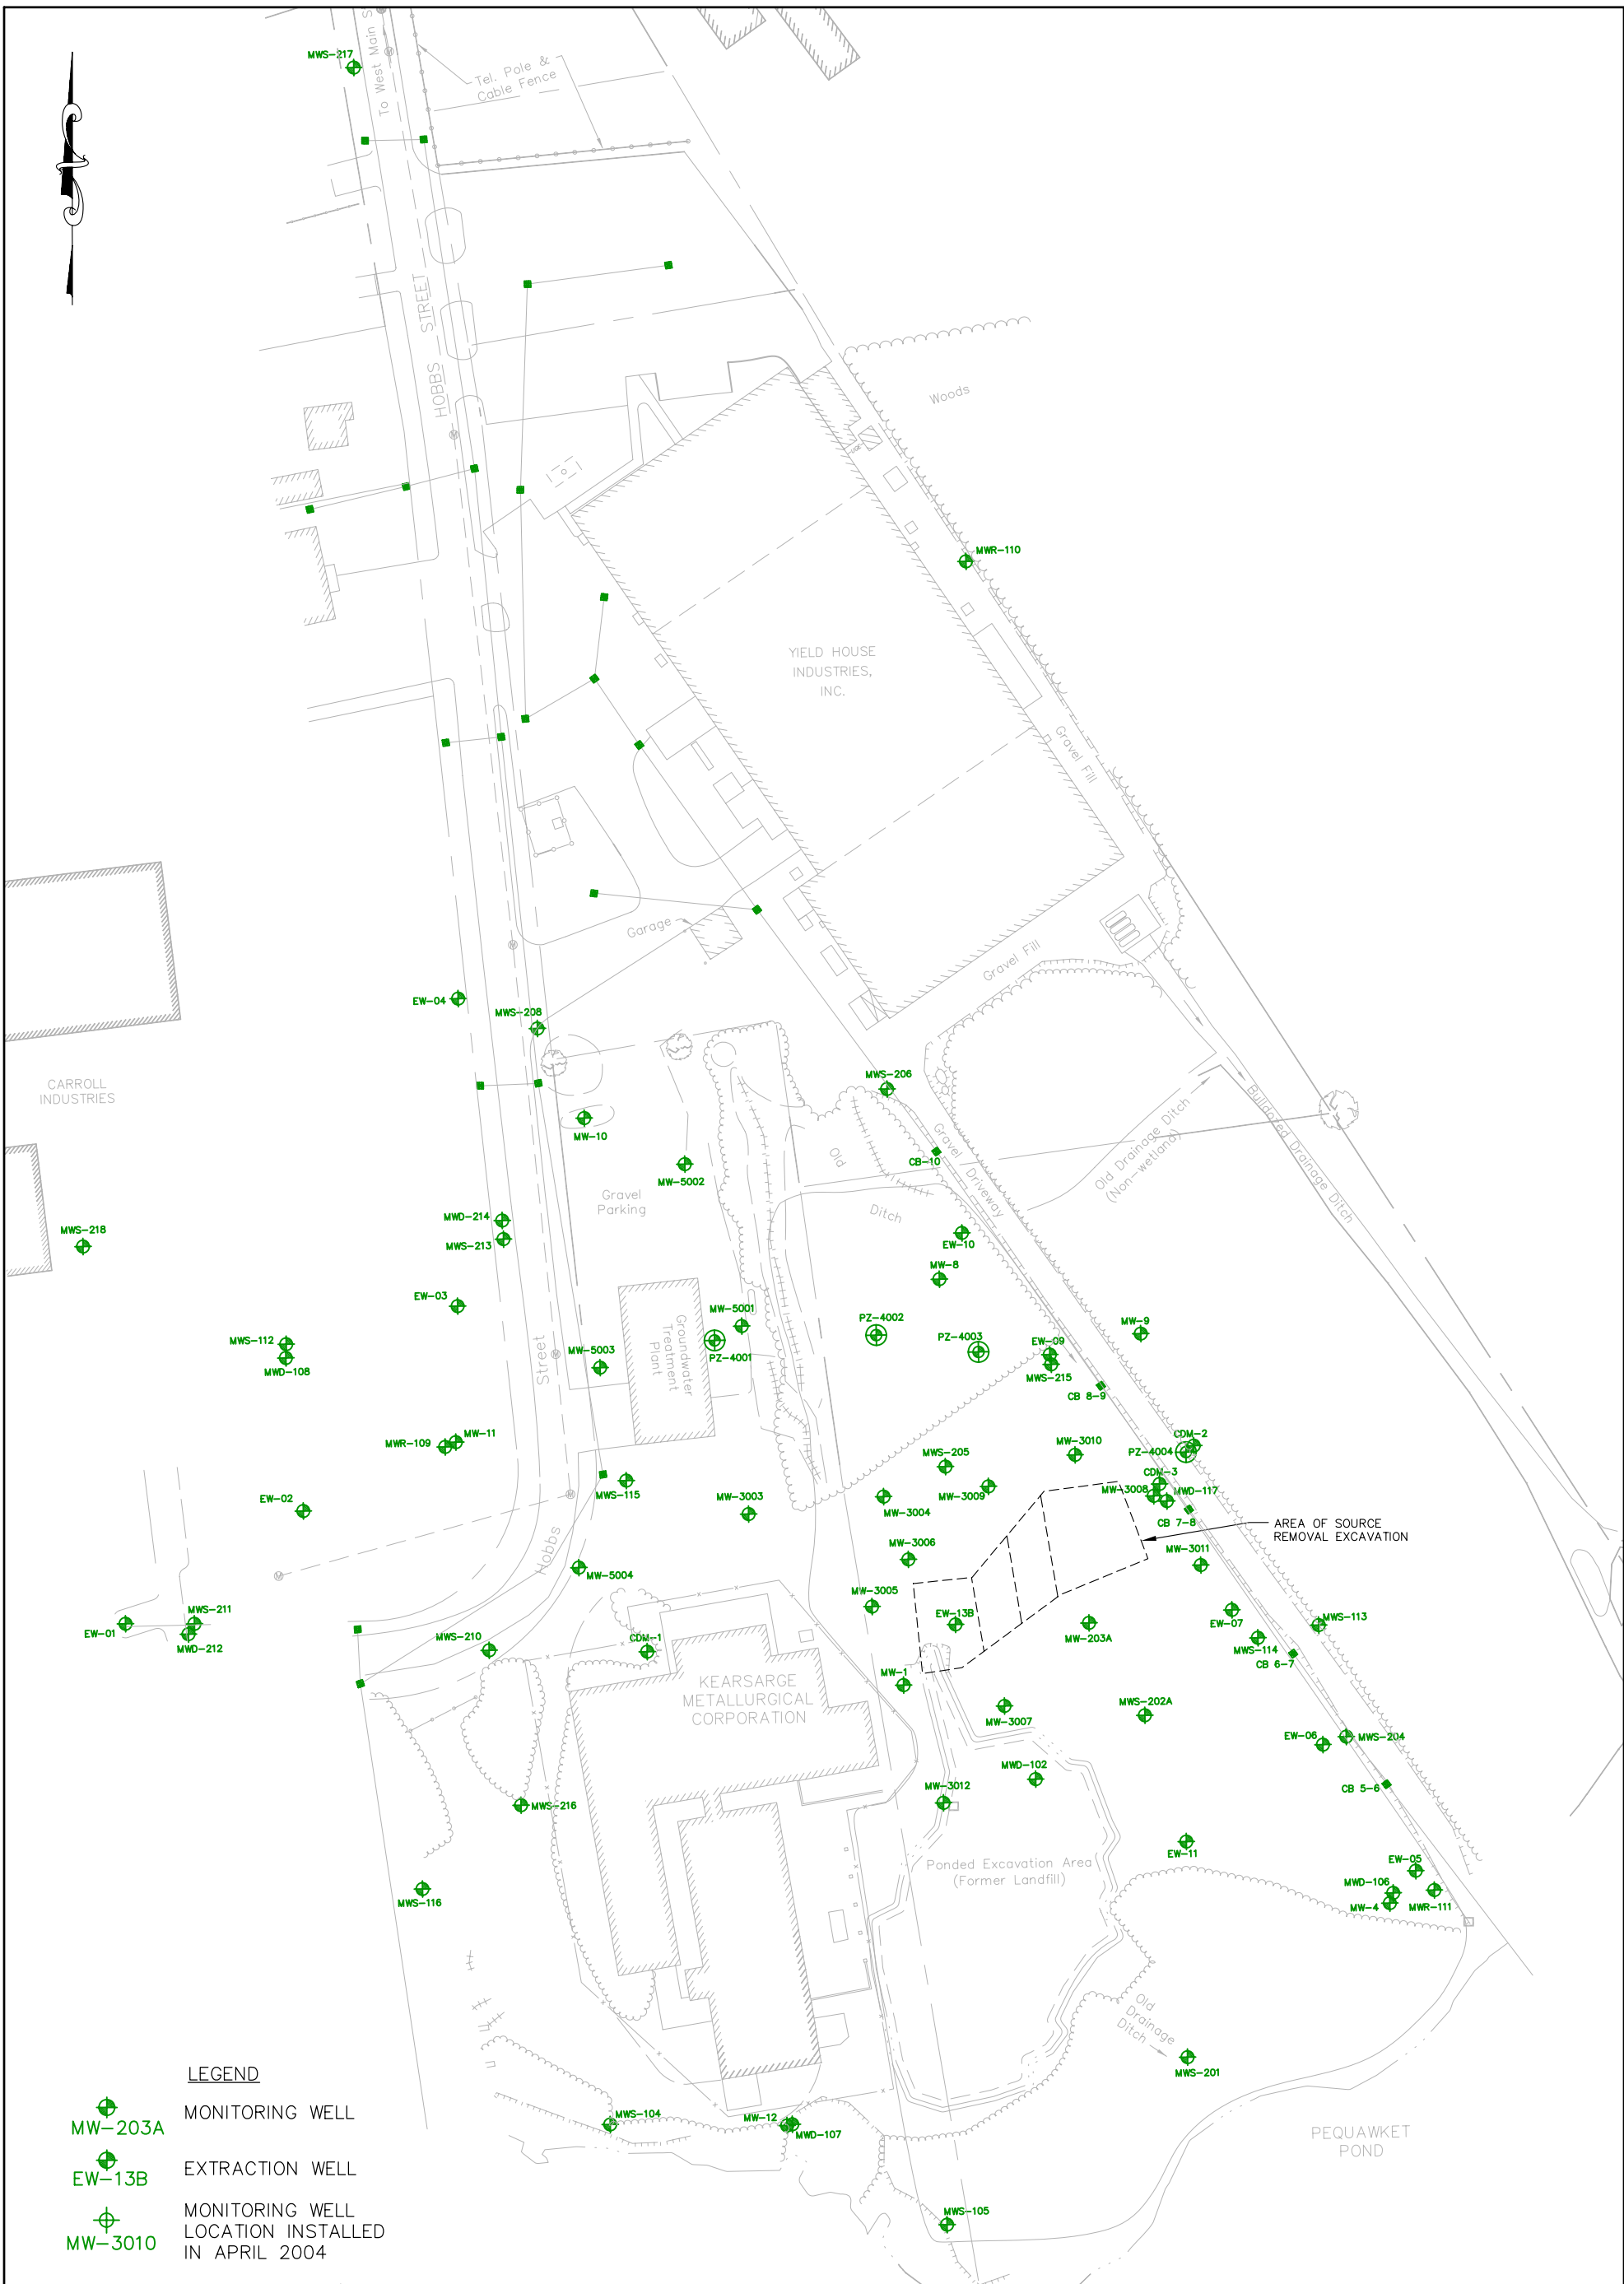
DRAWN	BEG
DATE	APR 2008
FIGURE NO.	1

SITE PLAN

The locations of previous P&T extraction wells, and the location of the source area excavation, are illustrated on the figures in Attachment A. Specific components of the site conceptual model are detailed below.

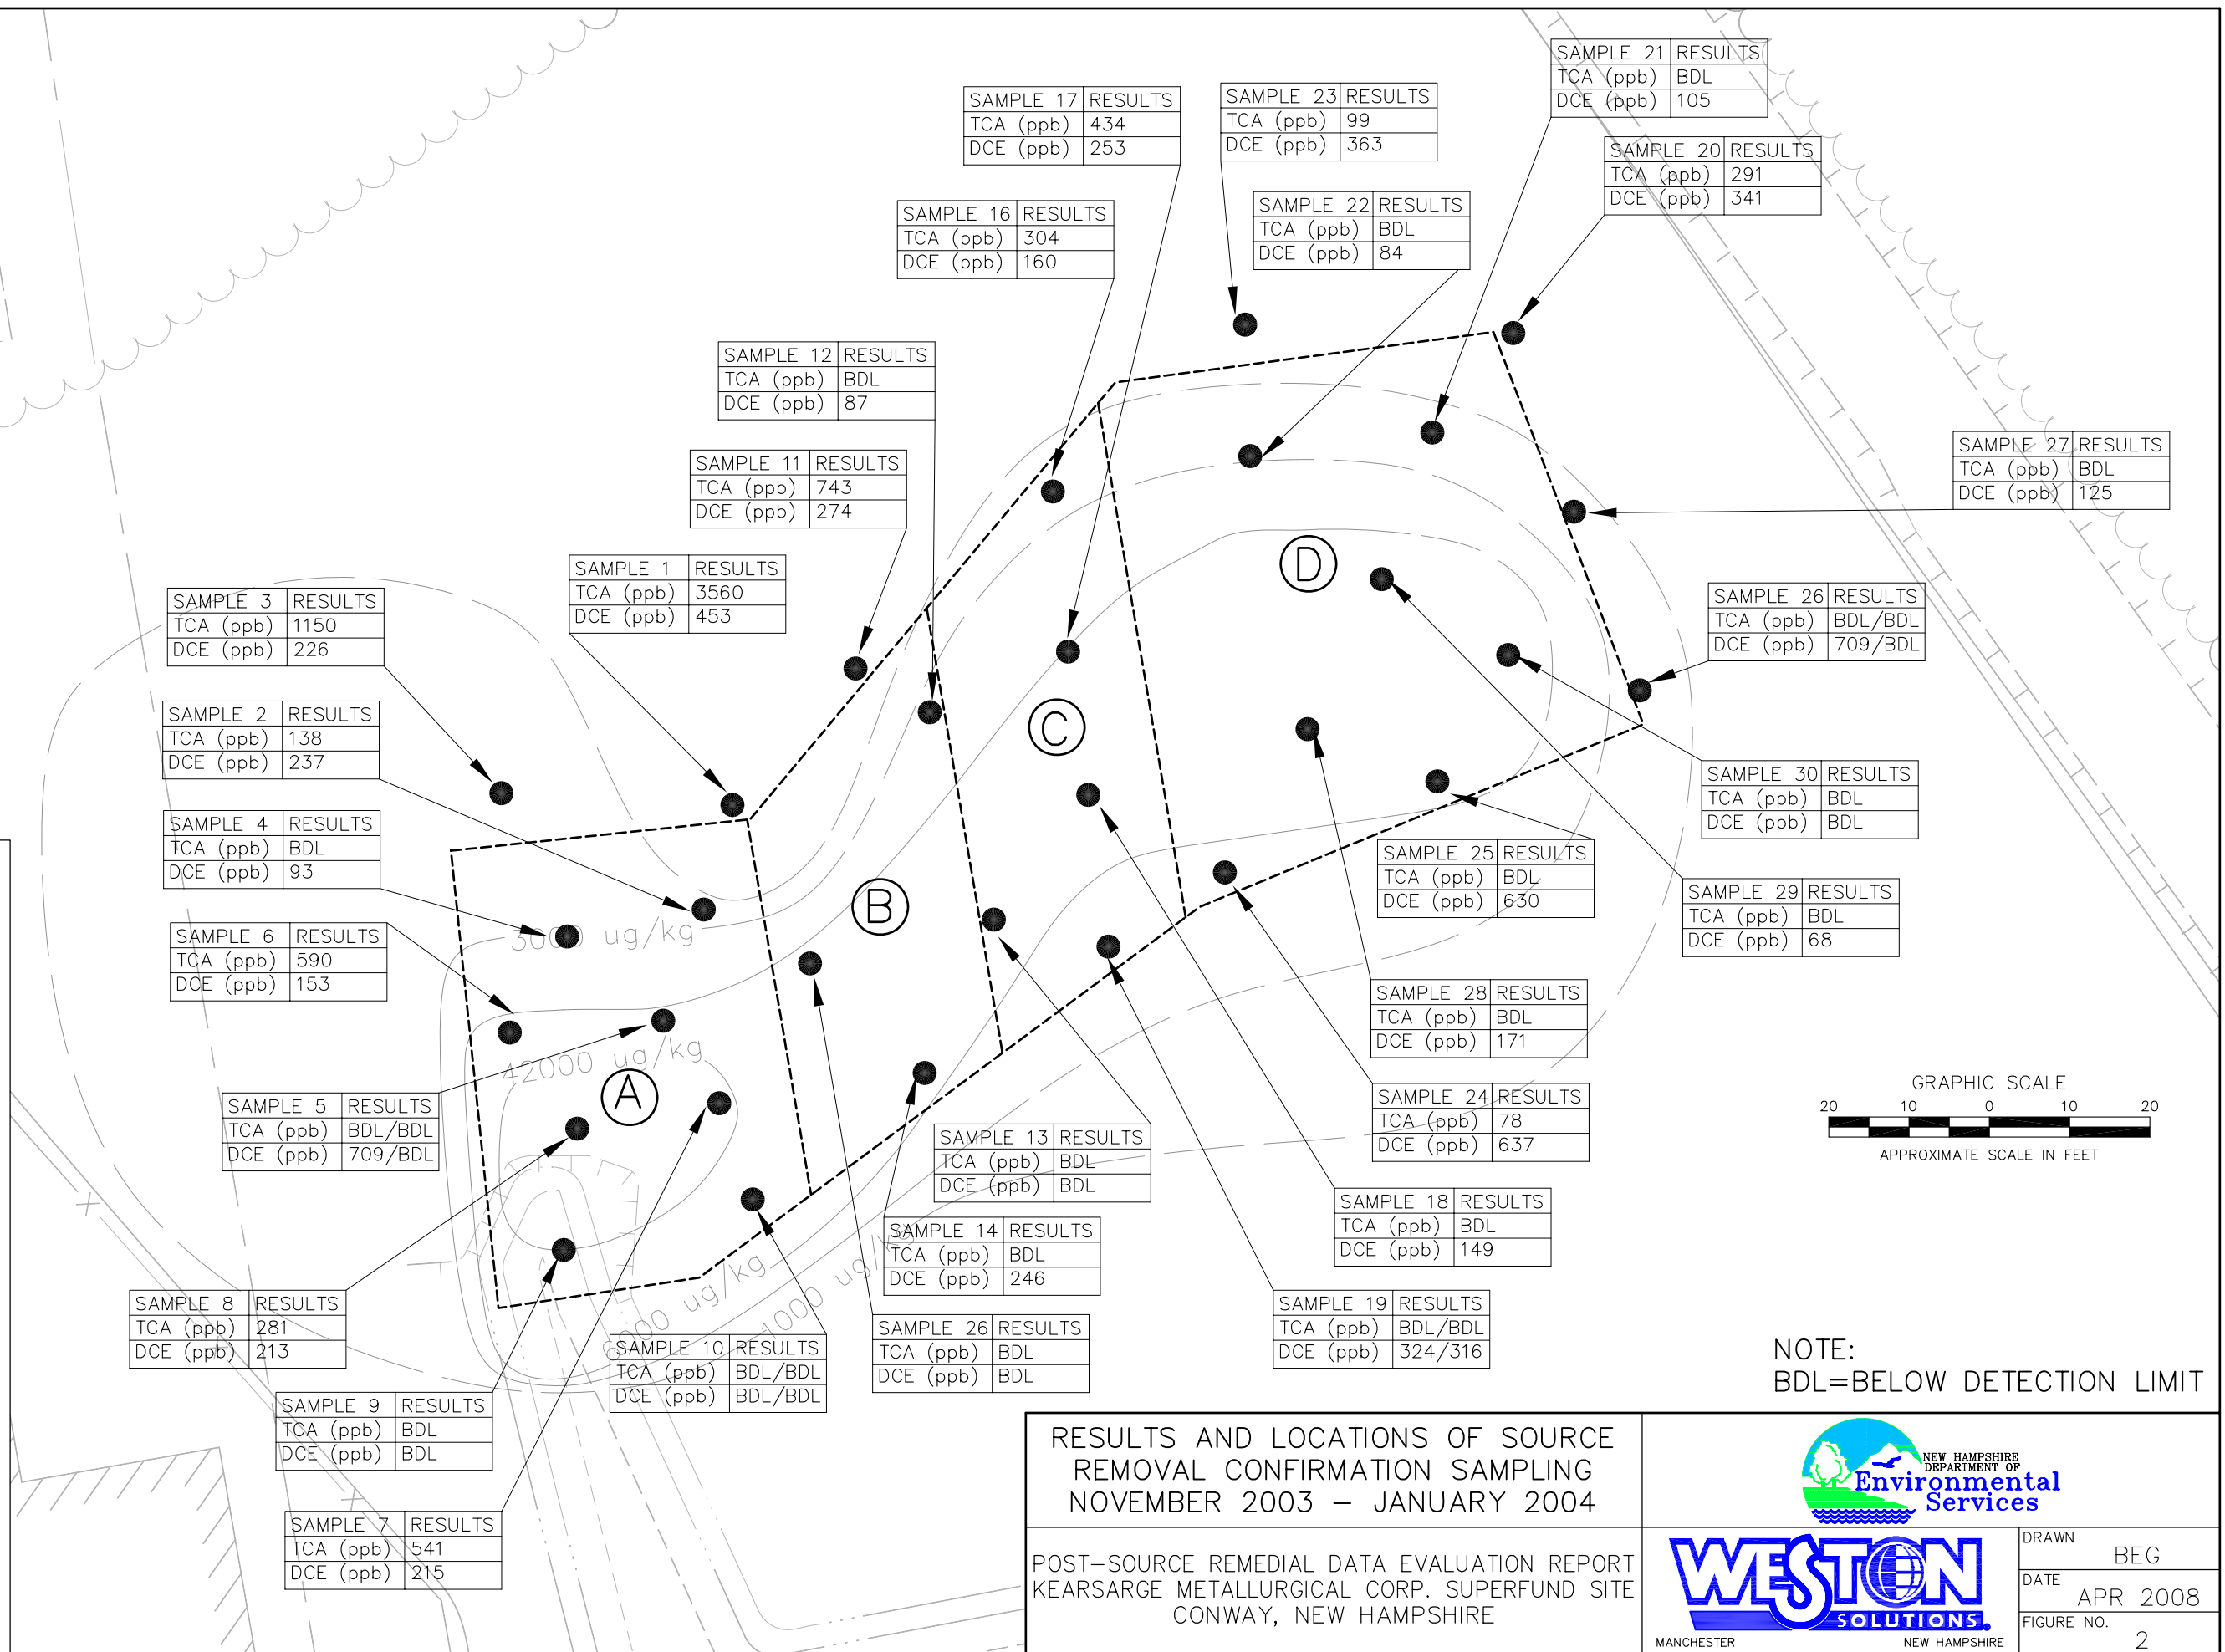
DRAWN: BEG
 DATE: APR 2008
 FIGURE NO.: 2

RESULTS AND LOCATIONS OF SOURCE REMOVAL CONFIRMATION SAMPLING NOVEMBER 2003 – JANUARY 2004

NOTE: BDL=BELOW DETECTION LIMIT

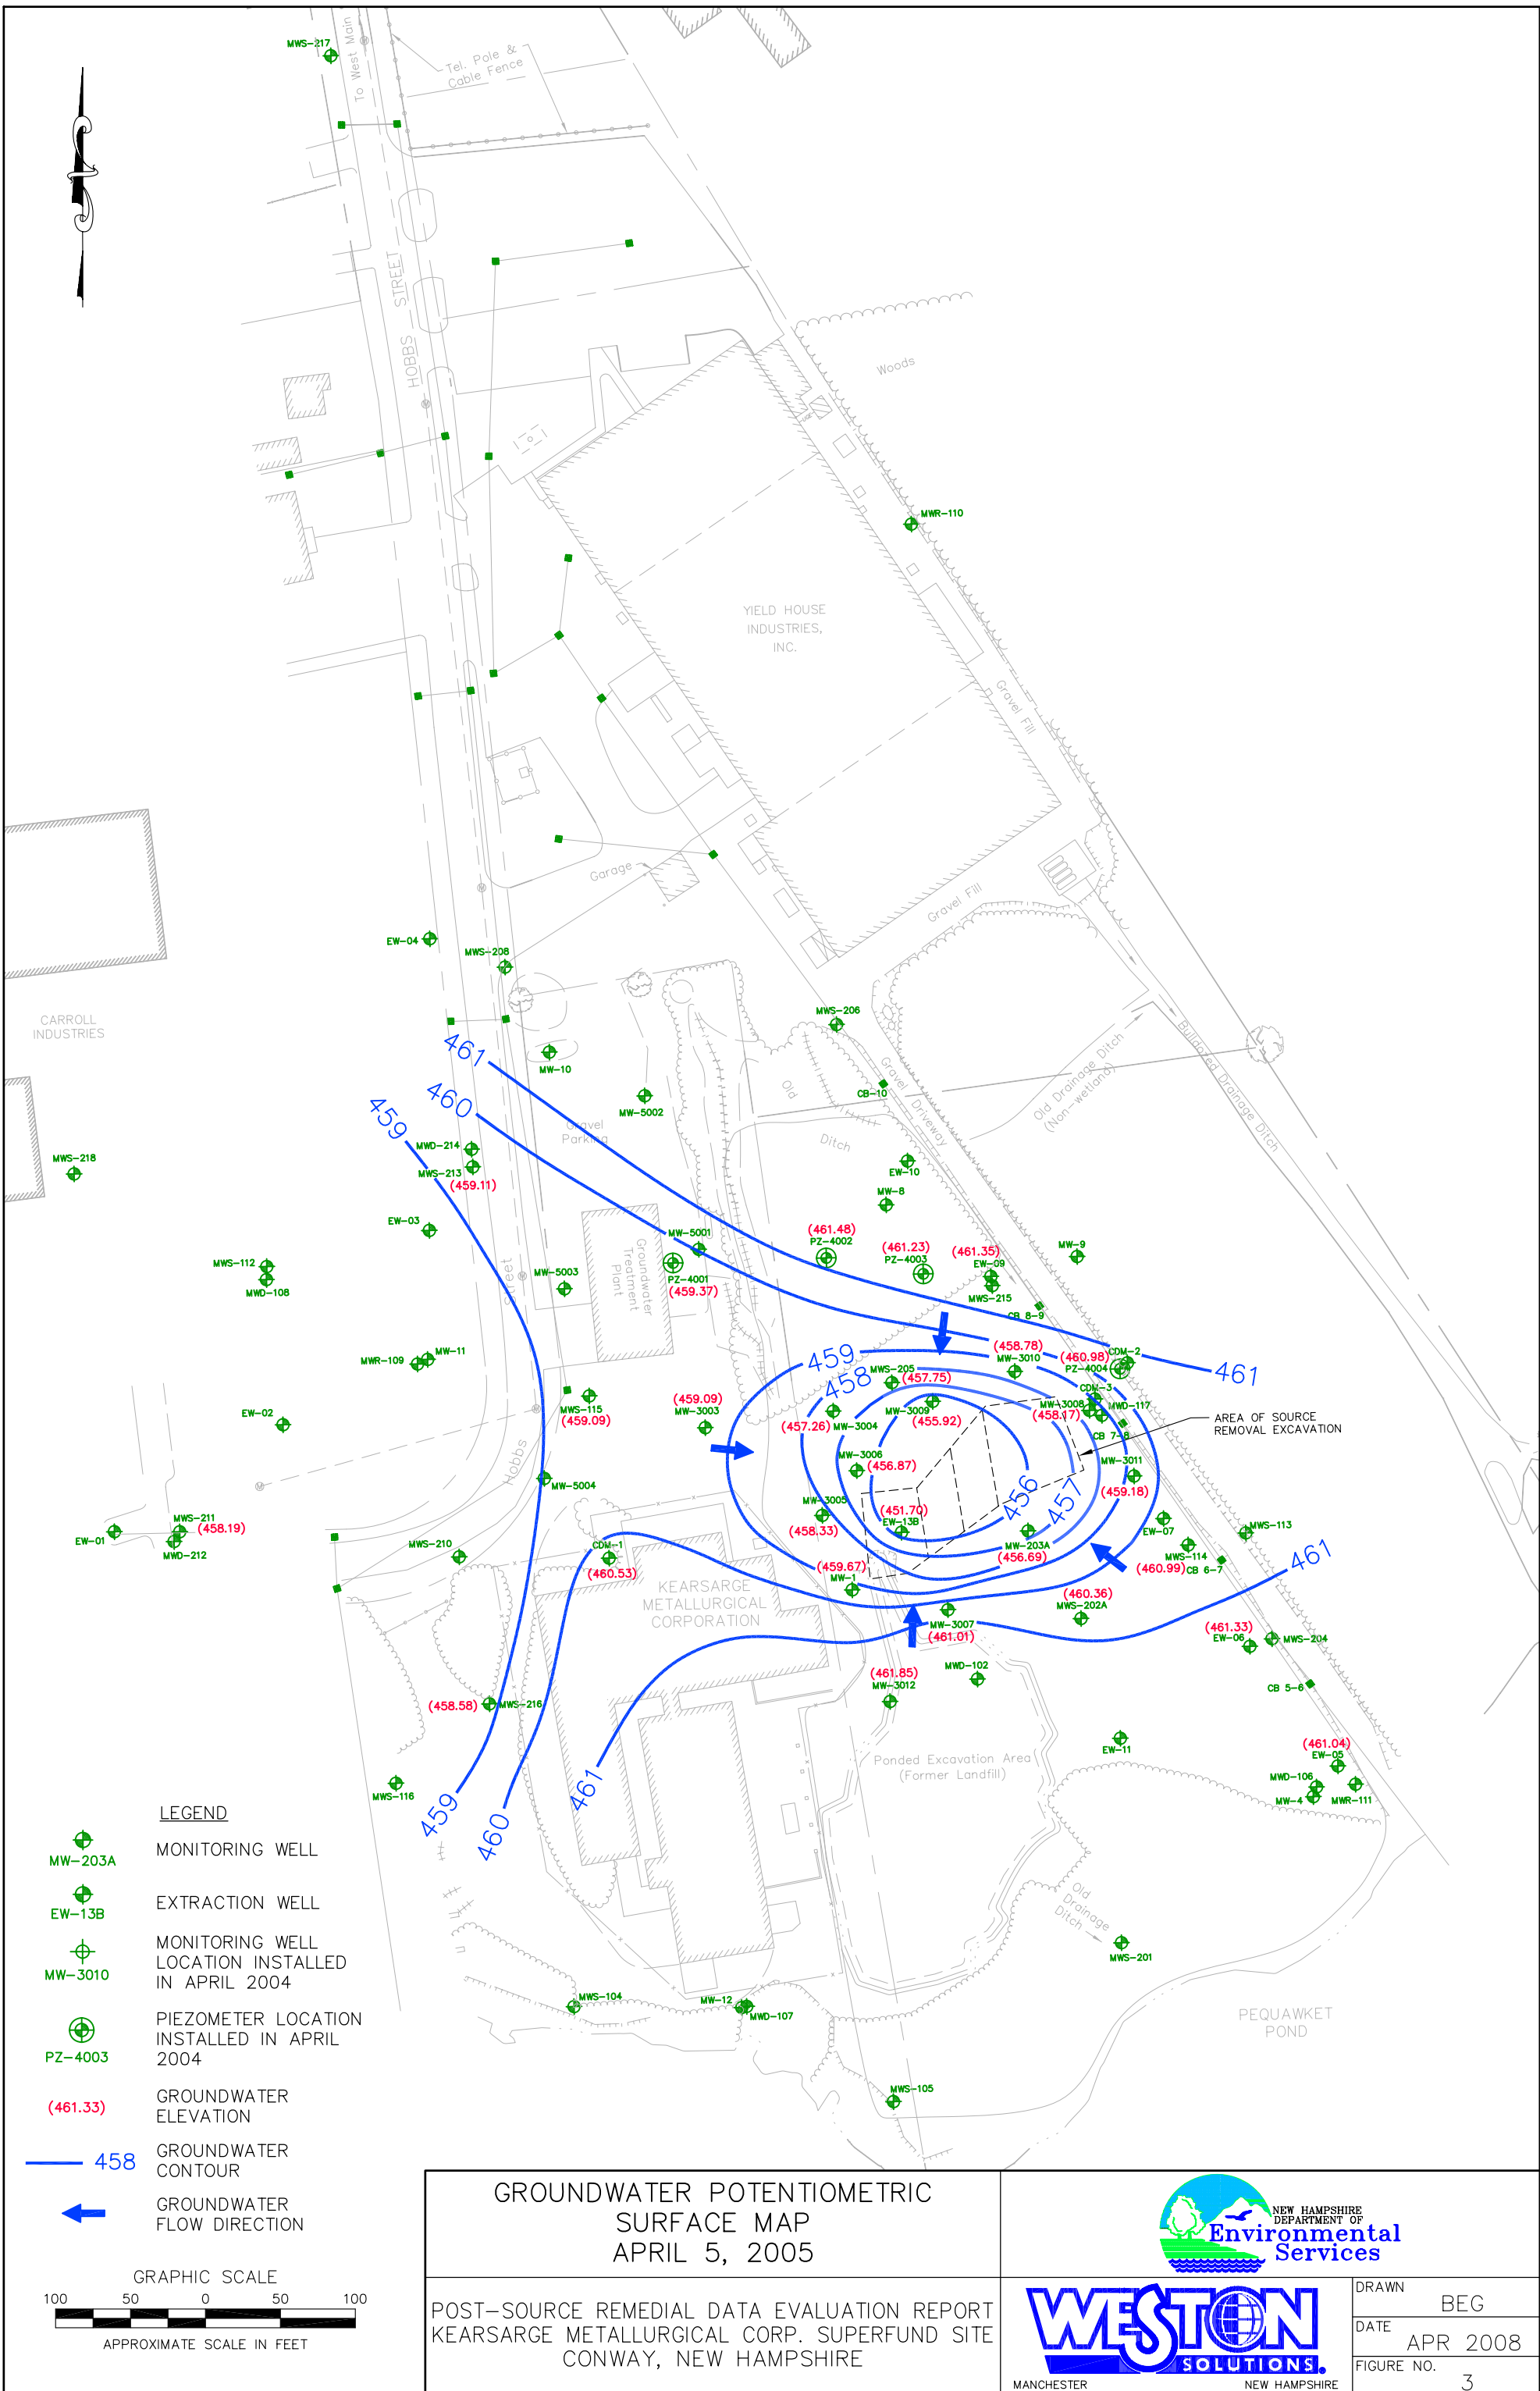
DRAWN	BEG
DATE	APR 2008
FIGURE NO.	3

**GROUNDWATER POTENTIOMETRIC SURFACE MAP
APRIL 5, 2005**

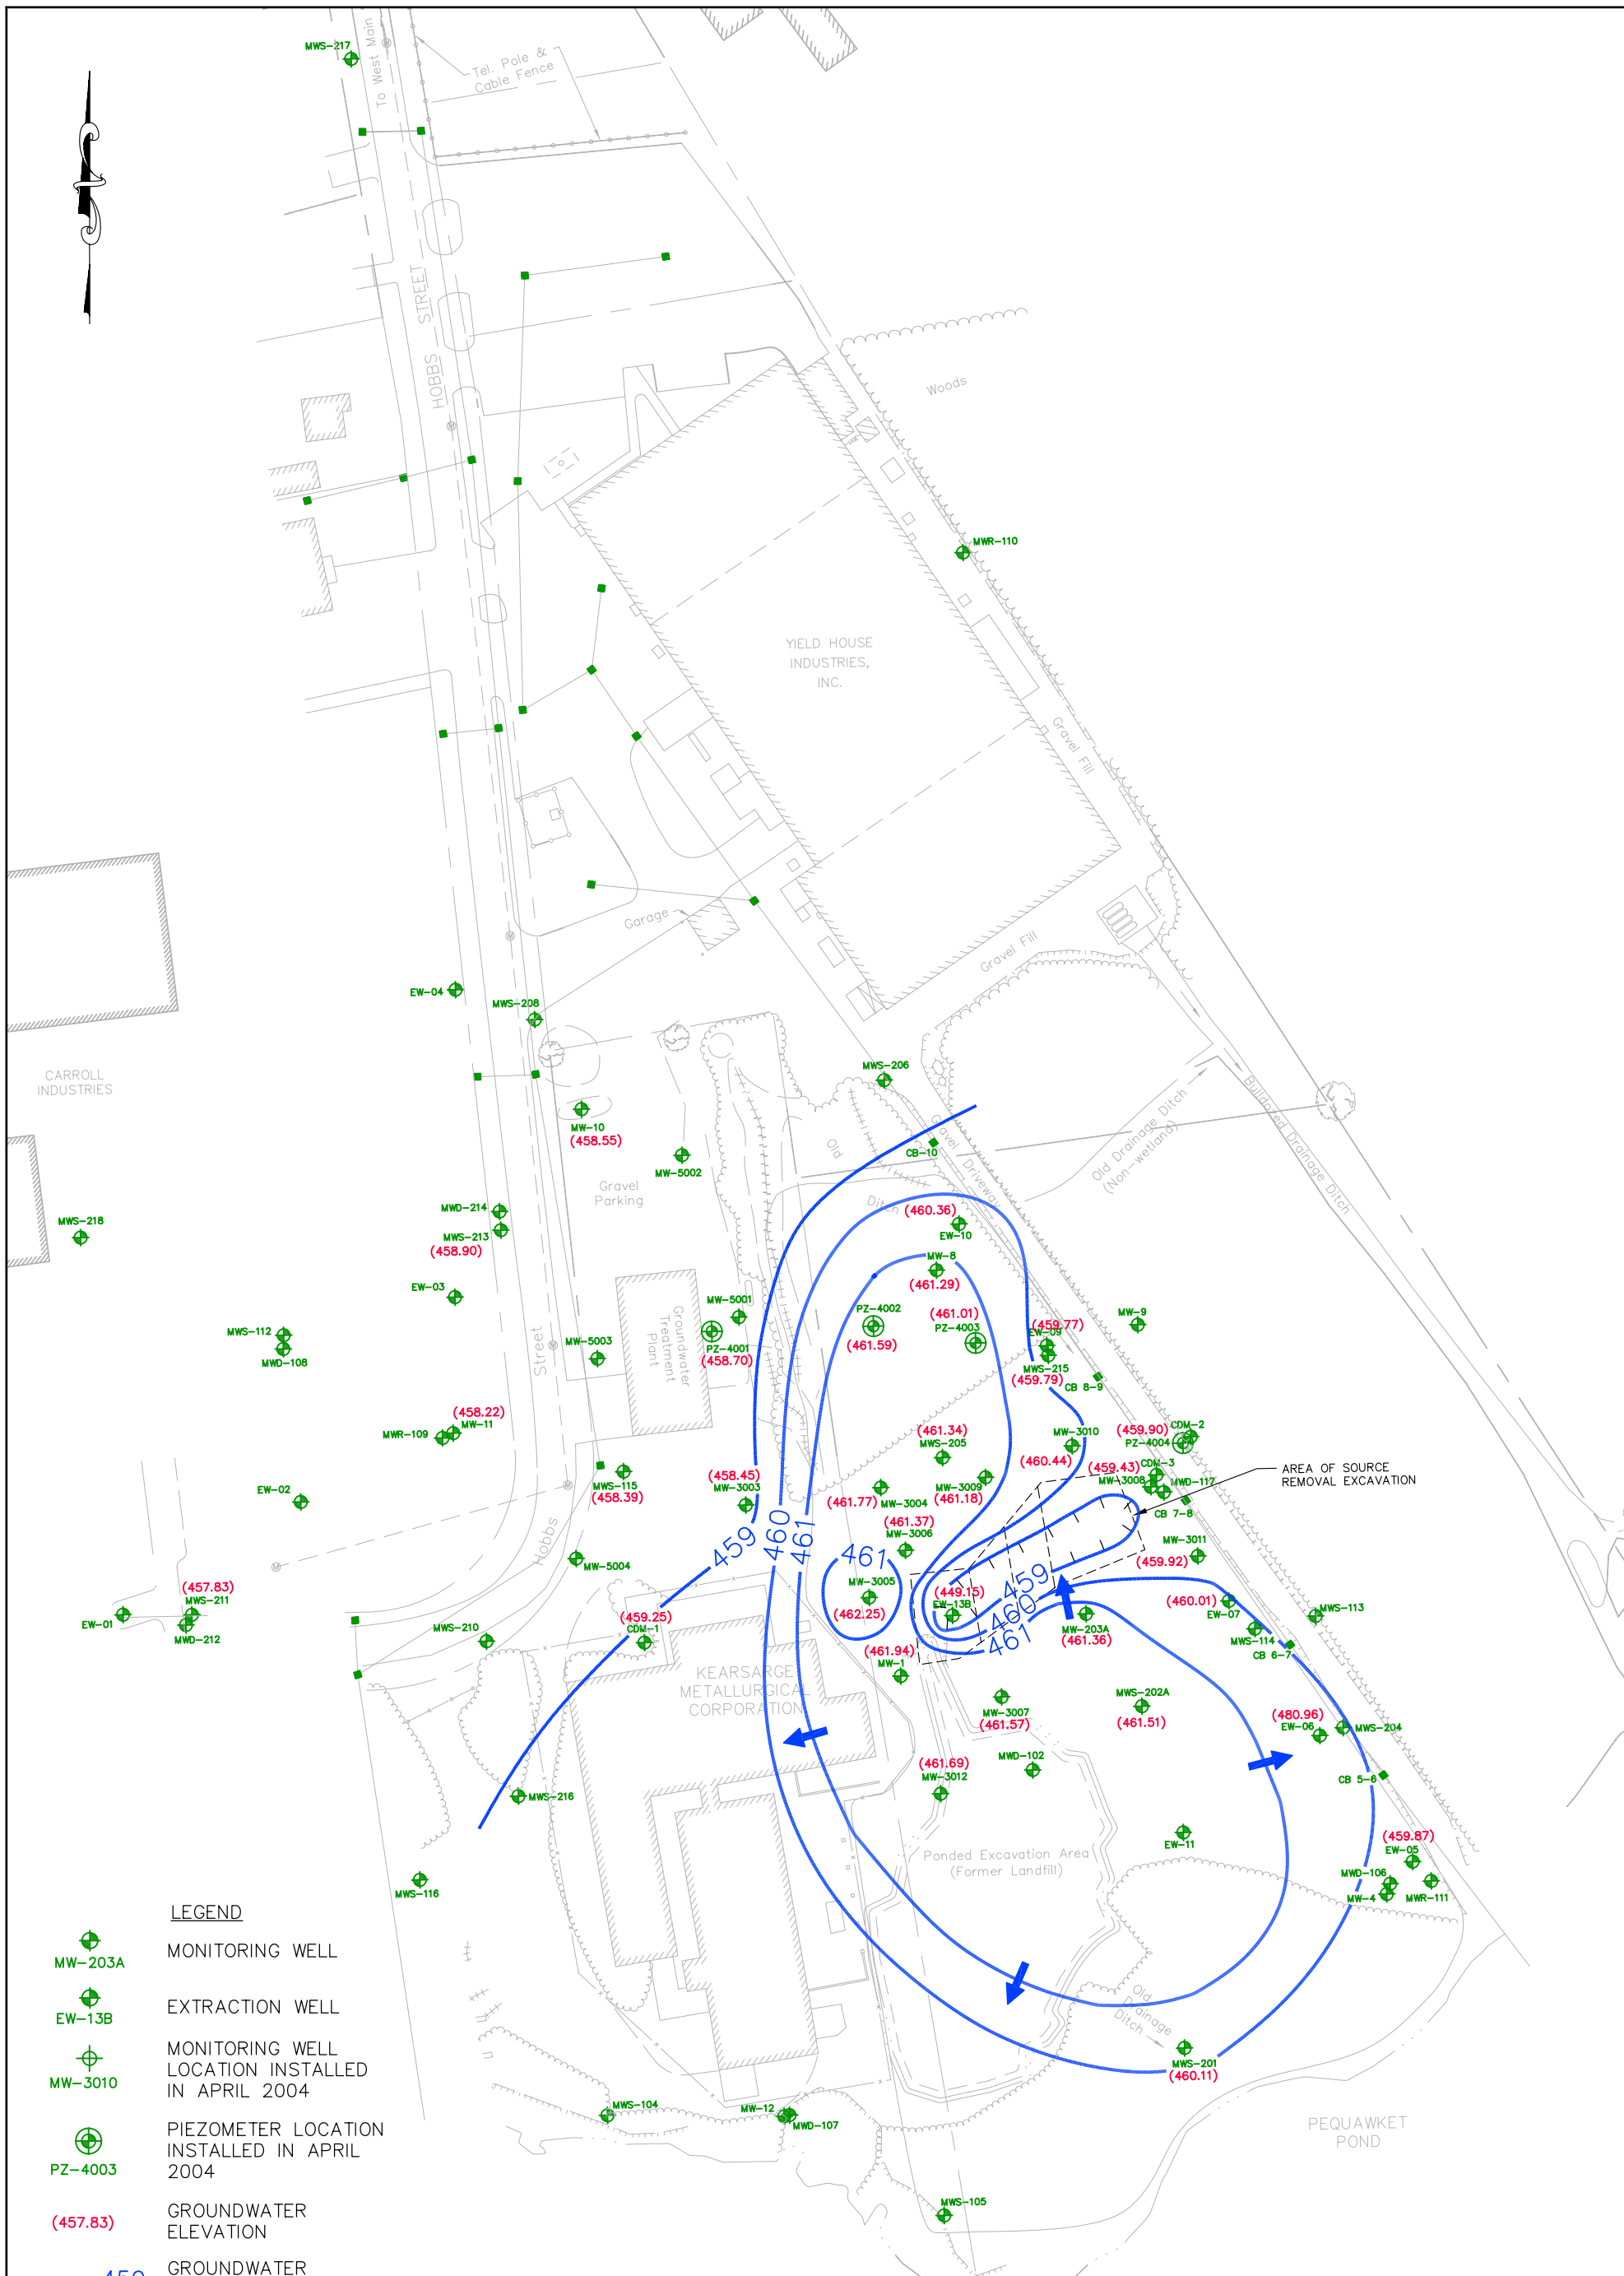
<p>DRAWN: BEG DATE: APR 2008 FIGURE NO.: 4</p>

<p>GROUNDWATER POTENTIOMETRIC SURFACE MAP DECEMBER 1, 2005</p>

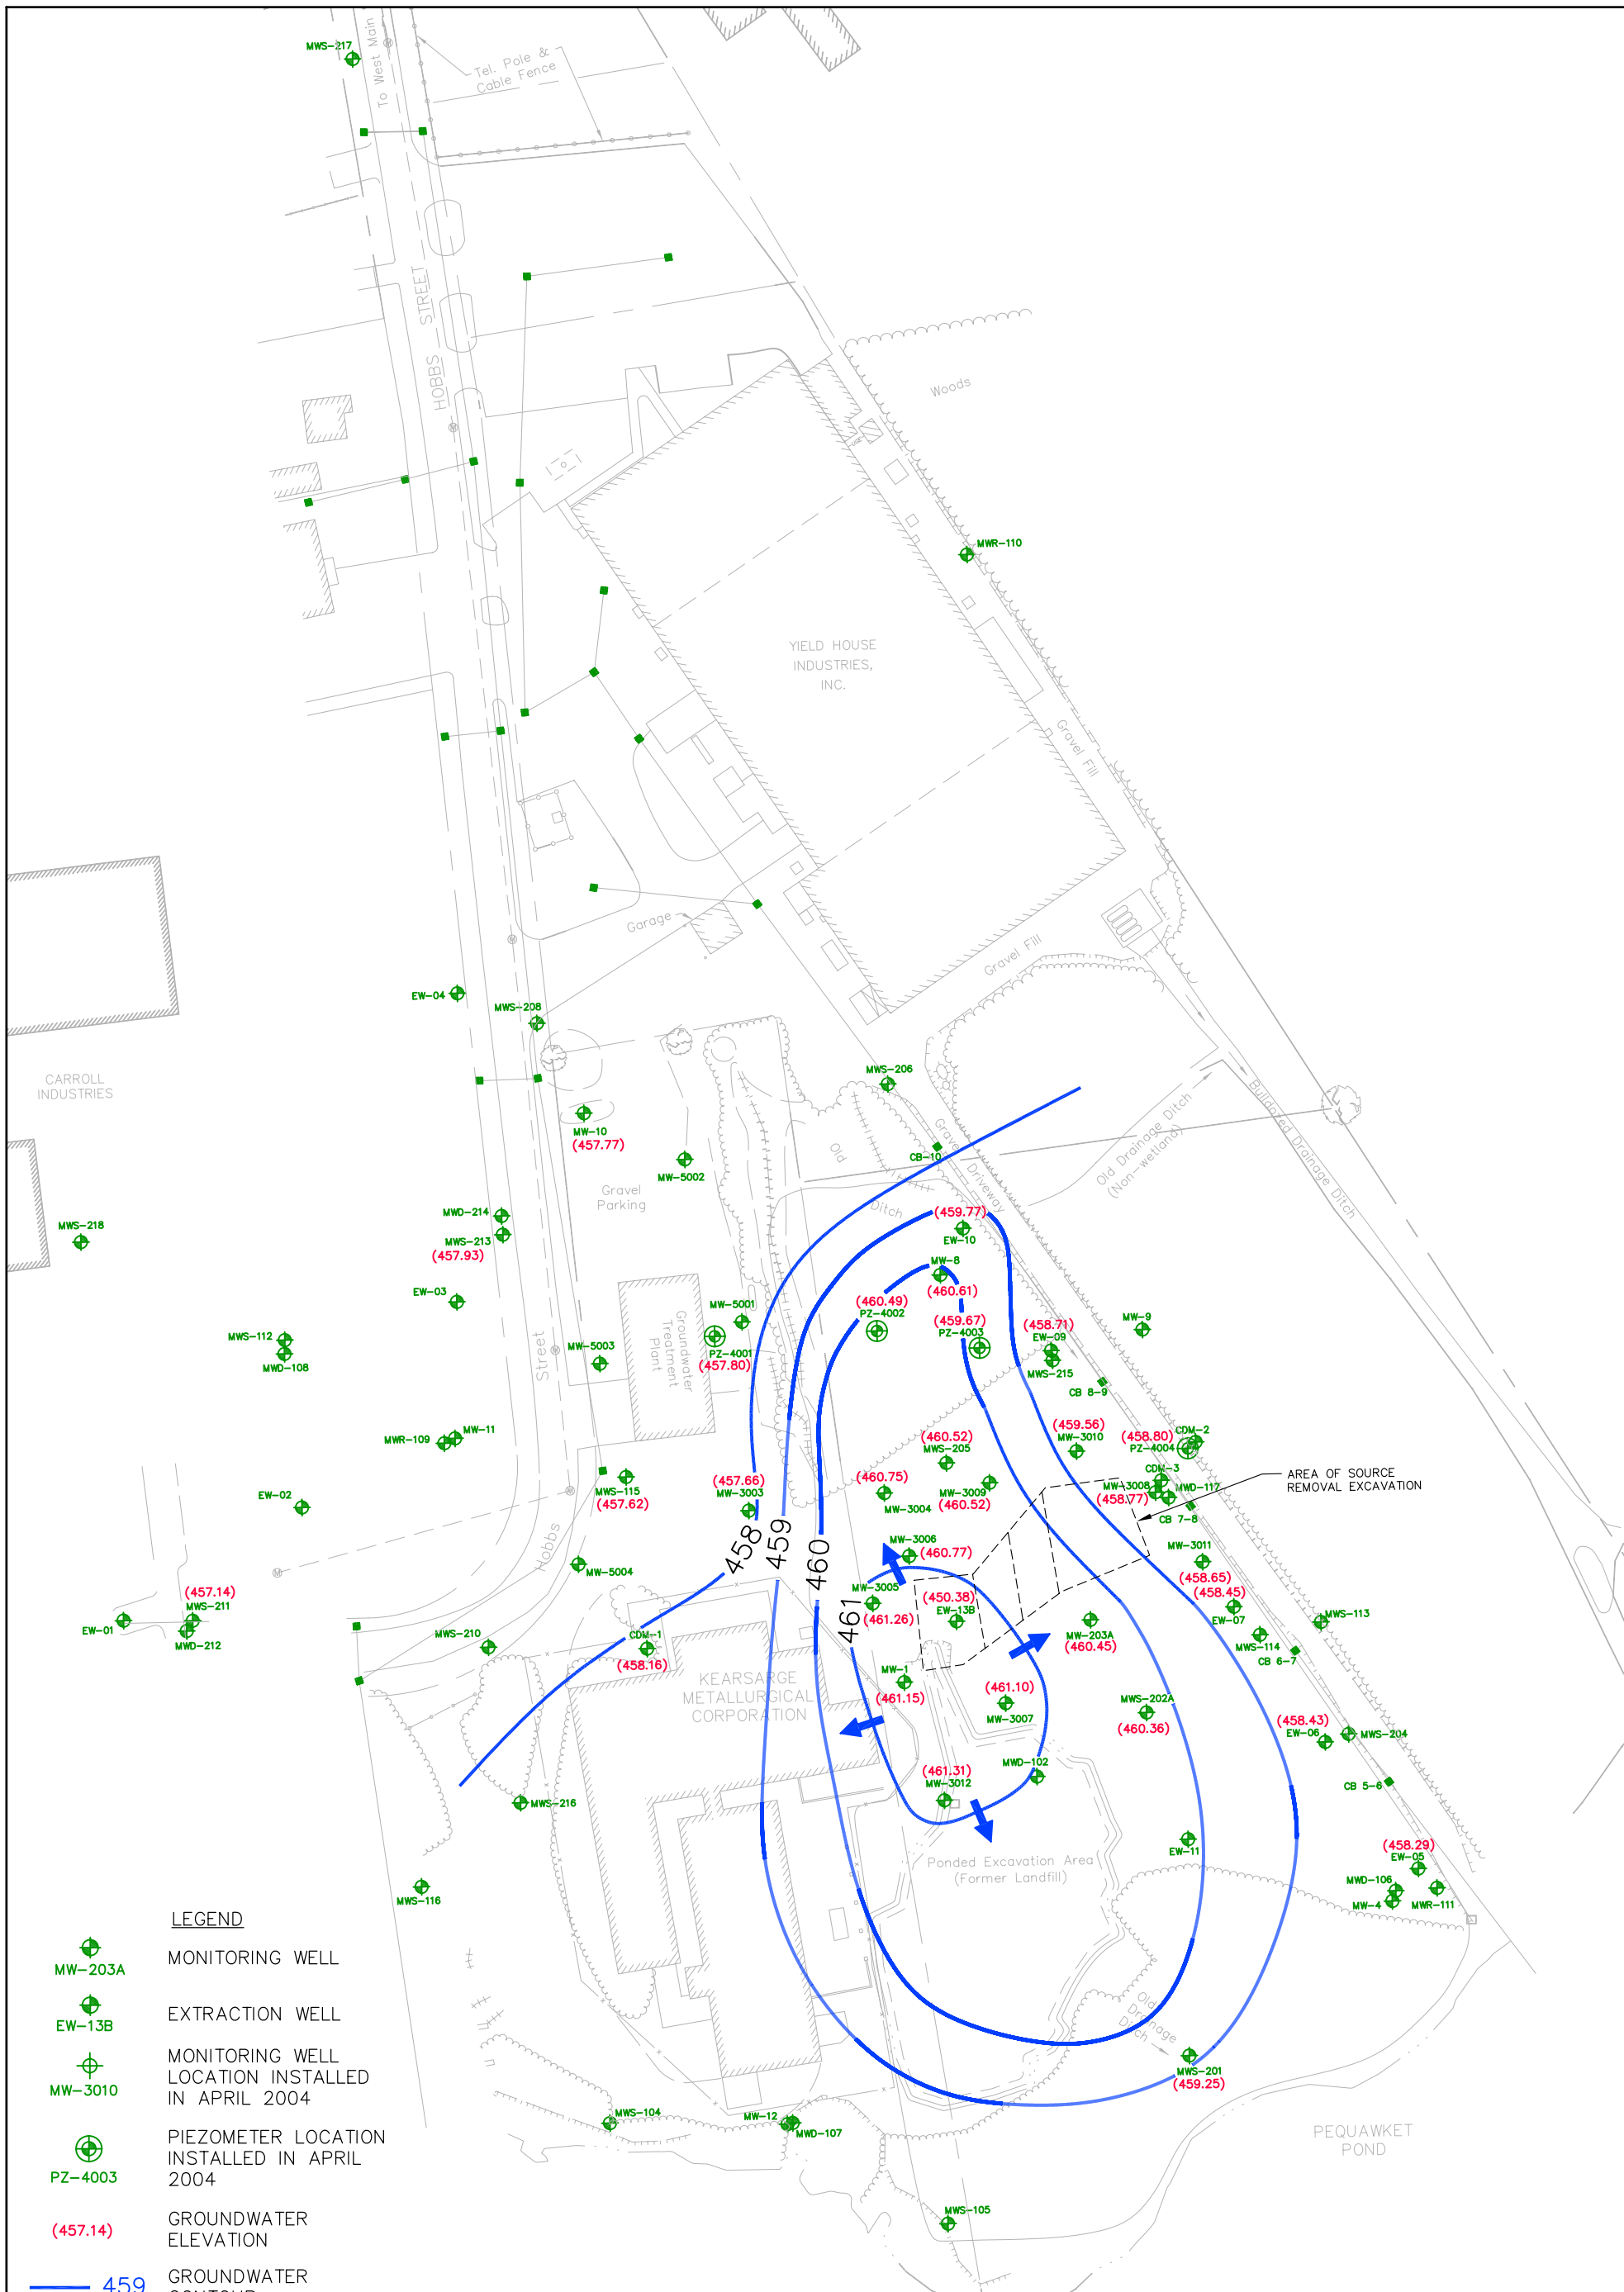
DRAWN	BEG
DATE	APR 2008
FIGURE NO.	5

**GROUNDWATER POTENTIOMETRIC SURFACE MAP
DECEMBER 6, 2005**

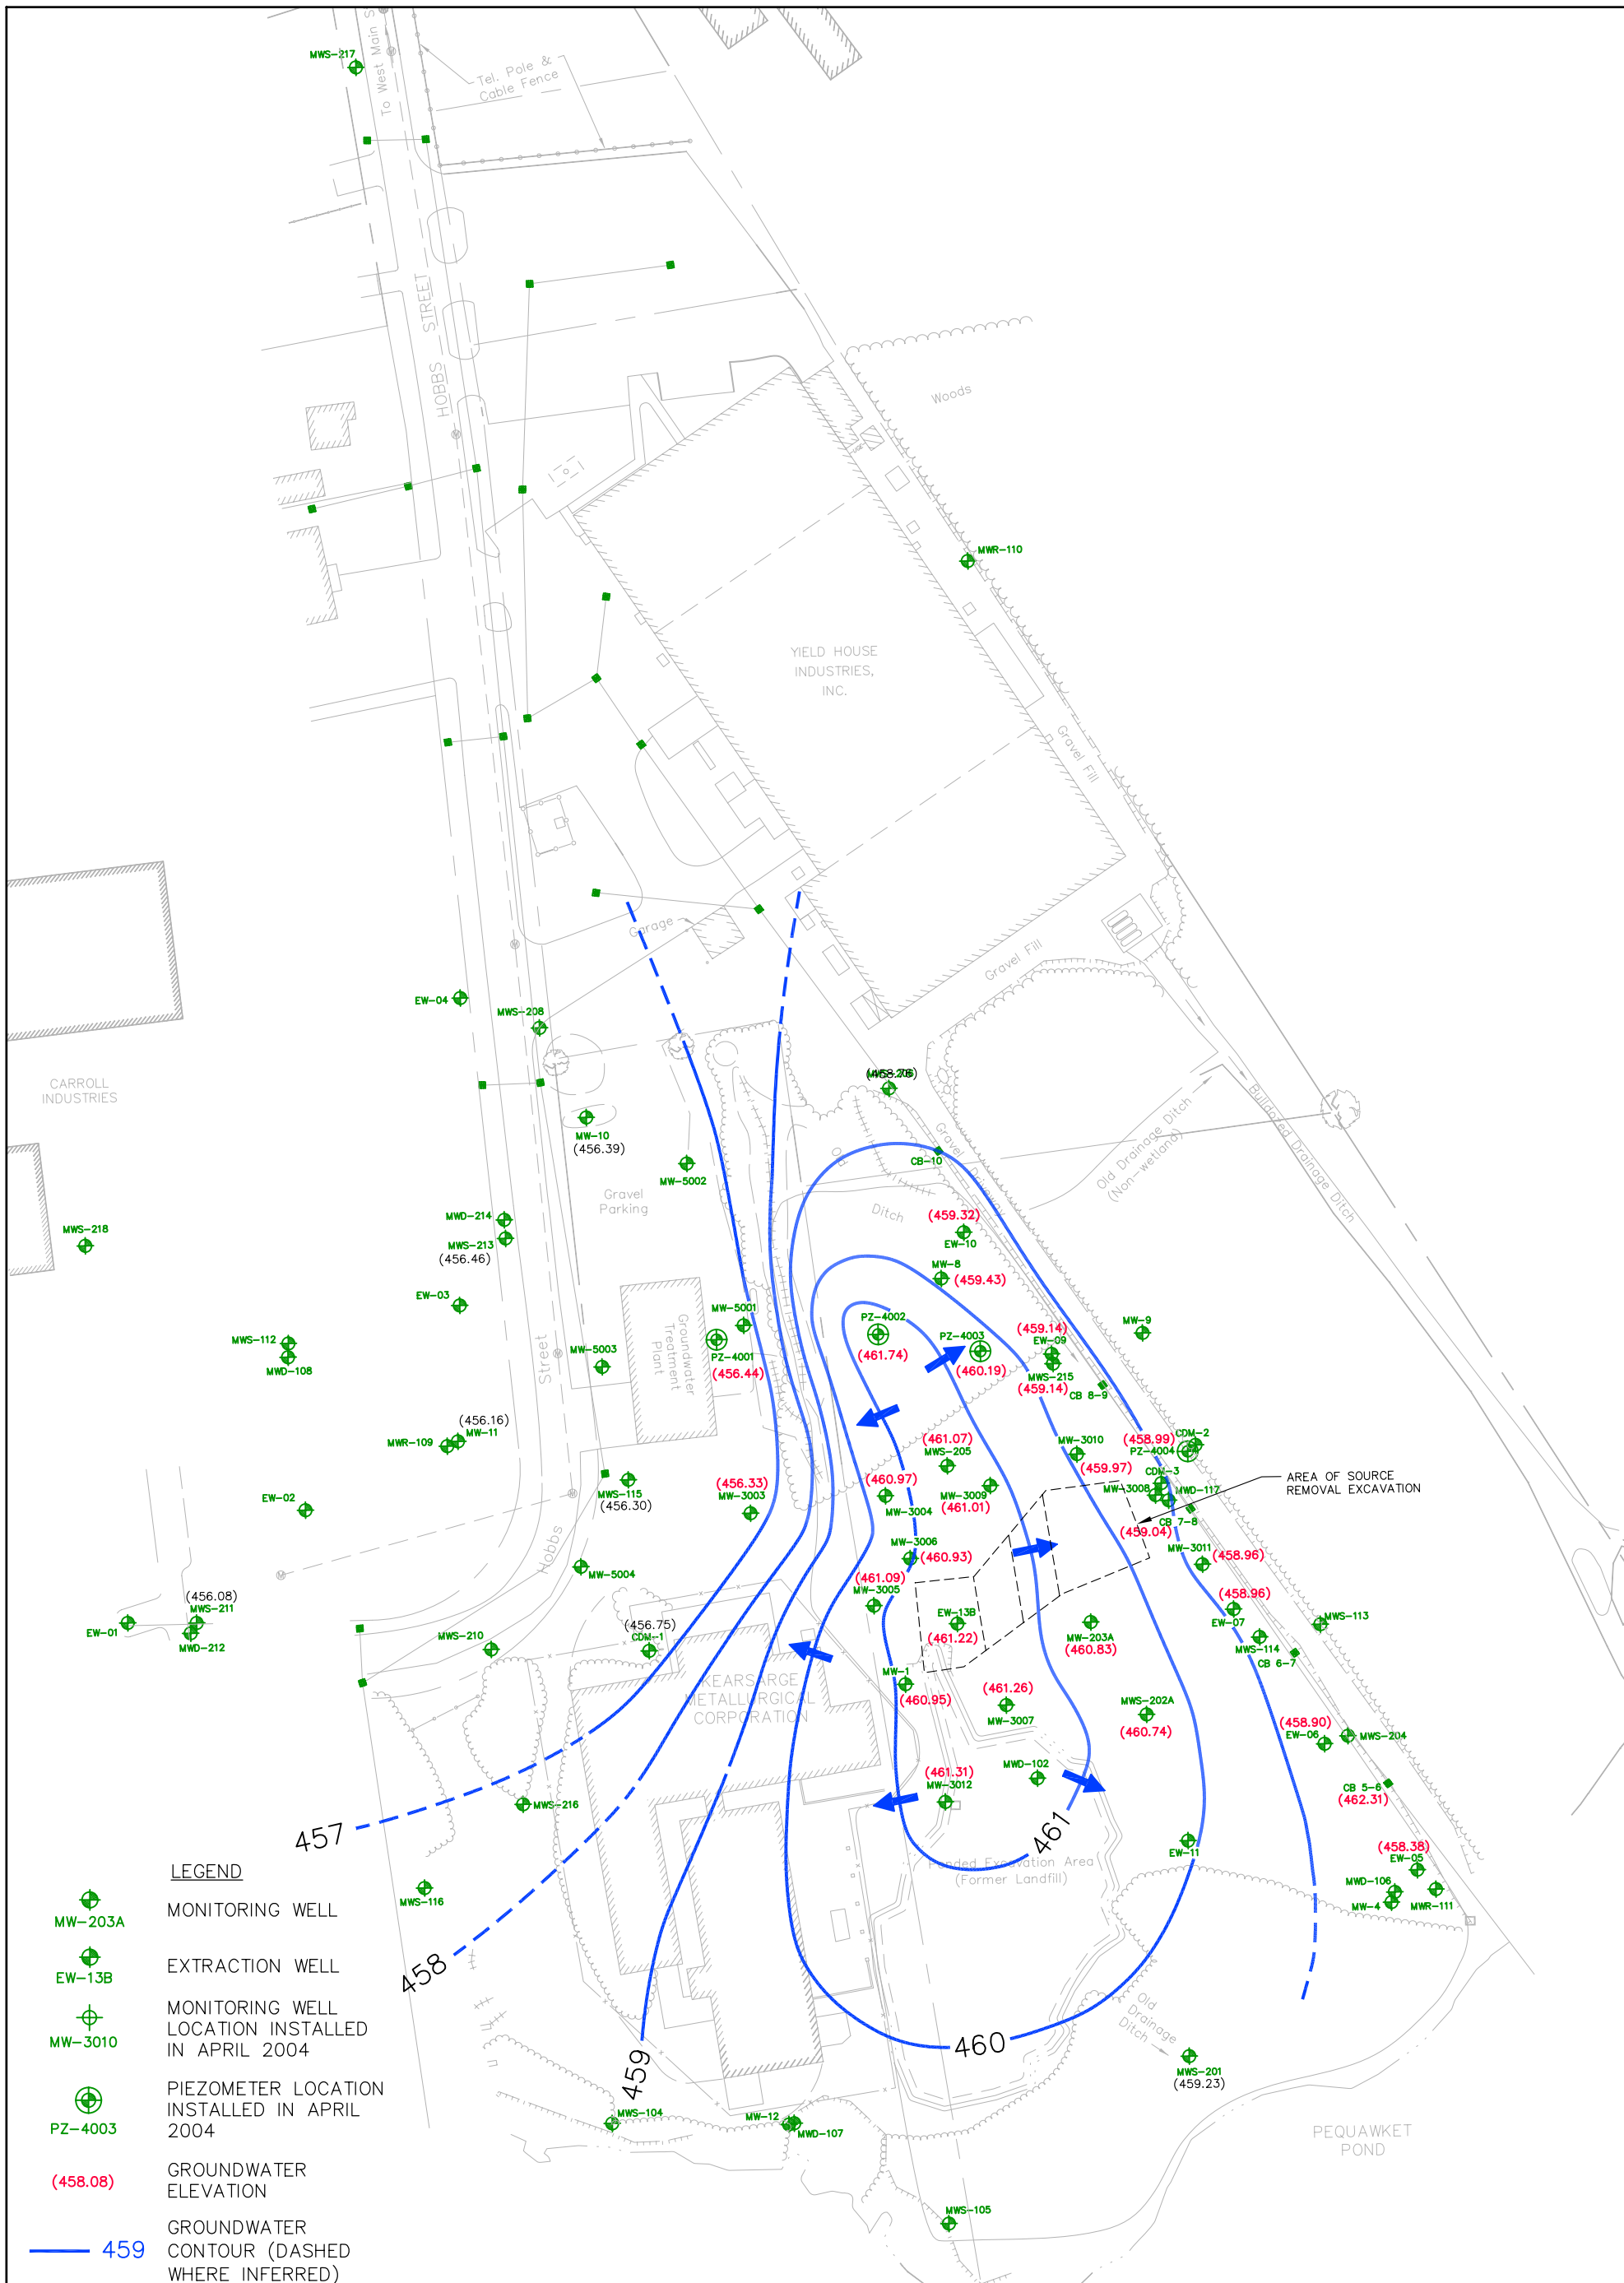
<p>DRAWN: BEG DATE: APR 2008 FIGURE NO.: 6</p>

<p>GROUNDWATER POTENTIOMETRIC SURFACE MAP MARCH 2006</p>

Locations where water level data have been collected have changed over the years, and this has impacted water level interpretations. For example, since March 2006 water levels have not been collected near the pond, which results in changes in the interpreted potentiometric surface map. For instance, Figures 4 to 6 in Attachment A illustrate interpreted water level contours from Dec 2005 to March 2006, and they illustrate a component of flow to the south based on measured water level at MWS-201 (near the pond). However, Figures 7 to 10 in Attachment A illustrate interpreted water level contours from August 2006 to November 2007, and they do not illustrate this component of flow to the south. This change in interpretation appears to be due to the discontinued data collection at MWS-201 (near the pond) rather than an actual change in flow conditions.
