MEMORANDUM

Date: May 15, 2009

Subject: Summary/Update Regarding Site Conceptual Model
Kearsarge Metallurgical Corporation Superfund Site, Conway, New Hampshire

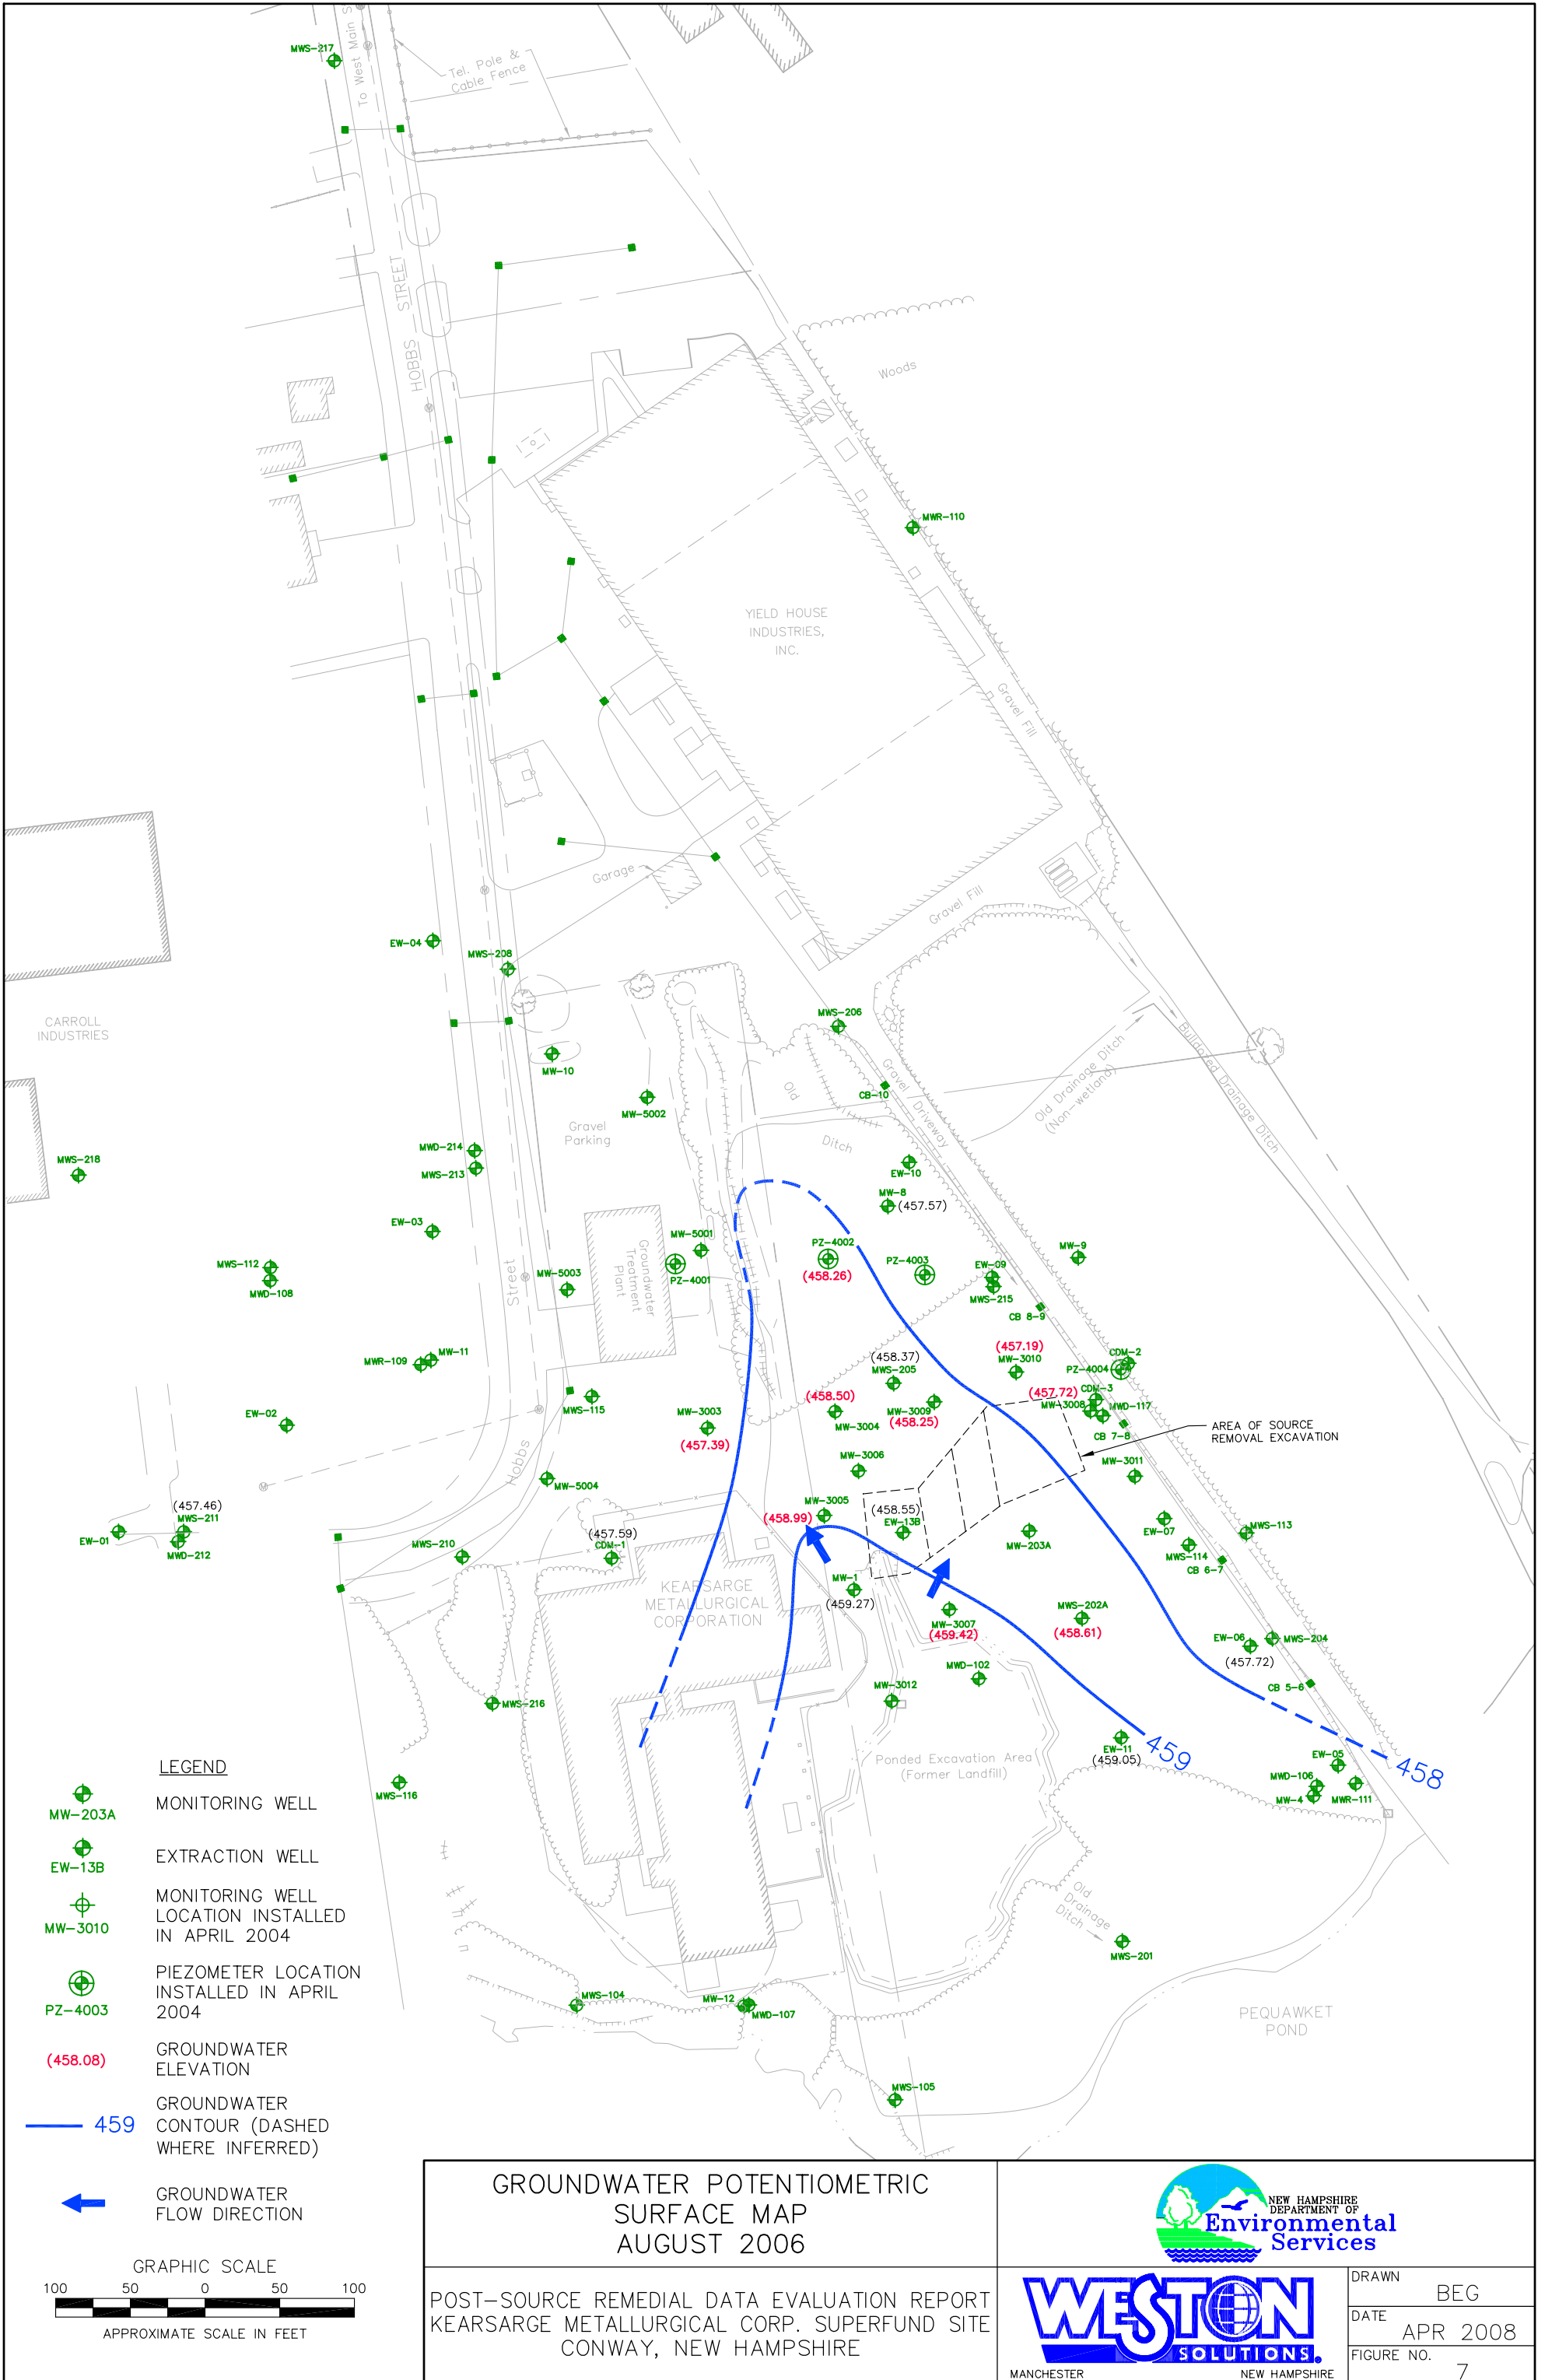
<table><tr> <td style="width: 50%;">DRAWN</td> <td>BEG</td> </tr><tr> <td>FIGURE NO.</td> <td>7</td> </tr></table>

<p>GROUNDWATER POTENTIOMETRIC SURFACE MAP AUGUST 2006</p>

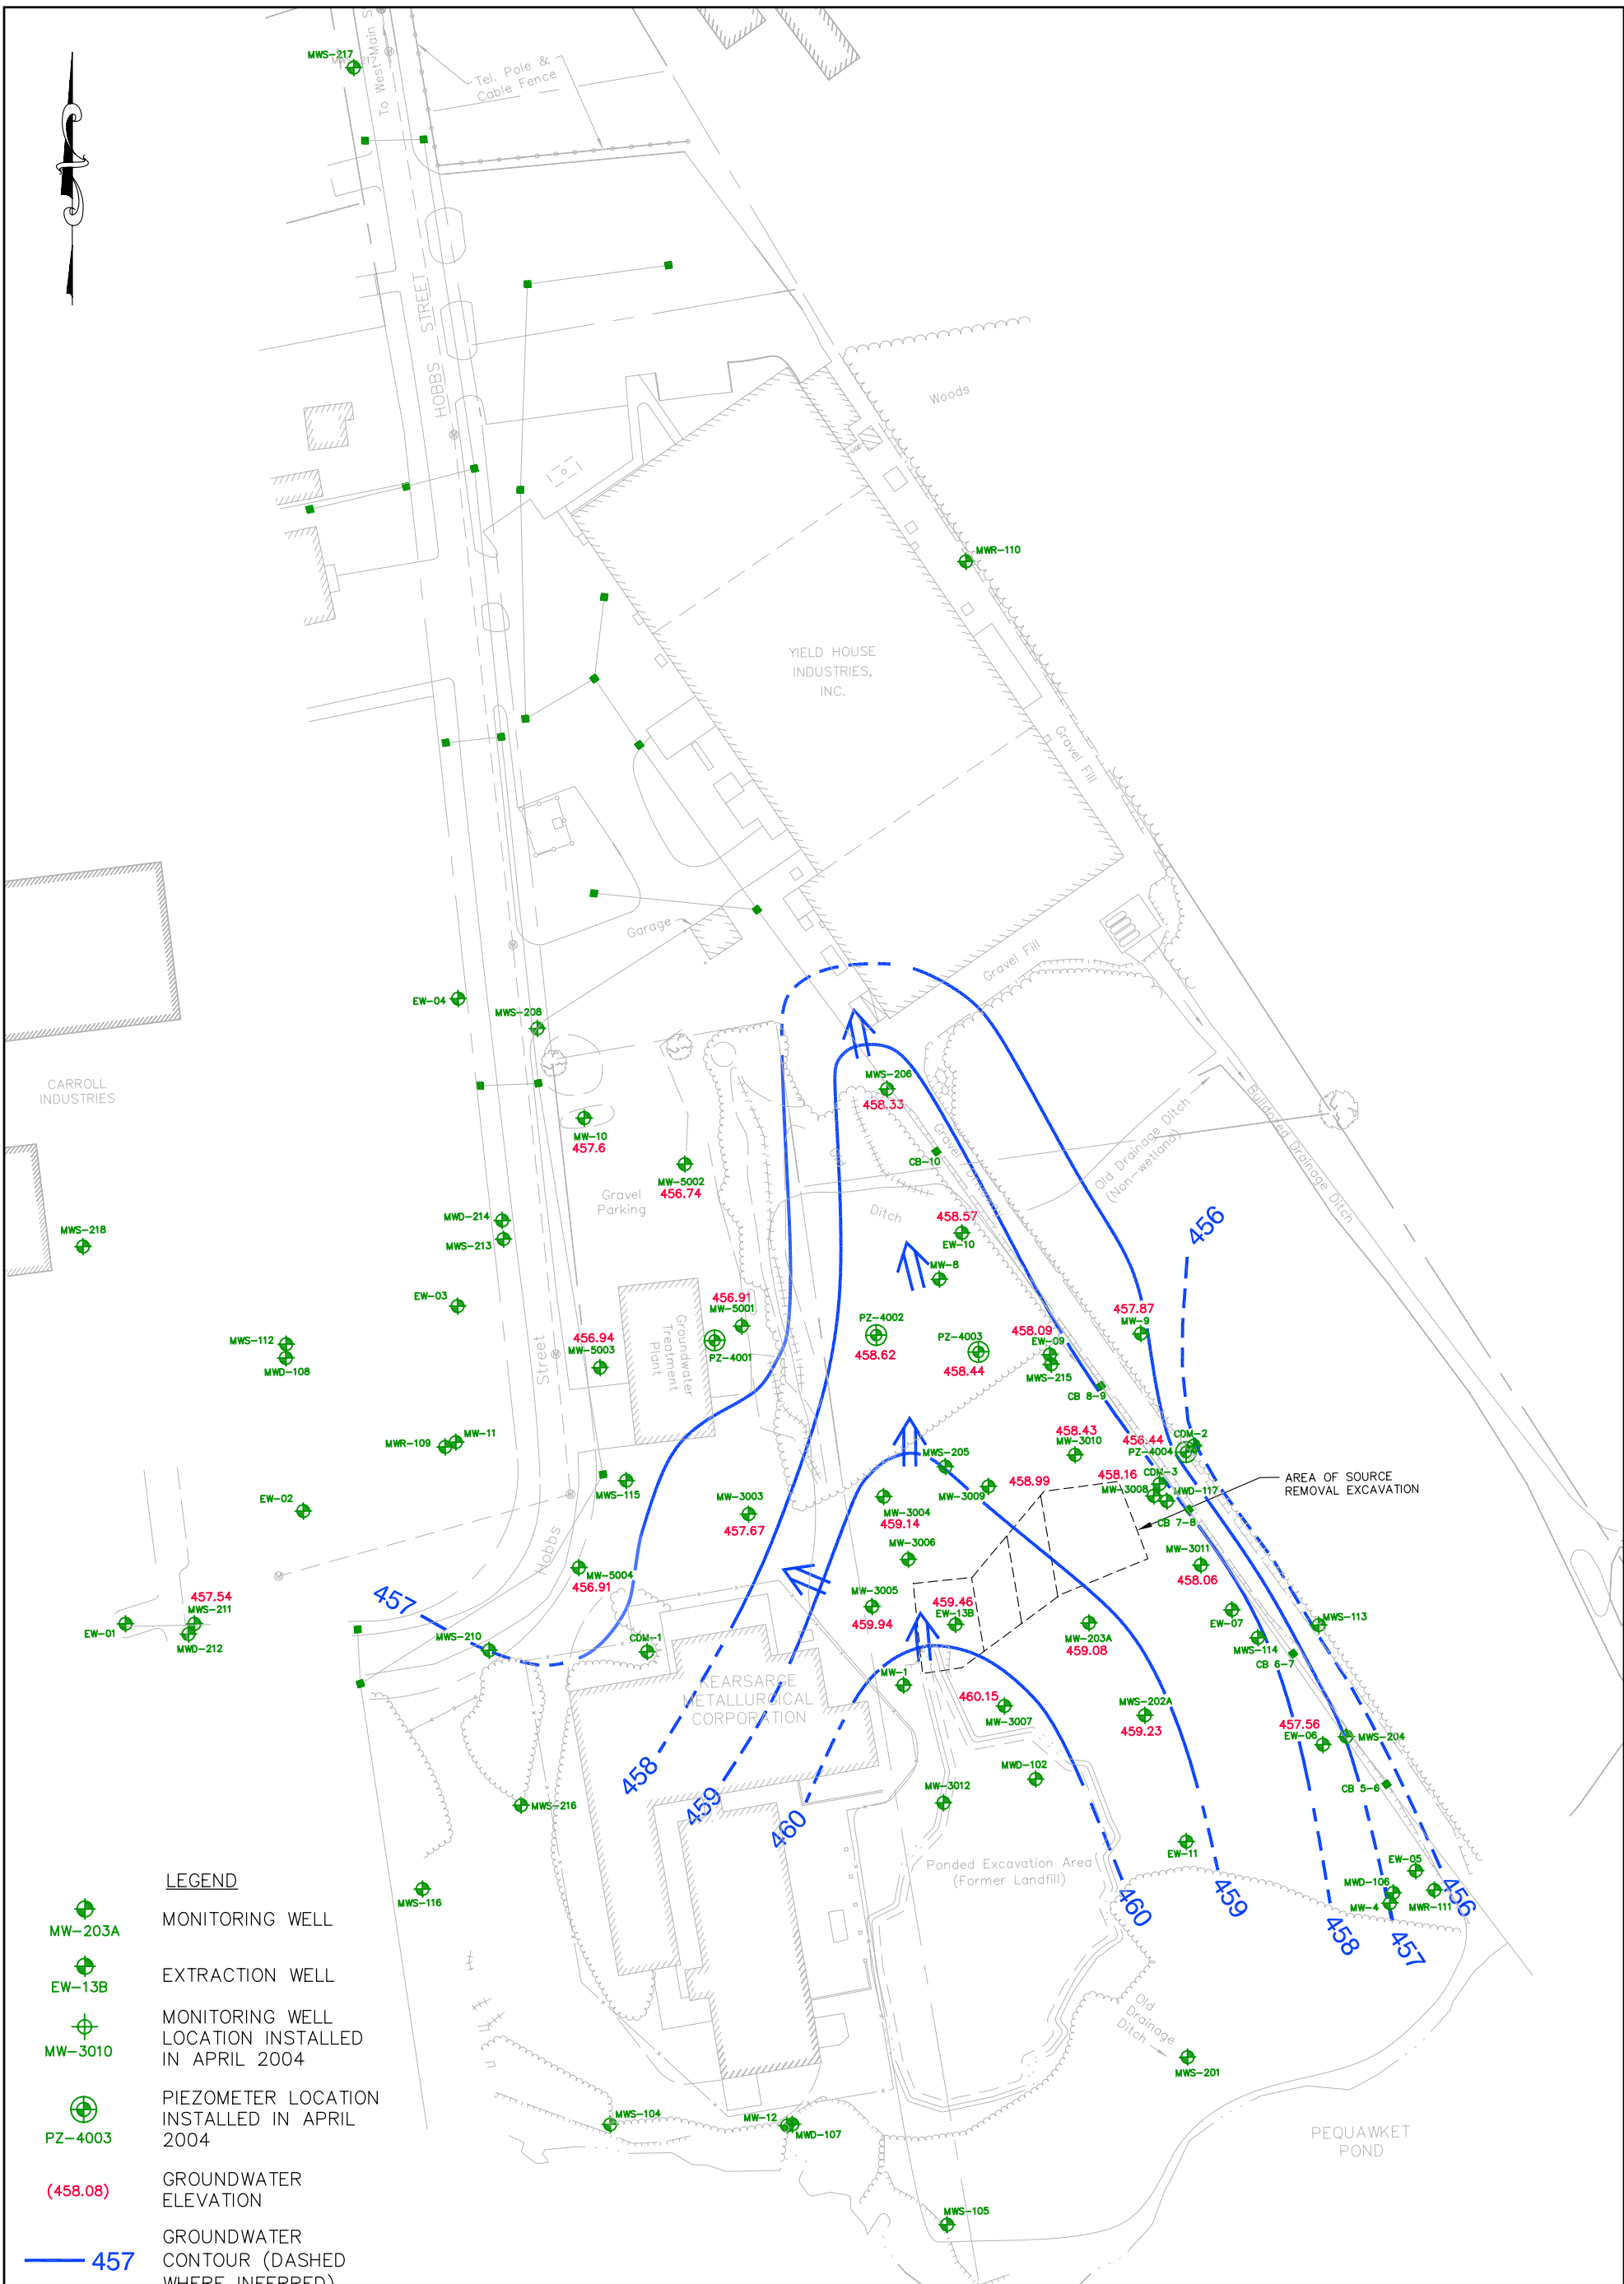
DRAWN	BEG
DATE	APR 2008
FIGURE NO.	8

**OVERBURDEN POTENTIOMETRIC SURFACE MAP
JUNE 19, 2007**

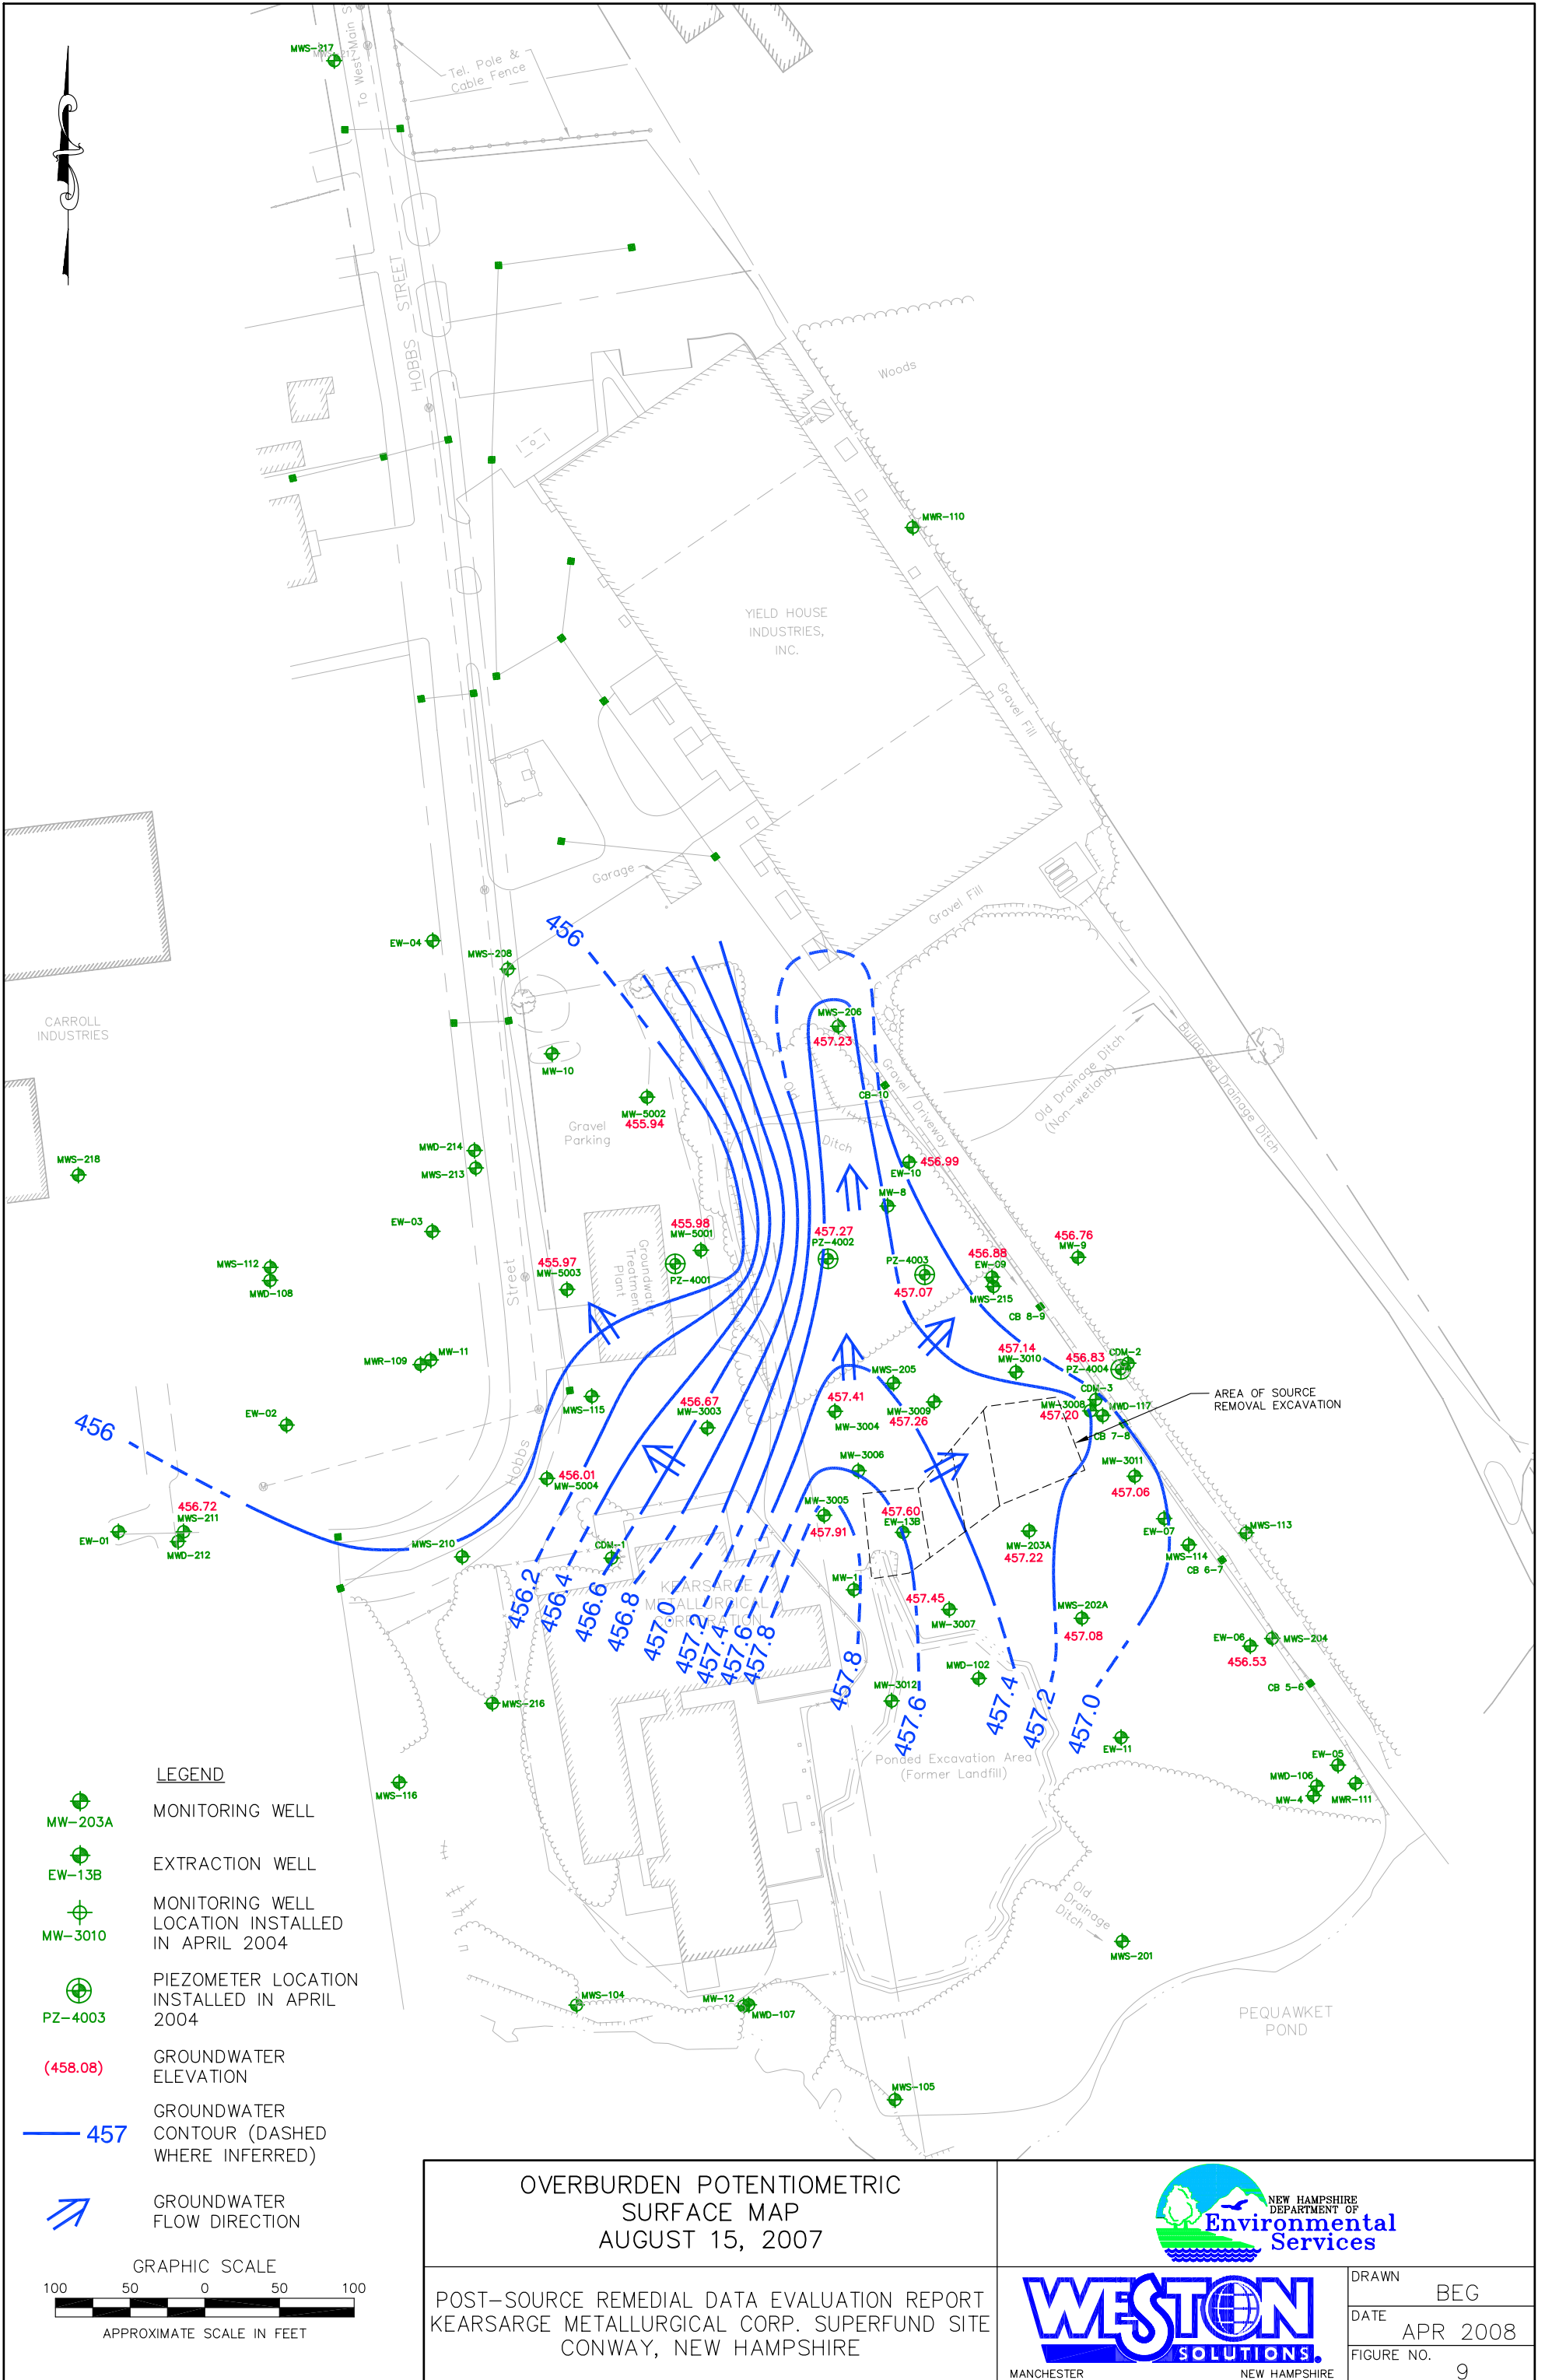
DRAWN: BEG
DATE: APR 2008
FIGURE NO.: 9

OVERBURDEN POTENTIOMETRIC SURFACE MAP
AUGUST 15, 2007

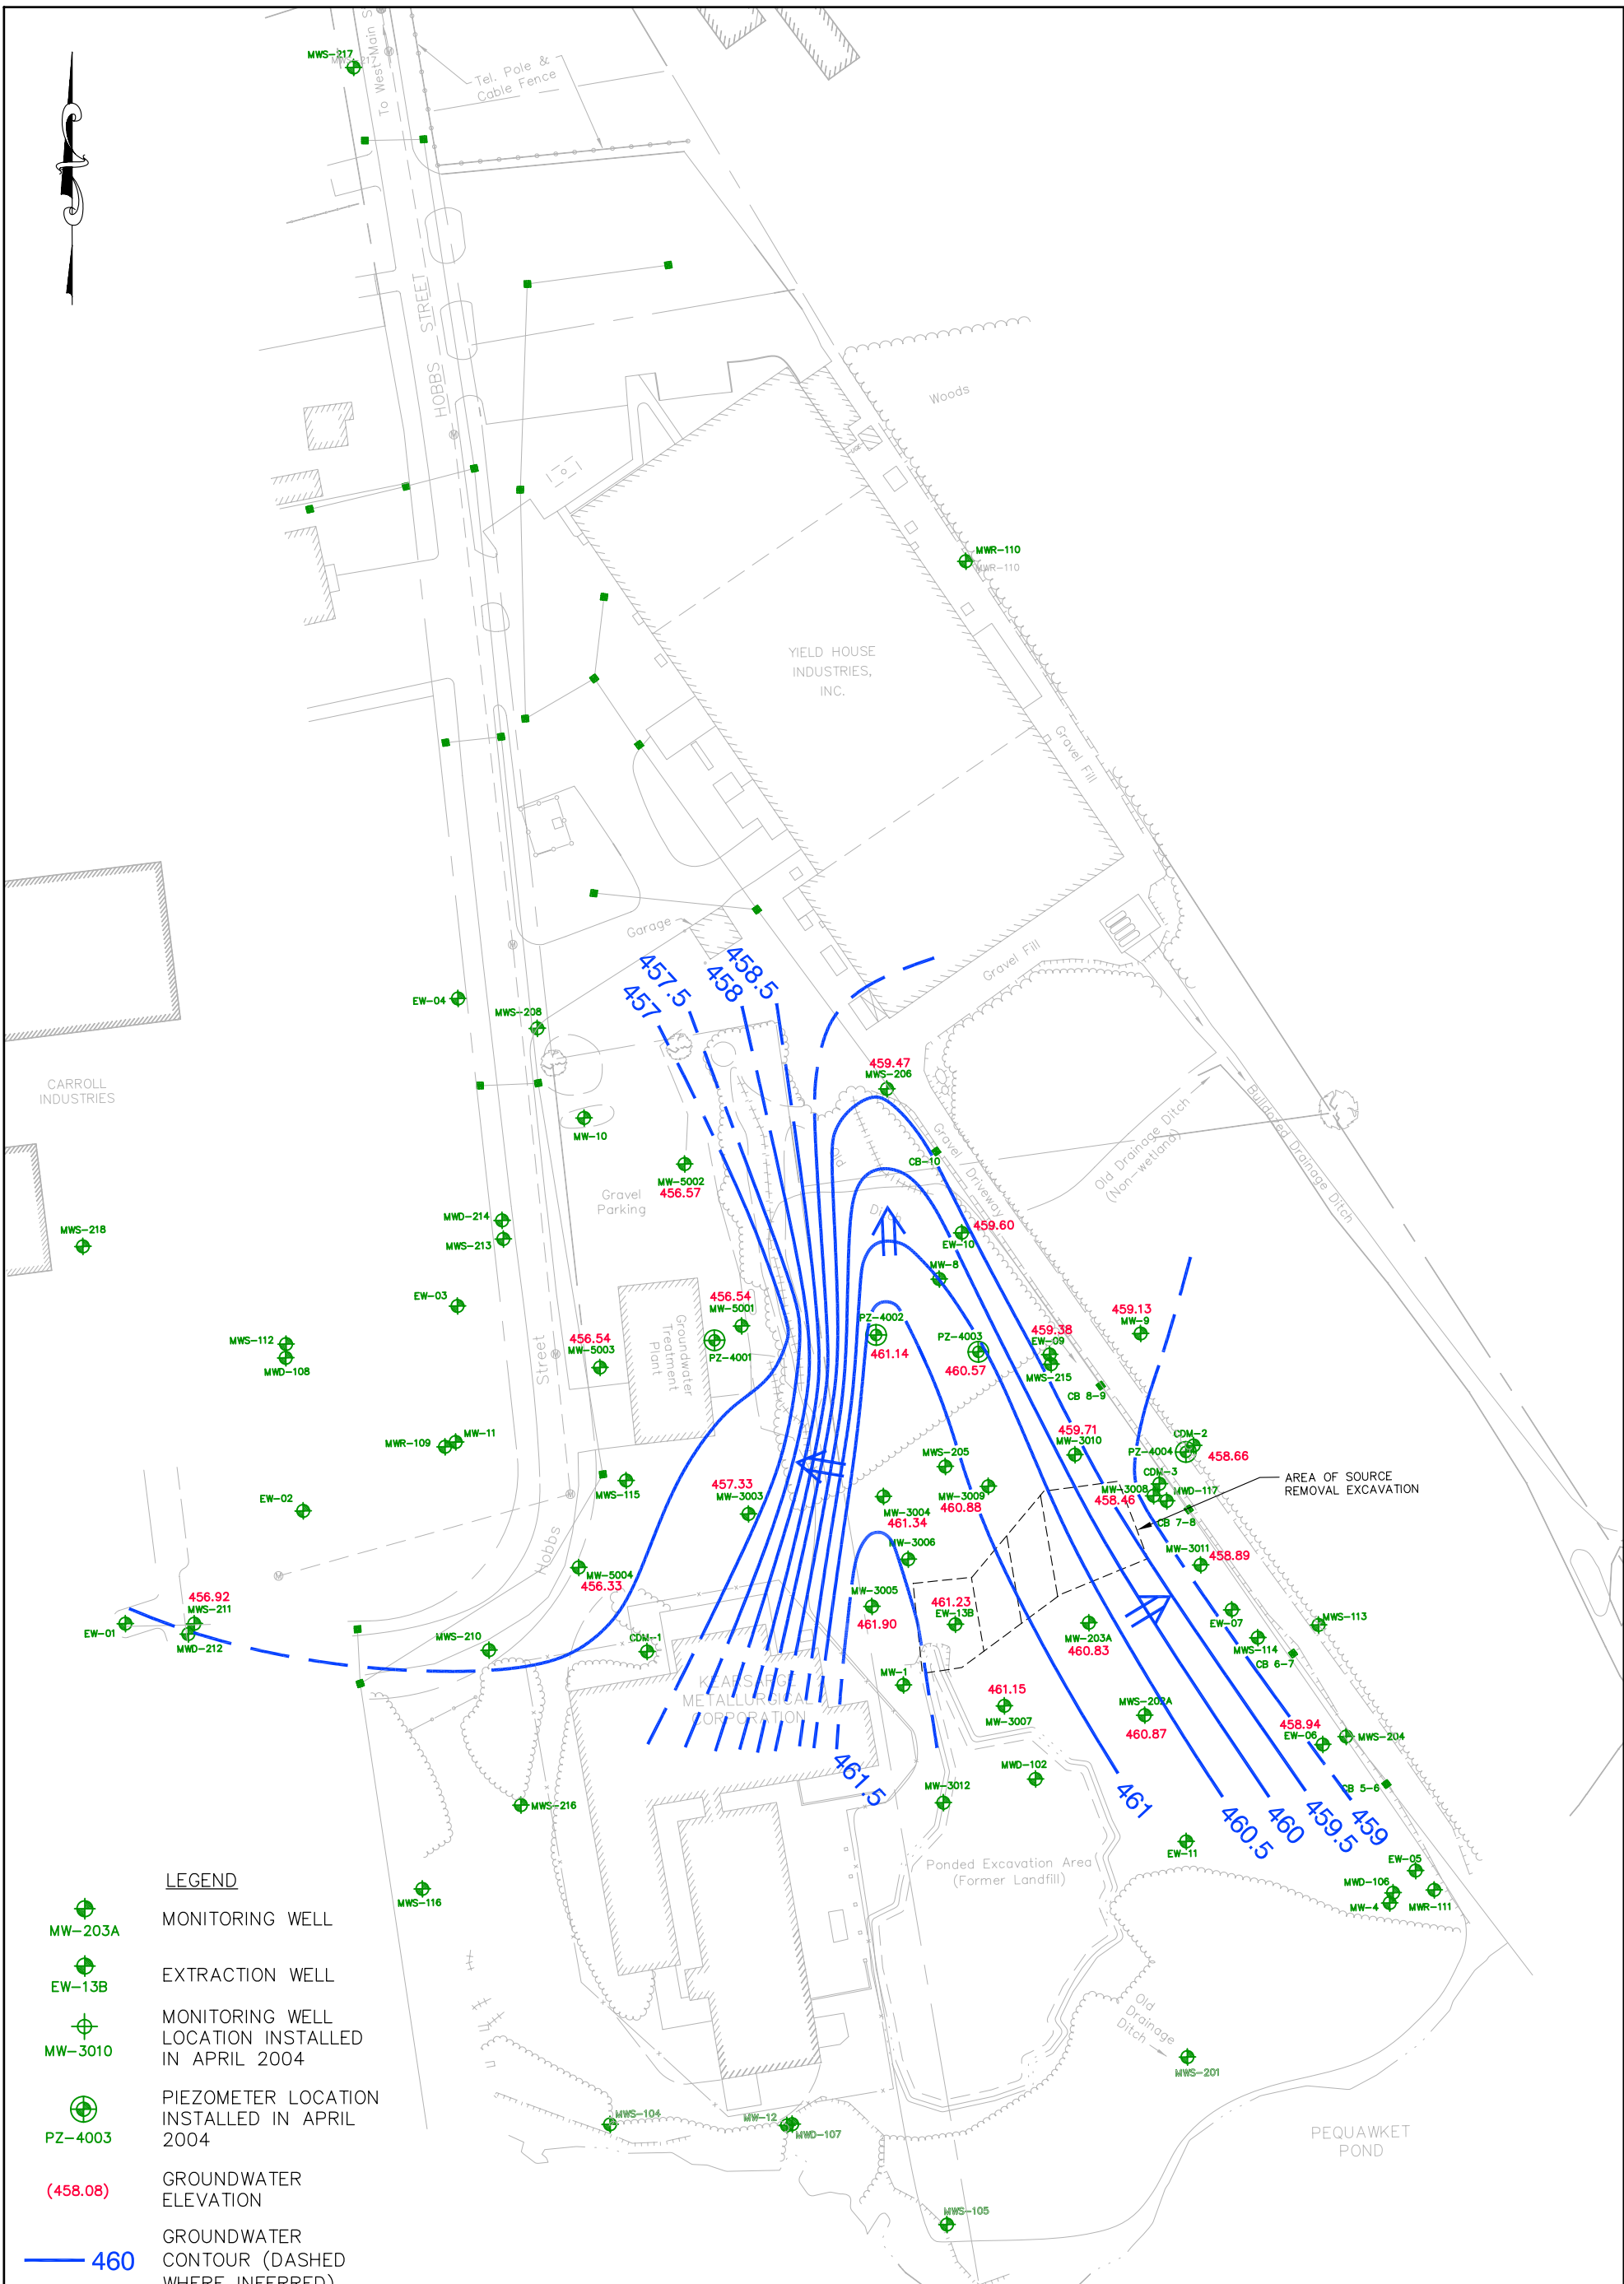
<p>OVERBURDEN POTENTIOMETRIC SURFACE MAP NOVEMBER 28, 2007</p>

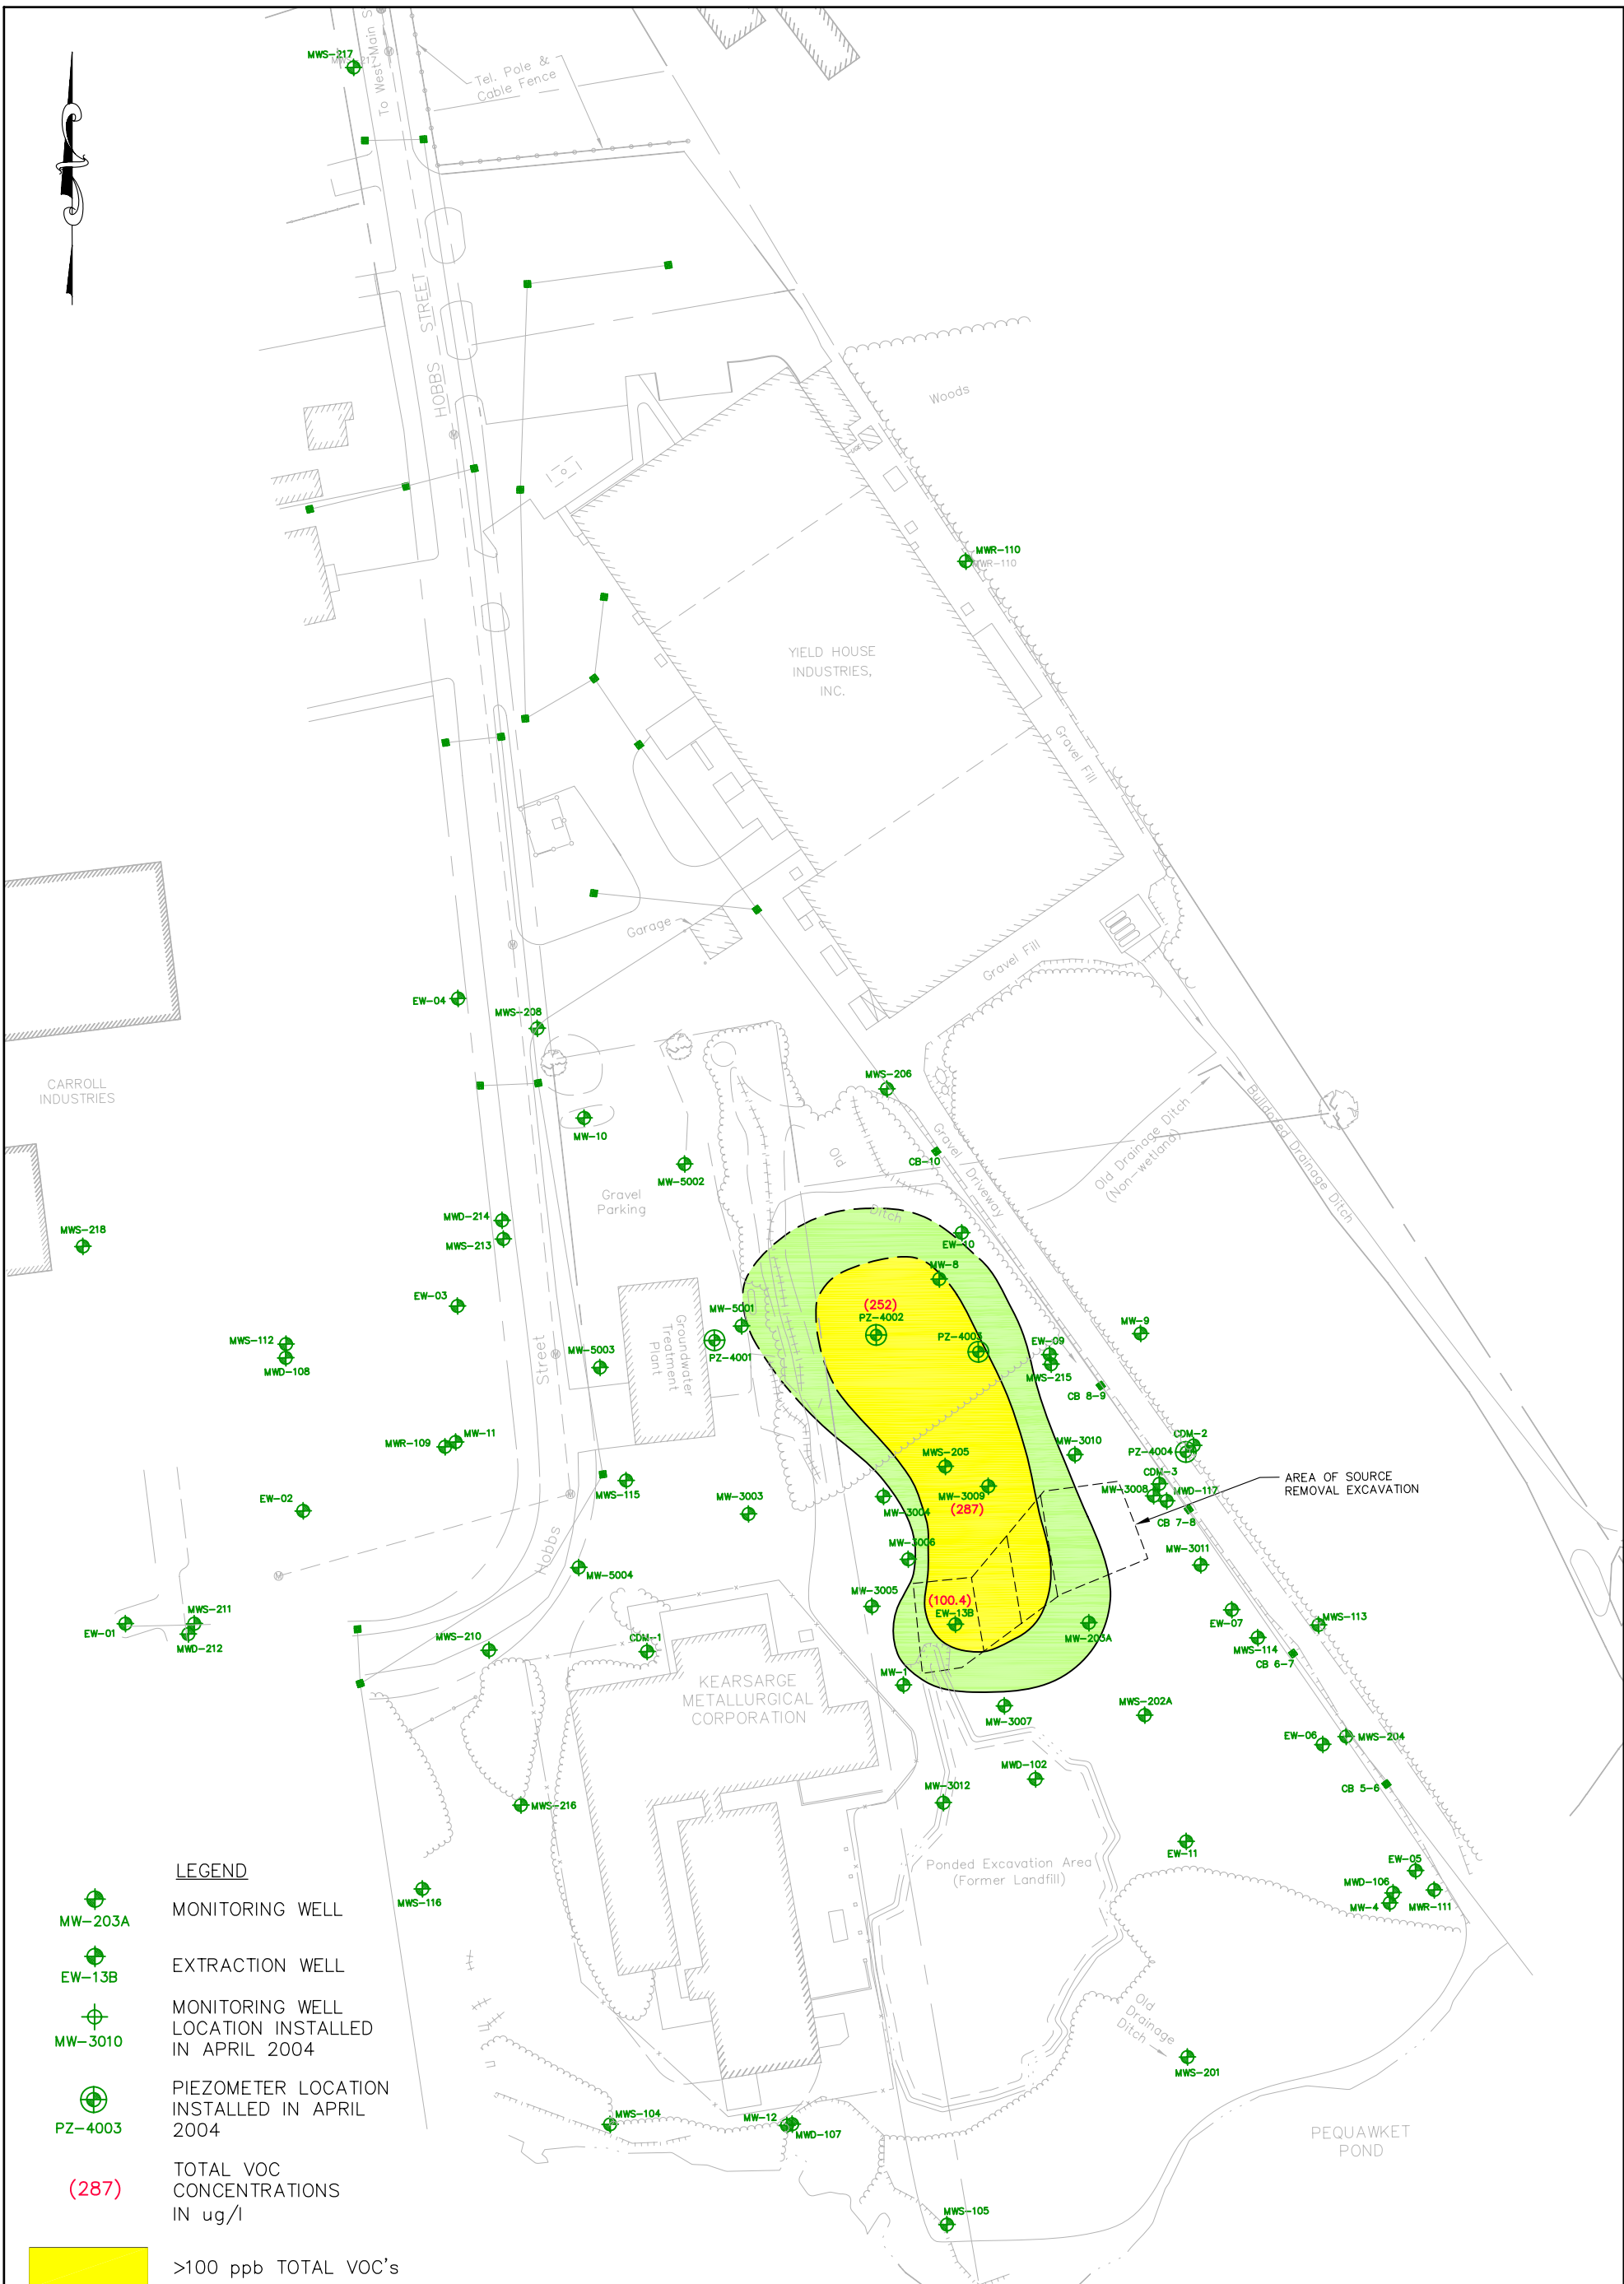
DRAWN: BEG
 DATE: APR 2008
 FIGURE NO.: 11

TOTAL VOC CONCENTRATIONS IN GROUNDWATER (EXISTING CLEANUP GOALS) AUGUST 2005

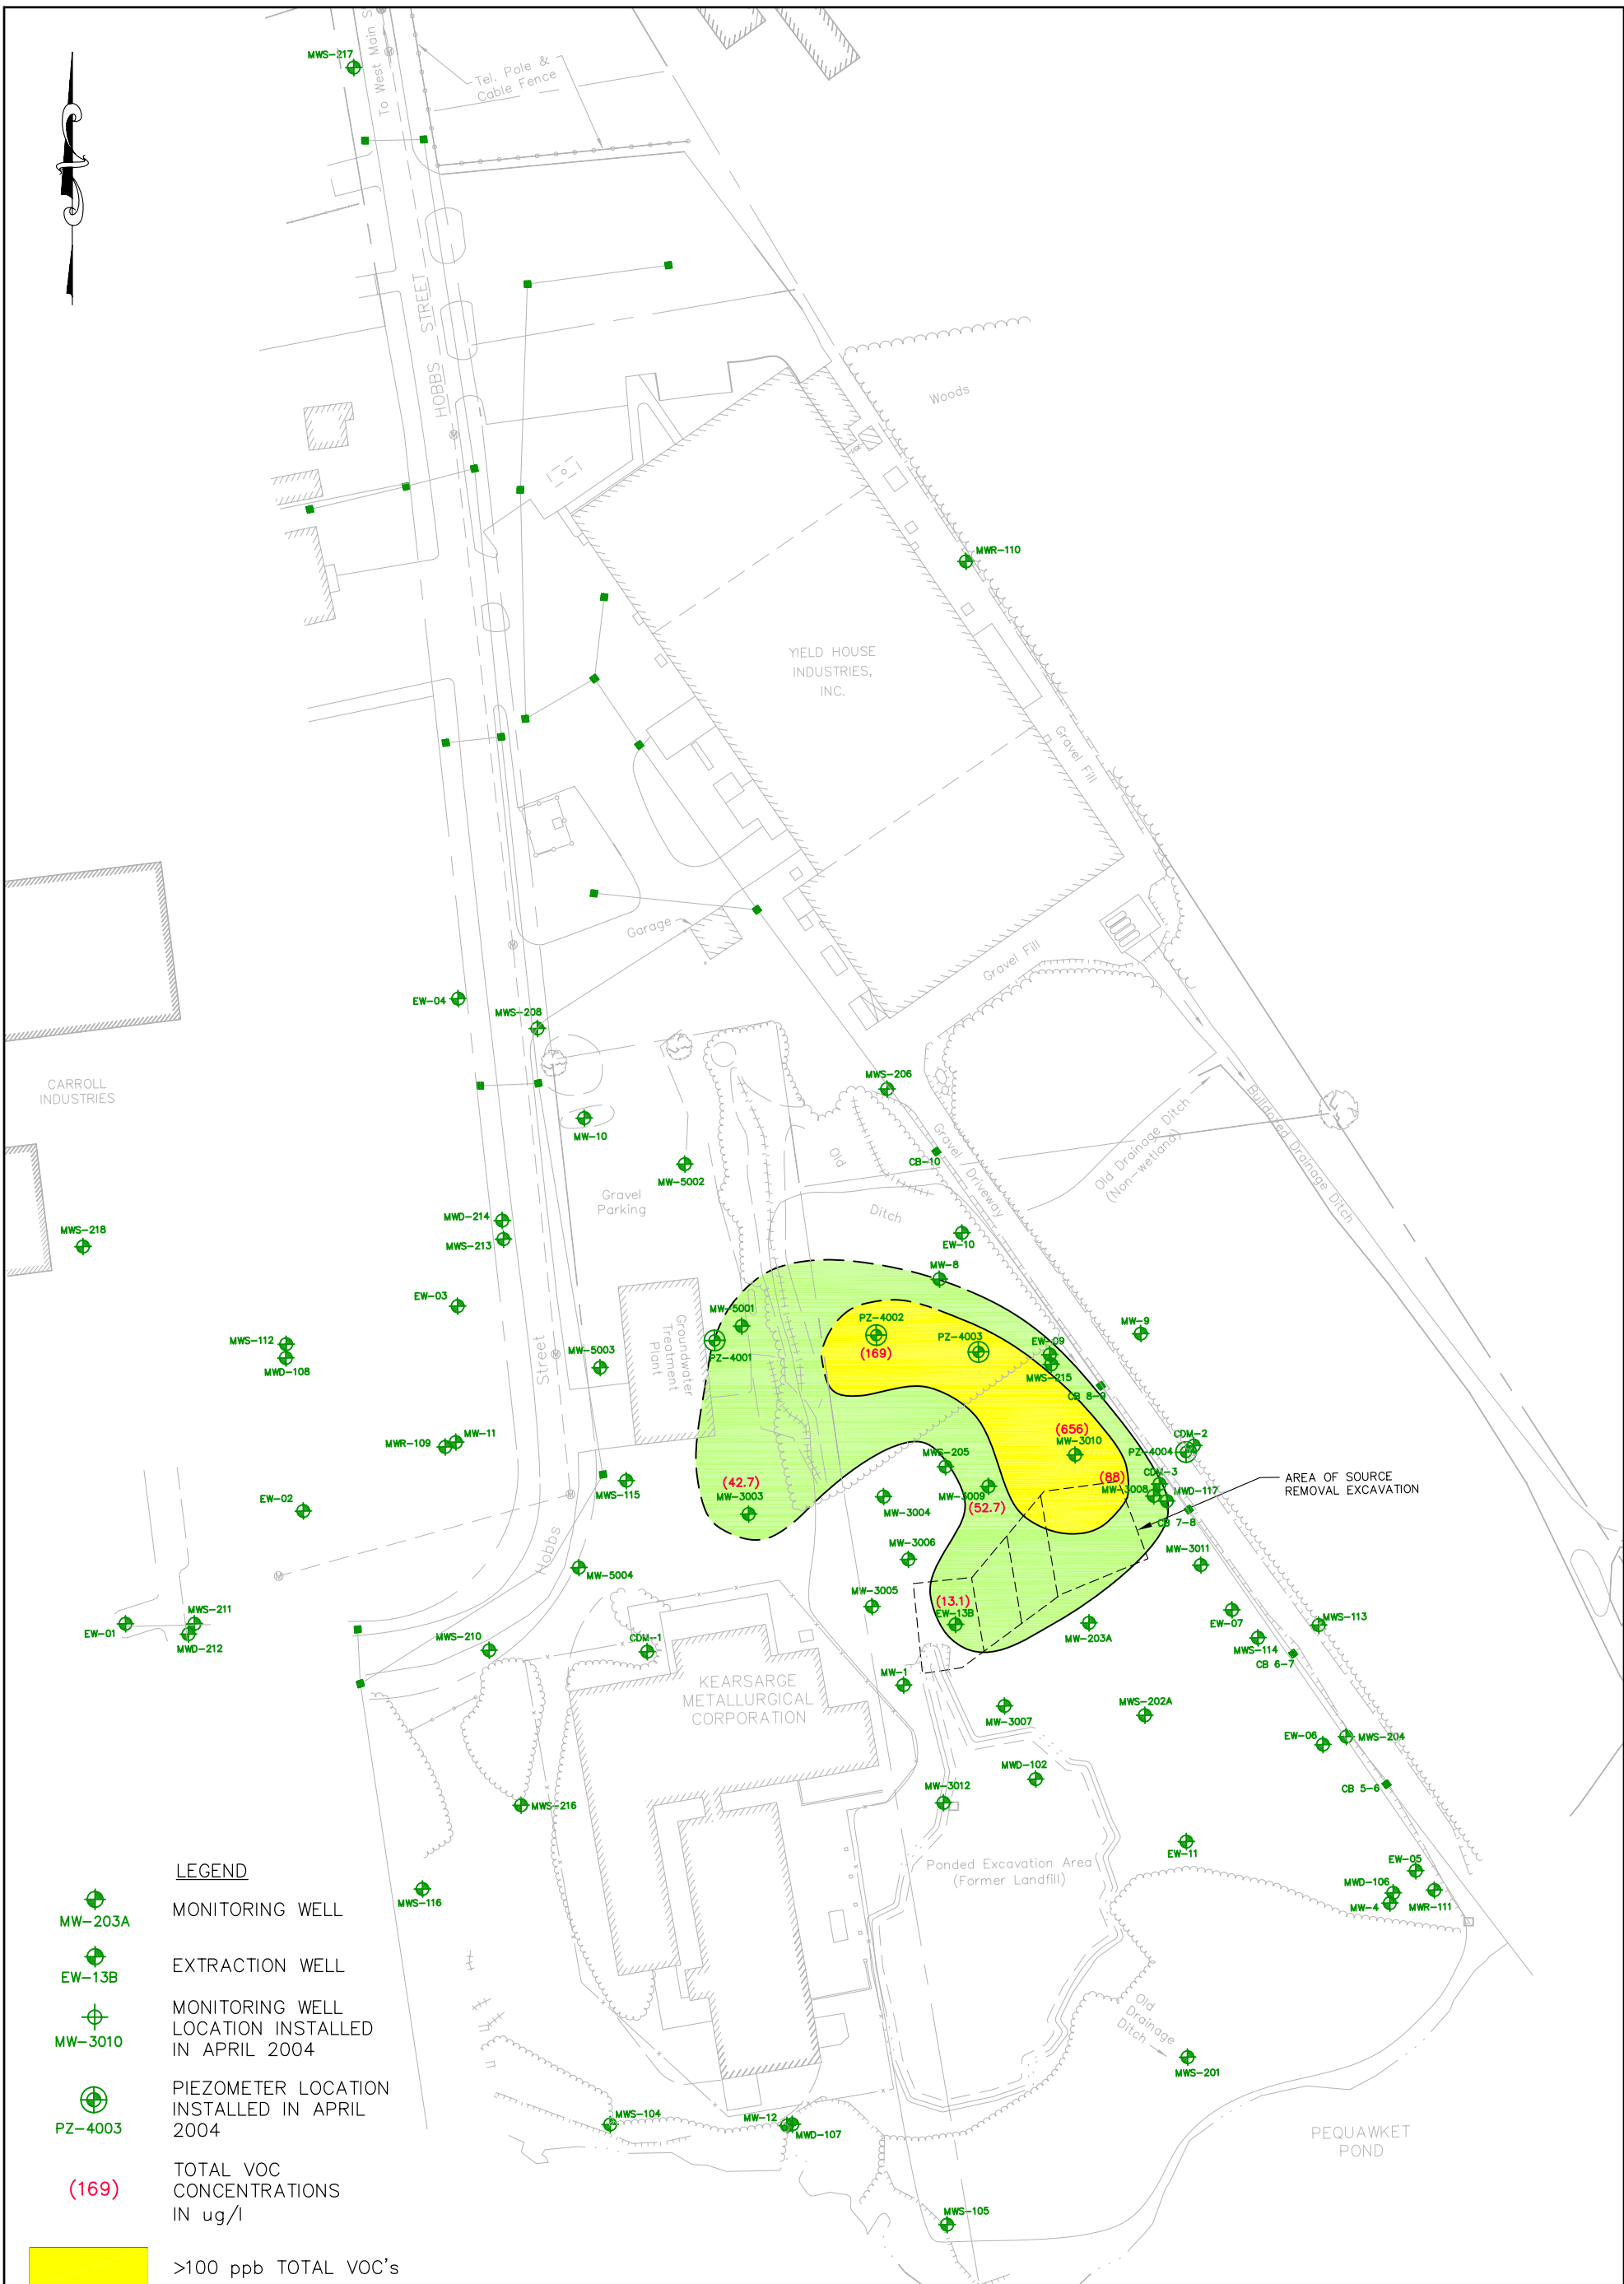
DRAWN: BEG
 DATE: APR 2008
 FIGURE NO.: 12

TOTAL VOC CONCENTRATIONS IN GROUNDWATER (EXISTING CLEANUP GOALS) AUGUST 2006
