MEMORANDUM

Date: May 15, 2009

Subject: Summary/Update Regarding Site Conceptual Model
Kearsarge Metallurgical Corporation Superfund Site, Conway, New Hampshire

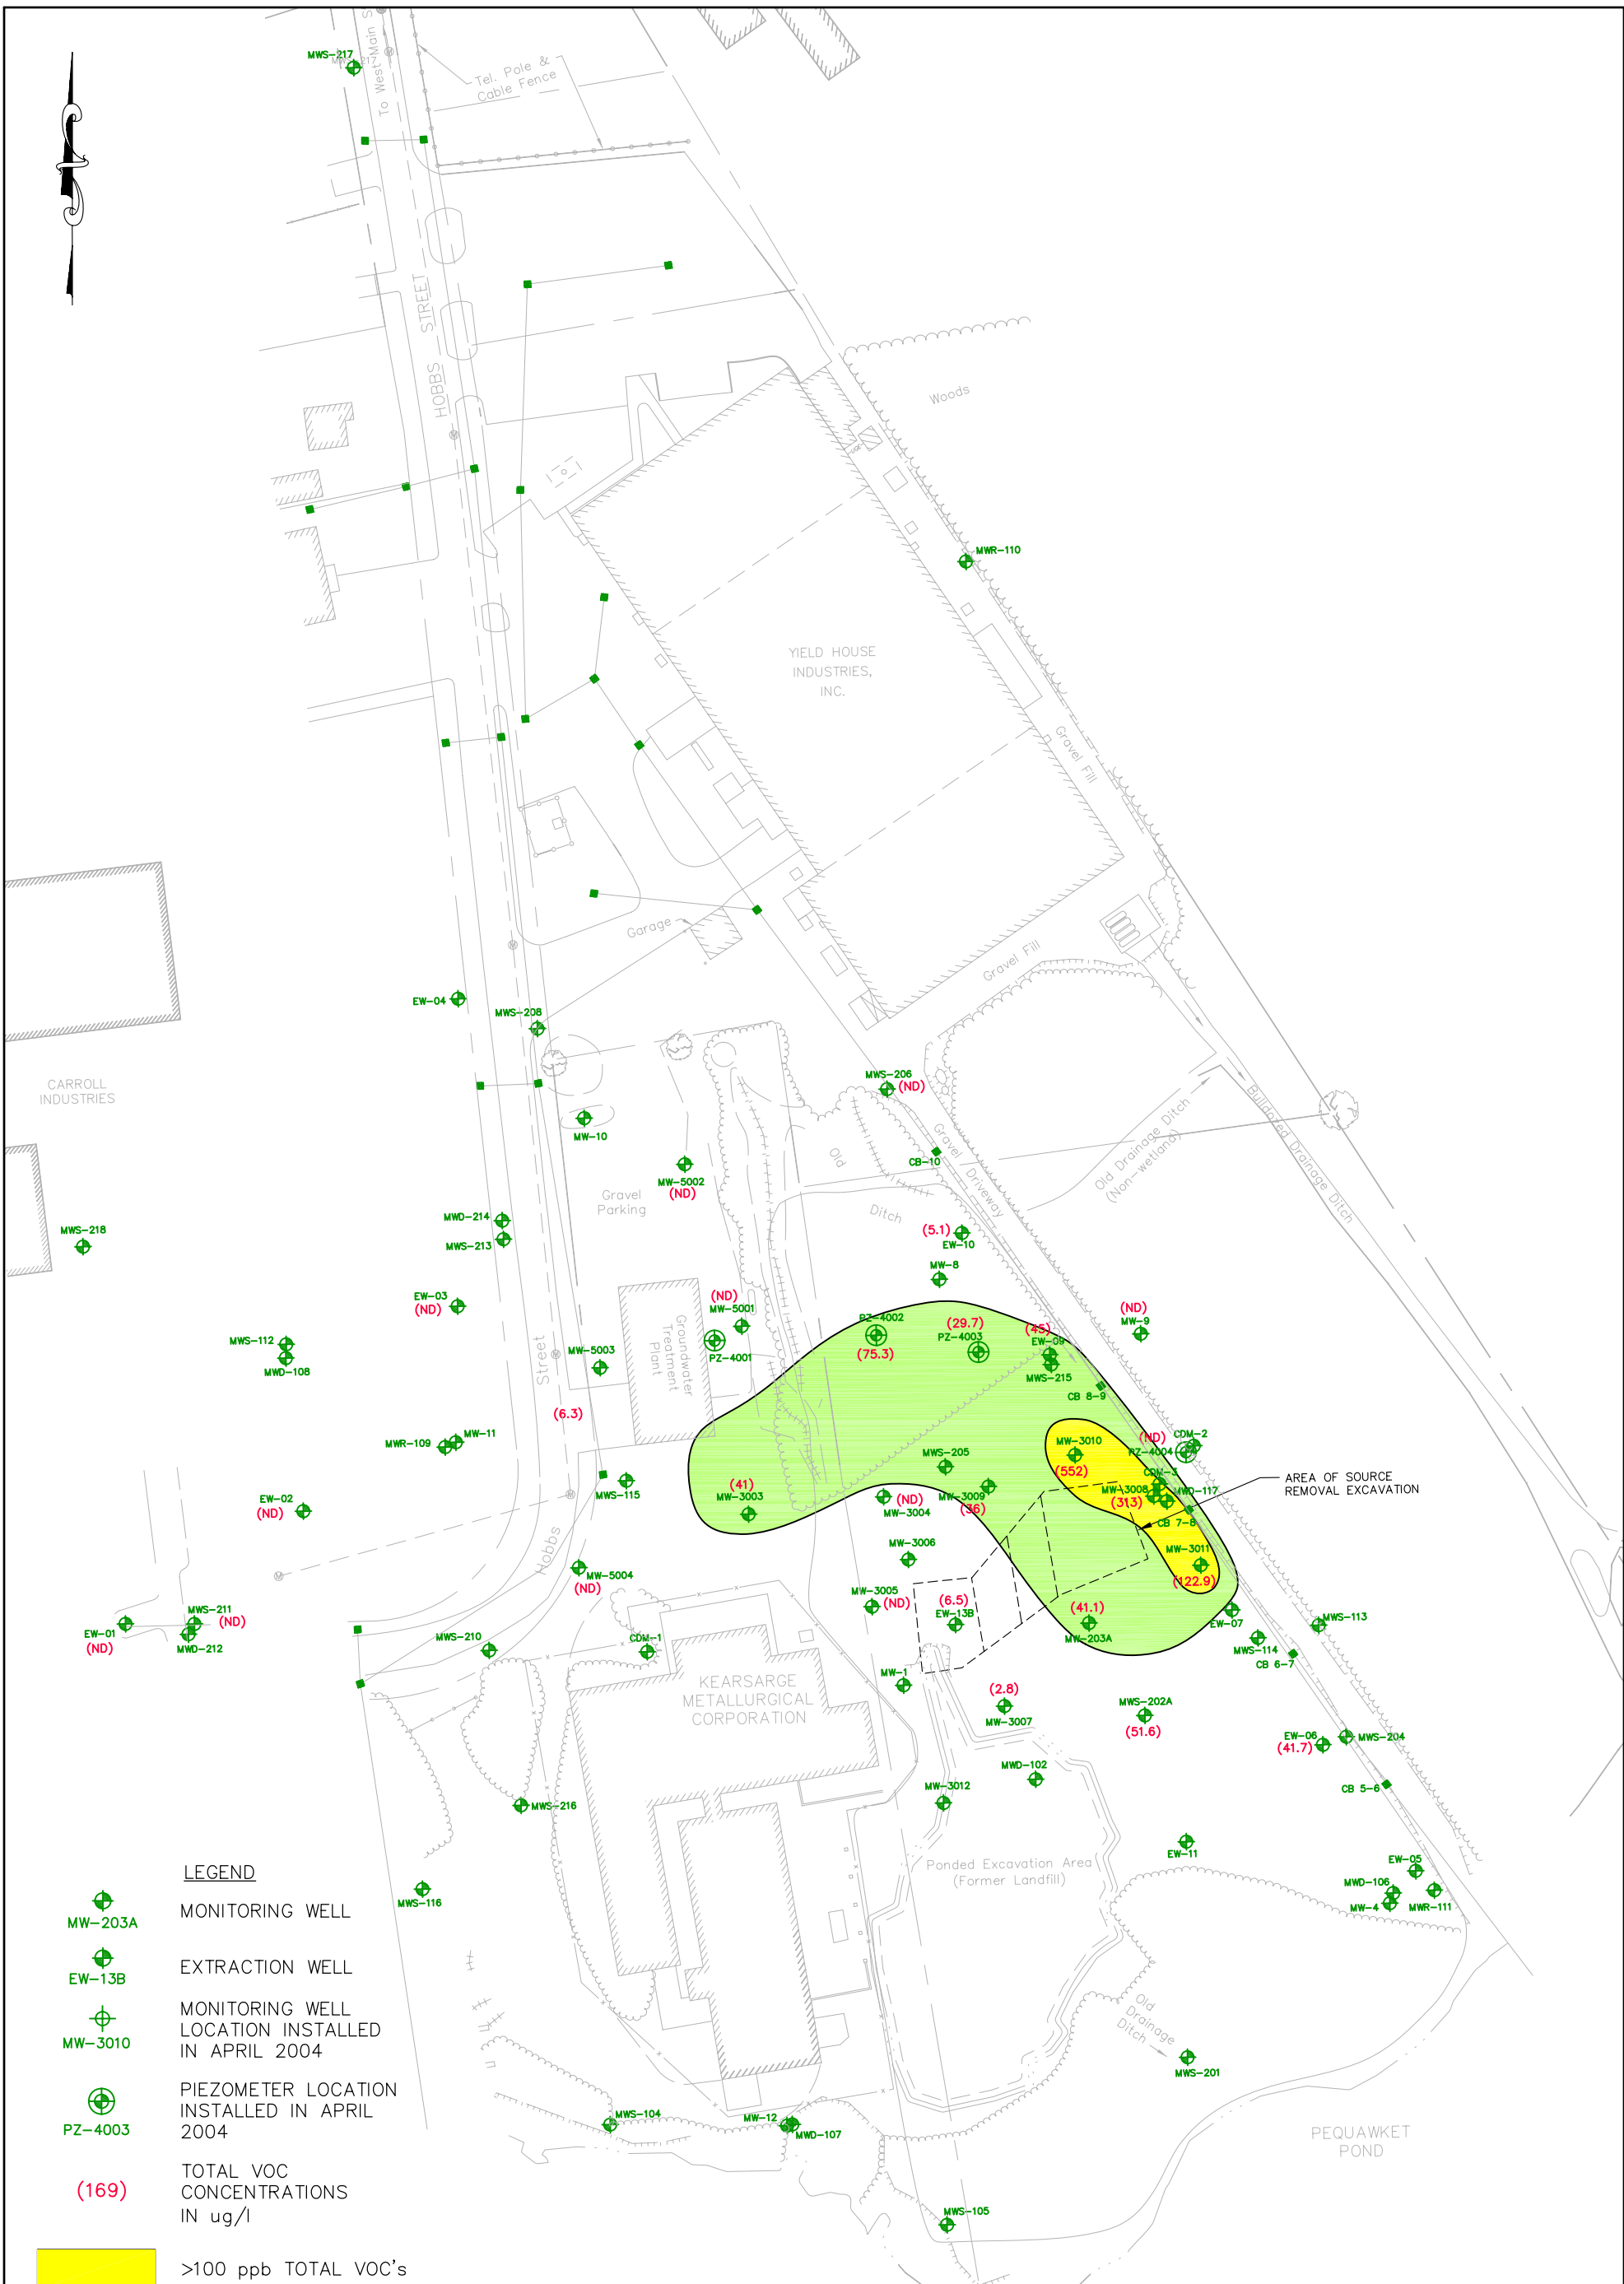
DRAWN: BEG
 DATE: APR 2008
 FIGURE NO.: 13

TOTAL VOC CONCENTRATIONS IN GROUNDWATER (EXISTING CLEAN-UP GOALS) AUGUST 2007

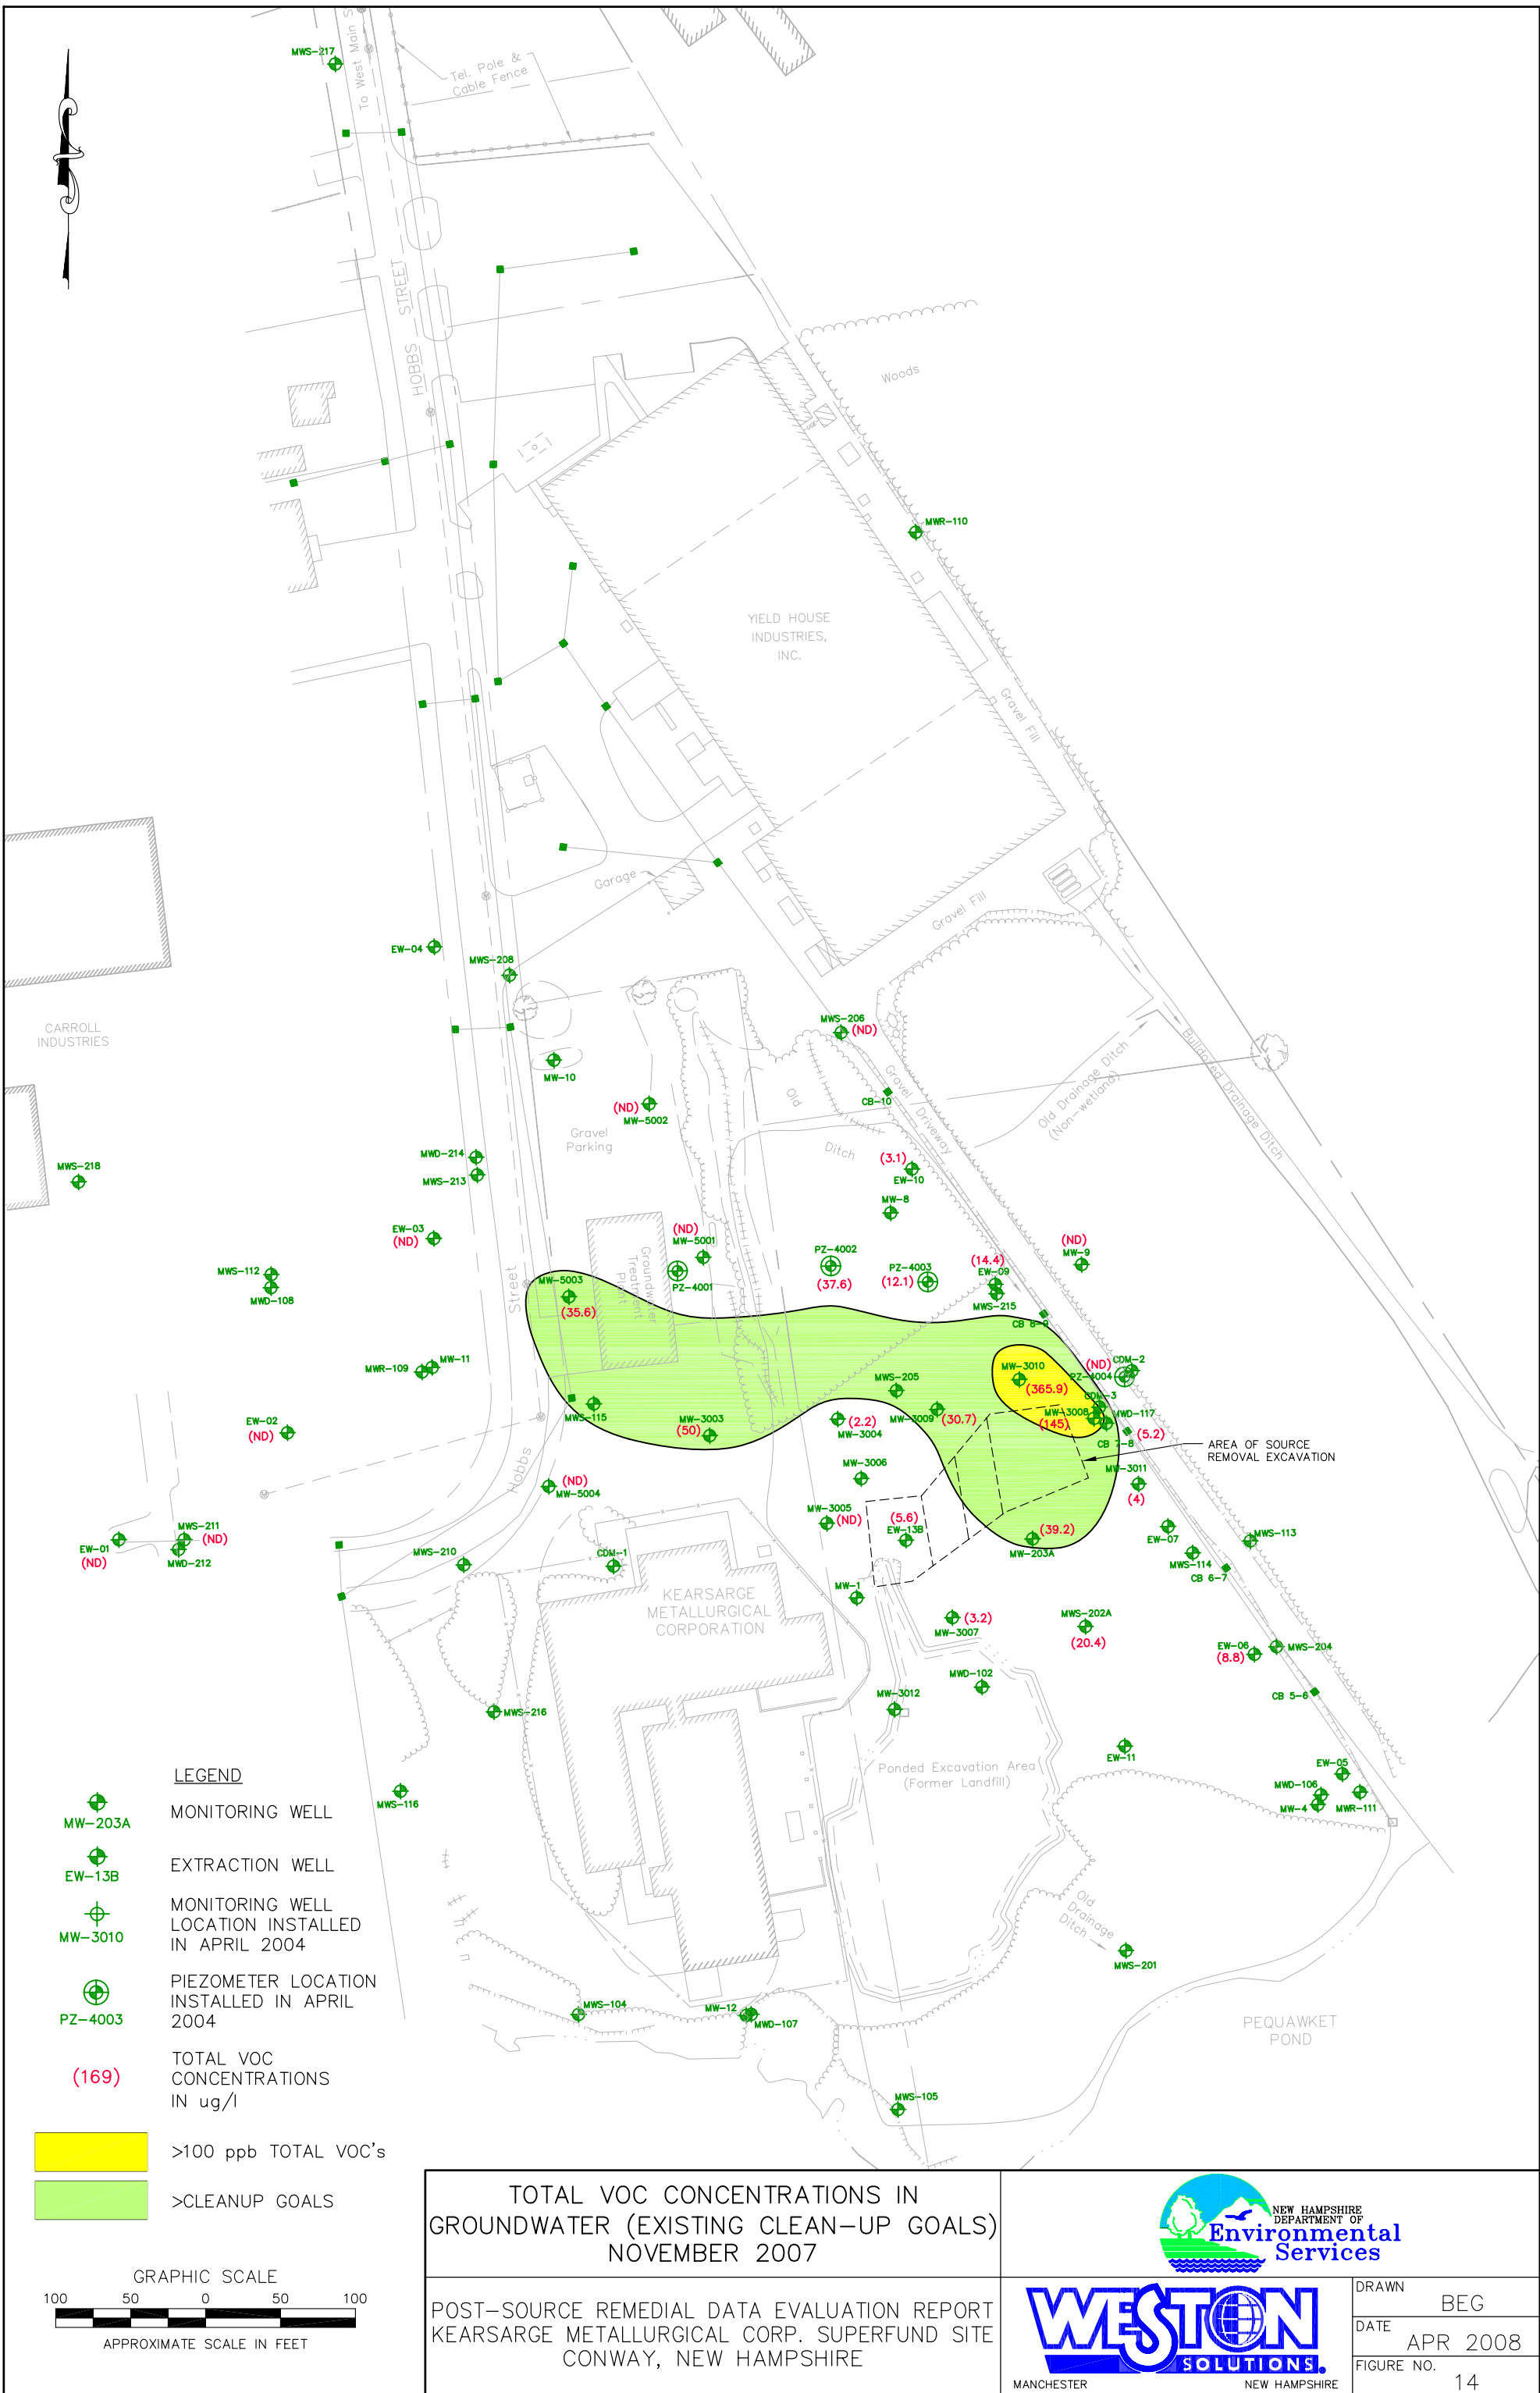
DRAWN: BEG
 DATE: APR 2008
 FIGURE NO.: 14

TOTAL VOC CONCENTRATIONS IN GROUNDWATER (EXISTING CLEAN-UP GOALS) NOVEMBER 2007

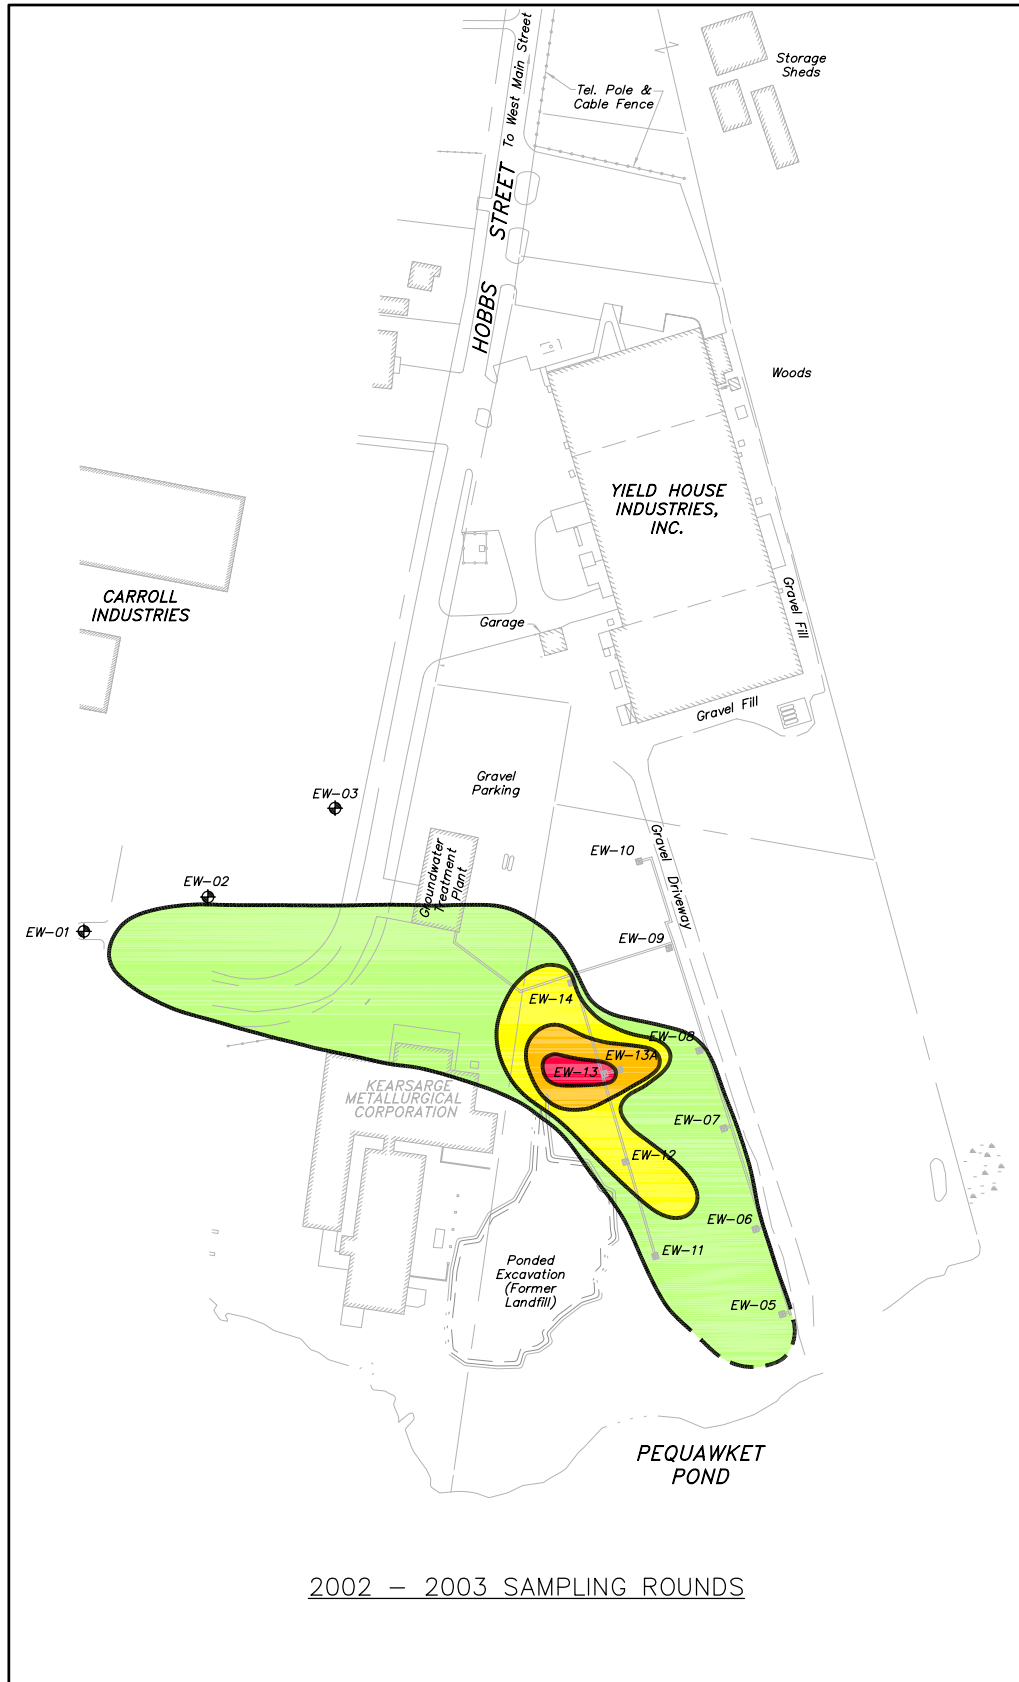
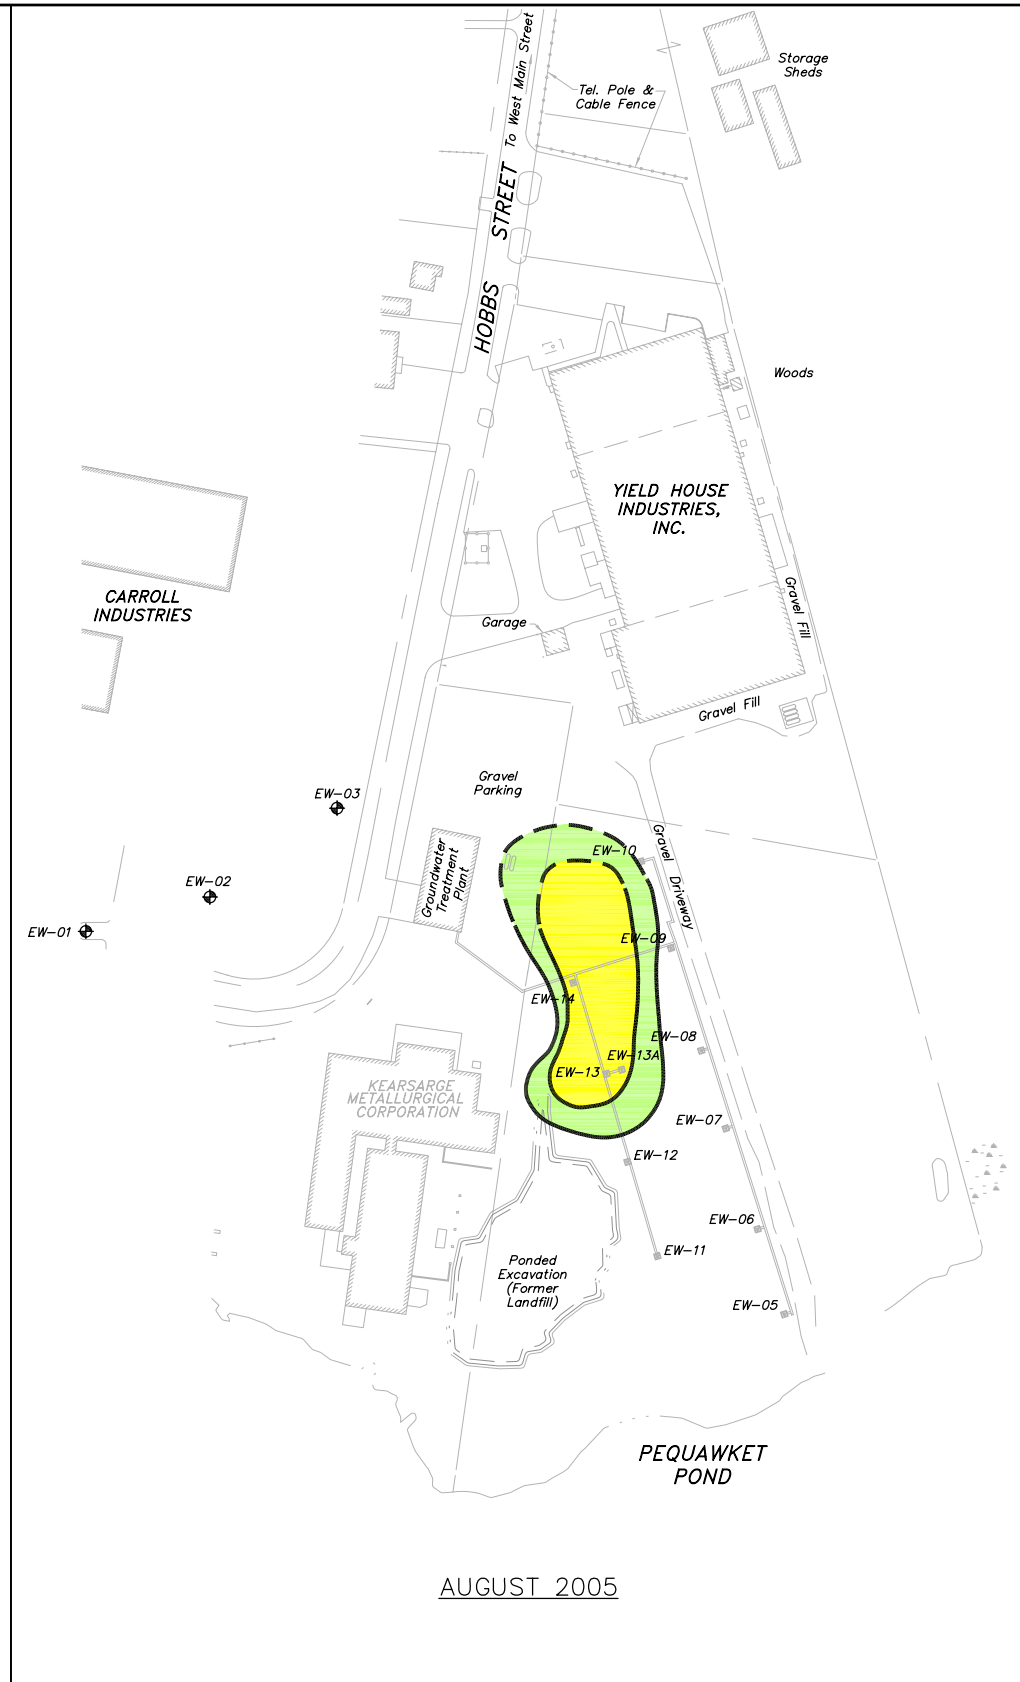
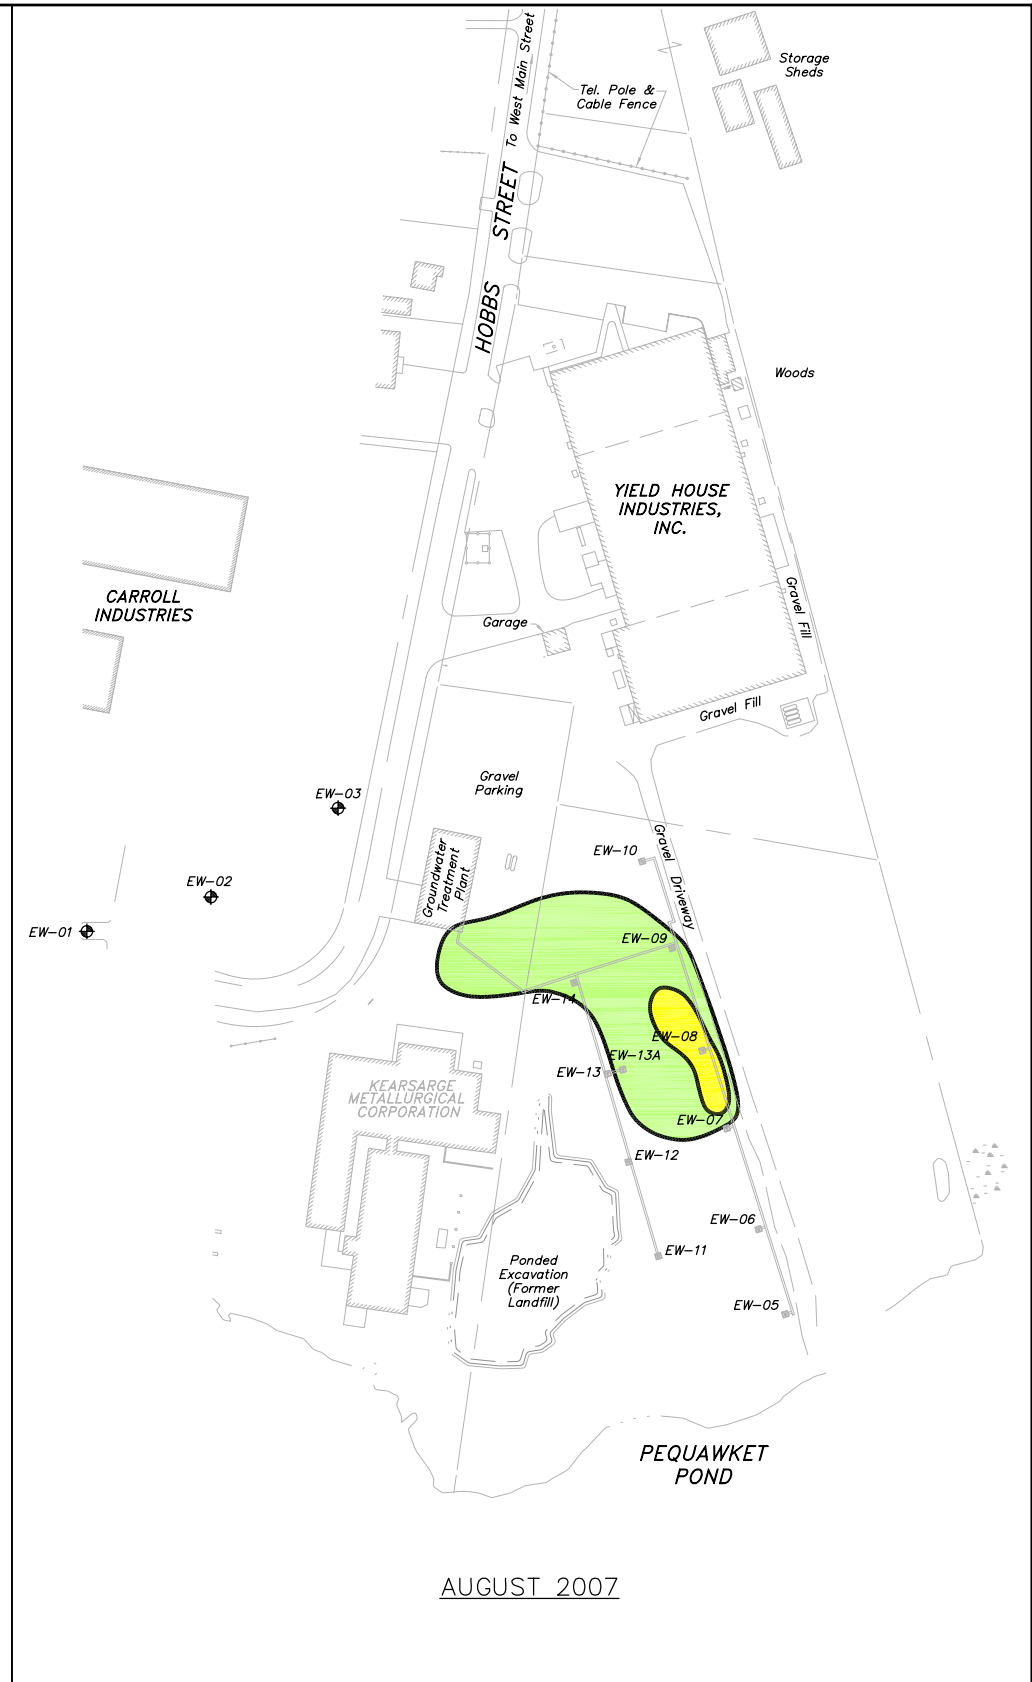
DRAWN: BEG
DATE: APR 2008
FIGURE NO.: 15

LEGEND		CLEANUP GOALS	
	>10,000 ppb TOTAL VOC's	1,1,1-TCA	200 ppb
	>1,000 ppb TOTAL VOC's	1,1-DCA	3650 ppb
	>100 ppb TOTAL VOC's	1,1-DCE	7 ppb
	>CLEANUP GOALS	1,2-DCA	5 ppb
		TCE	5 ppb

HISTORIC TOTAL VOC CONCENTRATIONS
IN GROUNDWATER
(EXISTING CLEANUP GOALS)

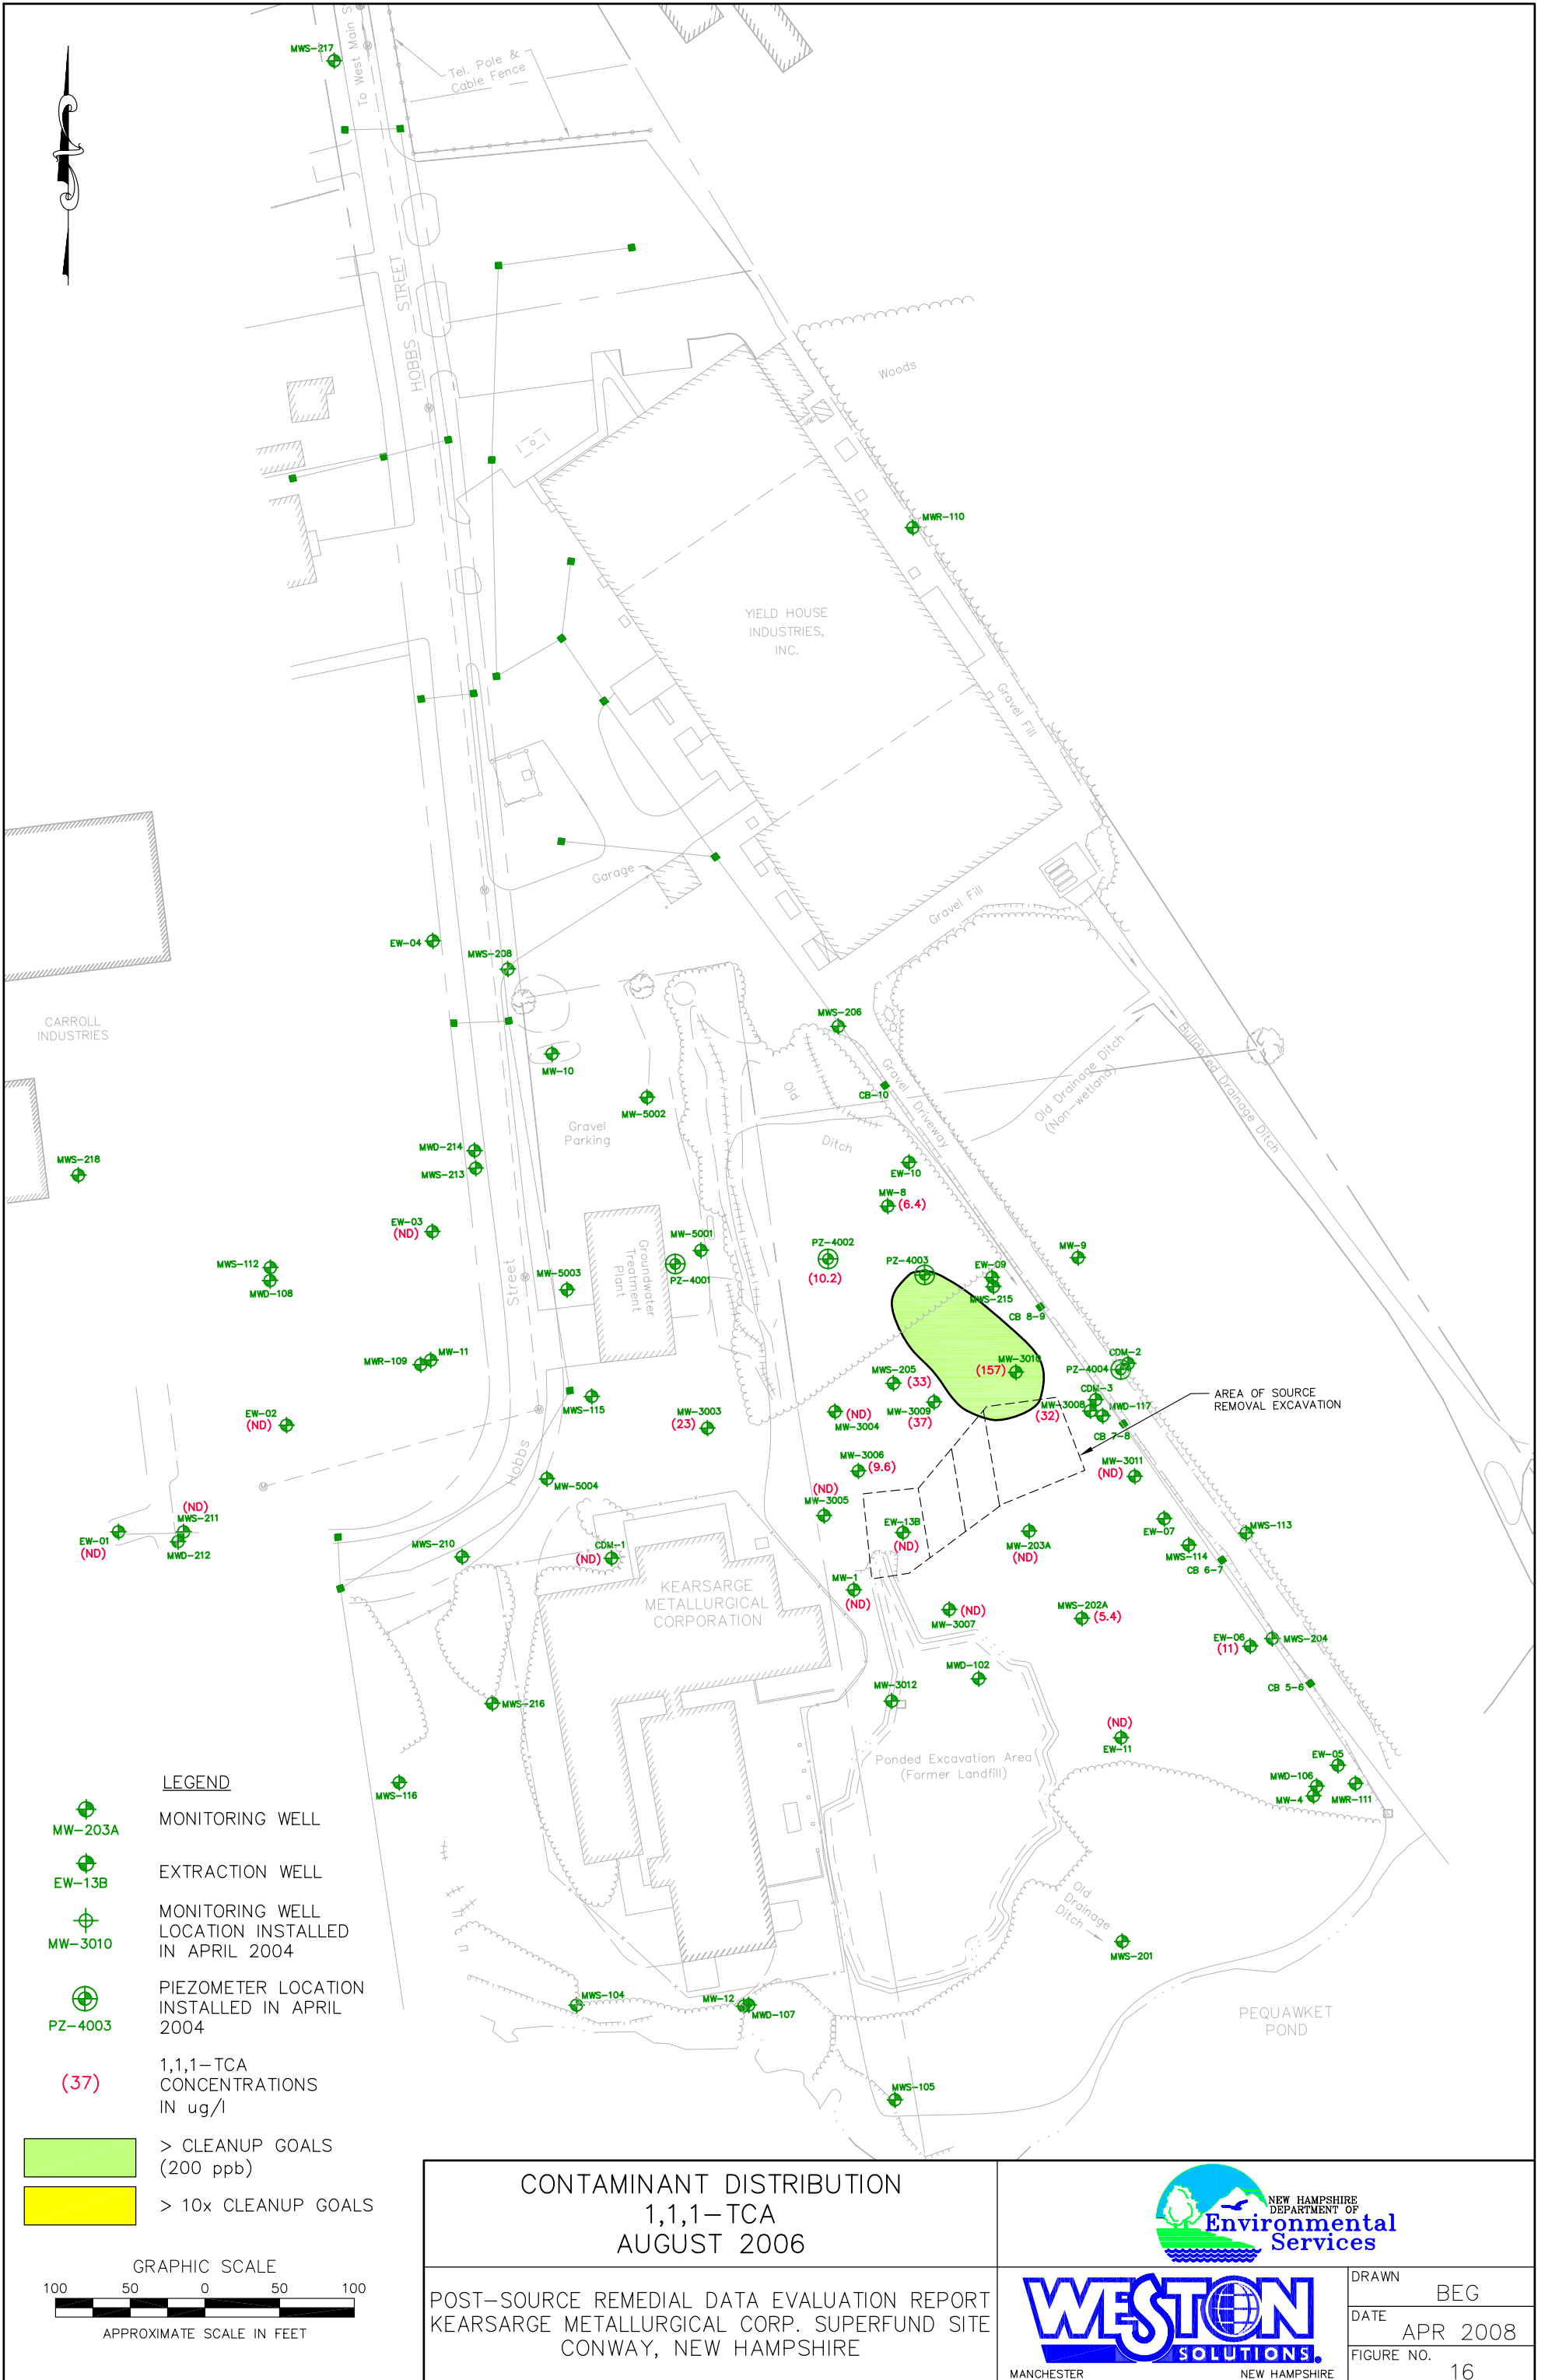
<p>CONTAMINANT DISTRIBUTION 1,1,1-TCA AUGUST 2006</p>	
<p>POST-SOURCE REMEDIAL DATA EVALUATION REPORT KEARSARGE METALLURGICAL CORP. SUPERFUND SITE CONWAY, NEW HAMPSHIRE</p>	
<p>MANCHESTER NEW HAMPSHIRE</p>	<p>DRAWN: BEG DATE: APR 2008 FIGURE NO.: 16</p>

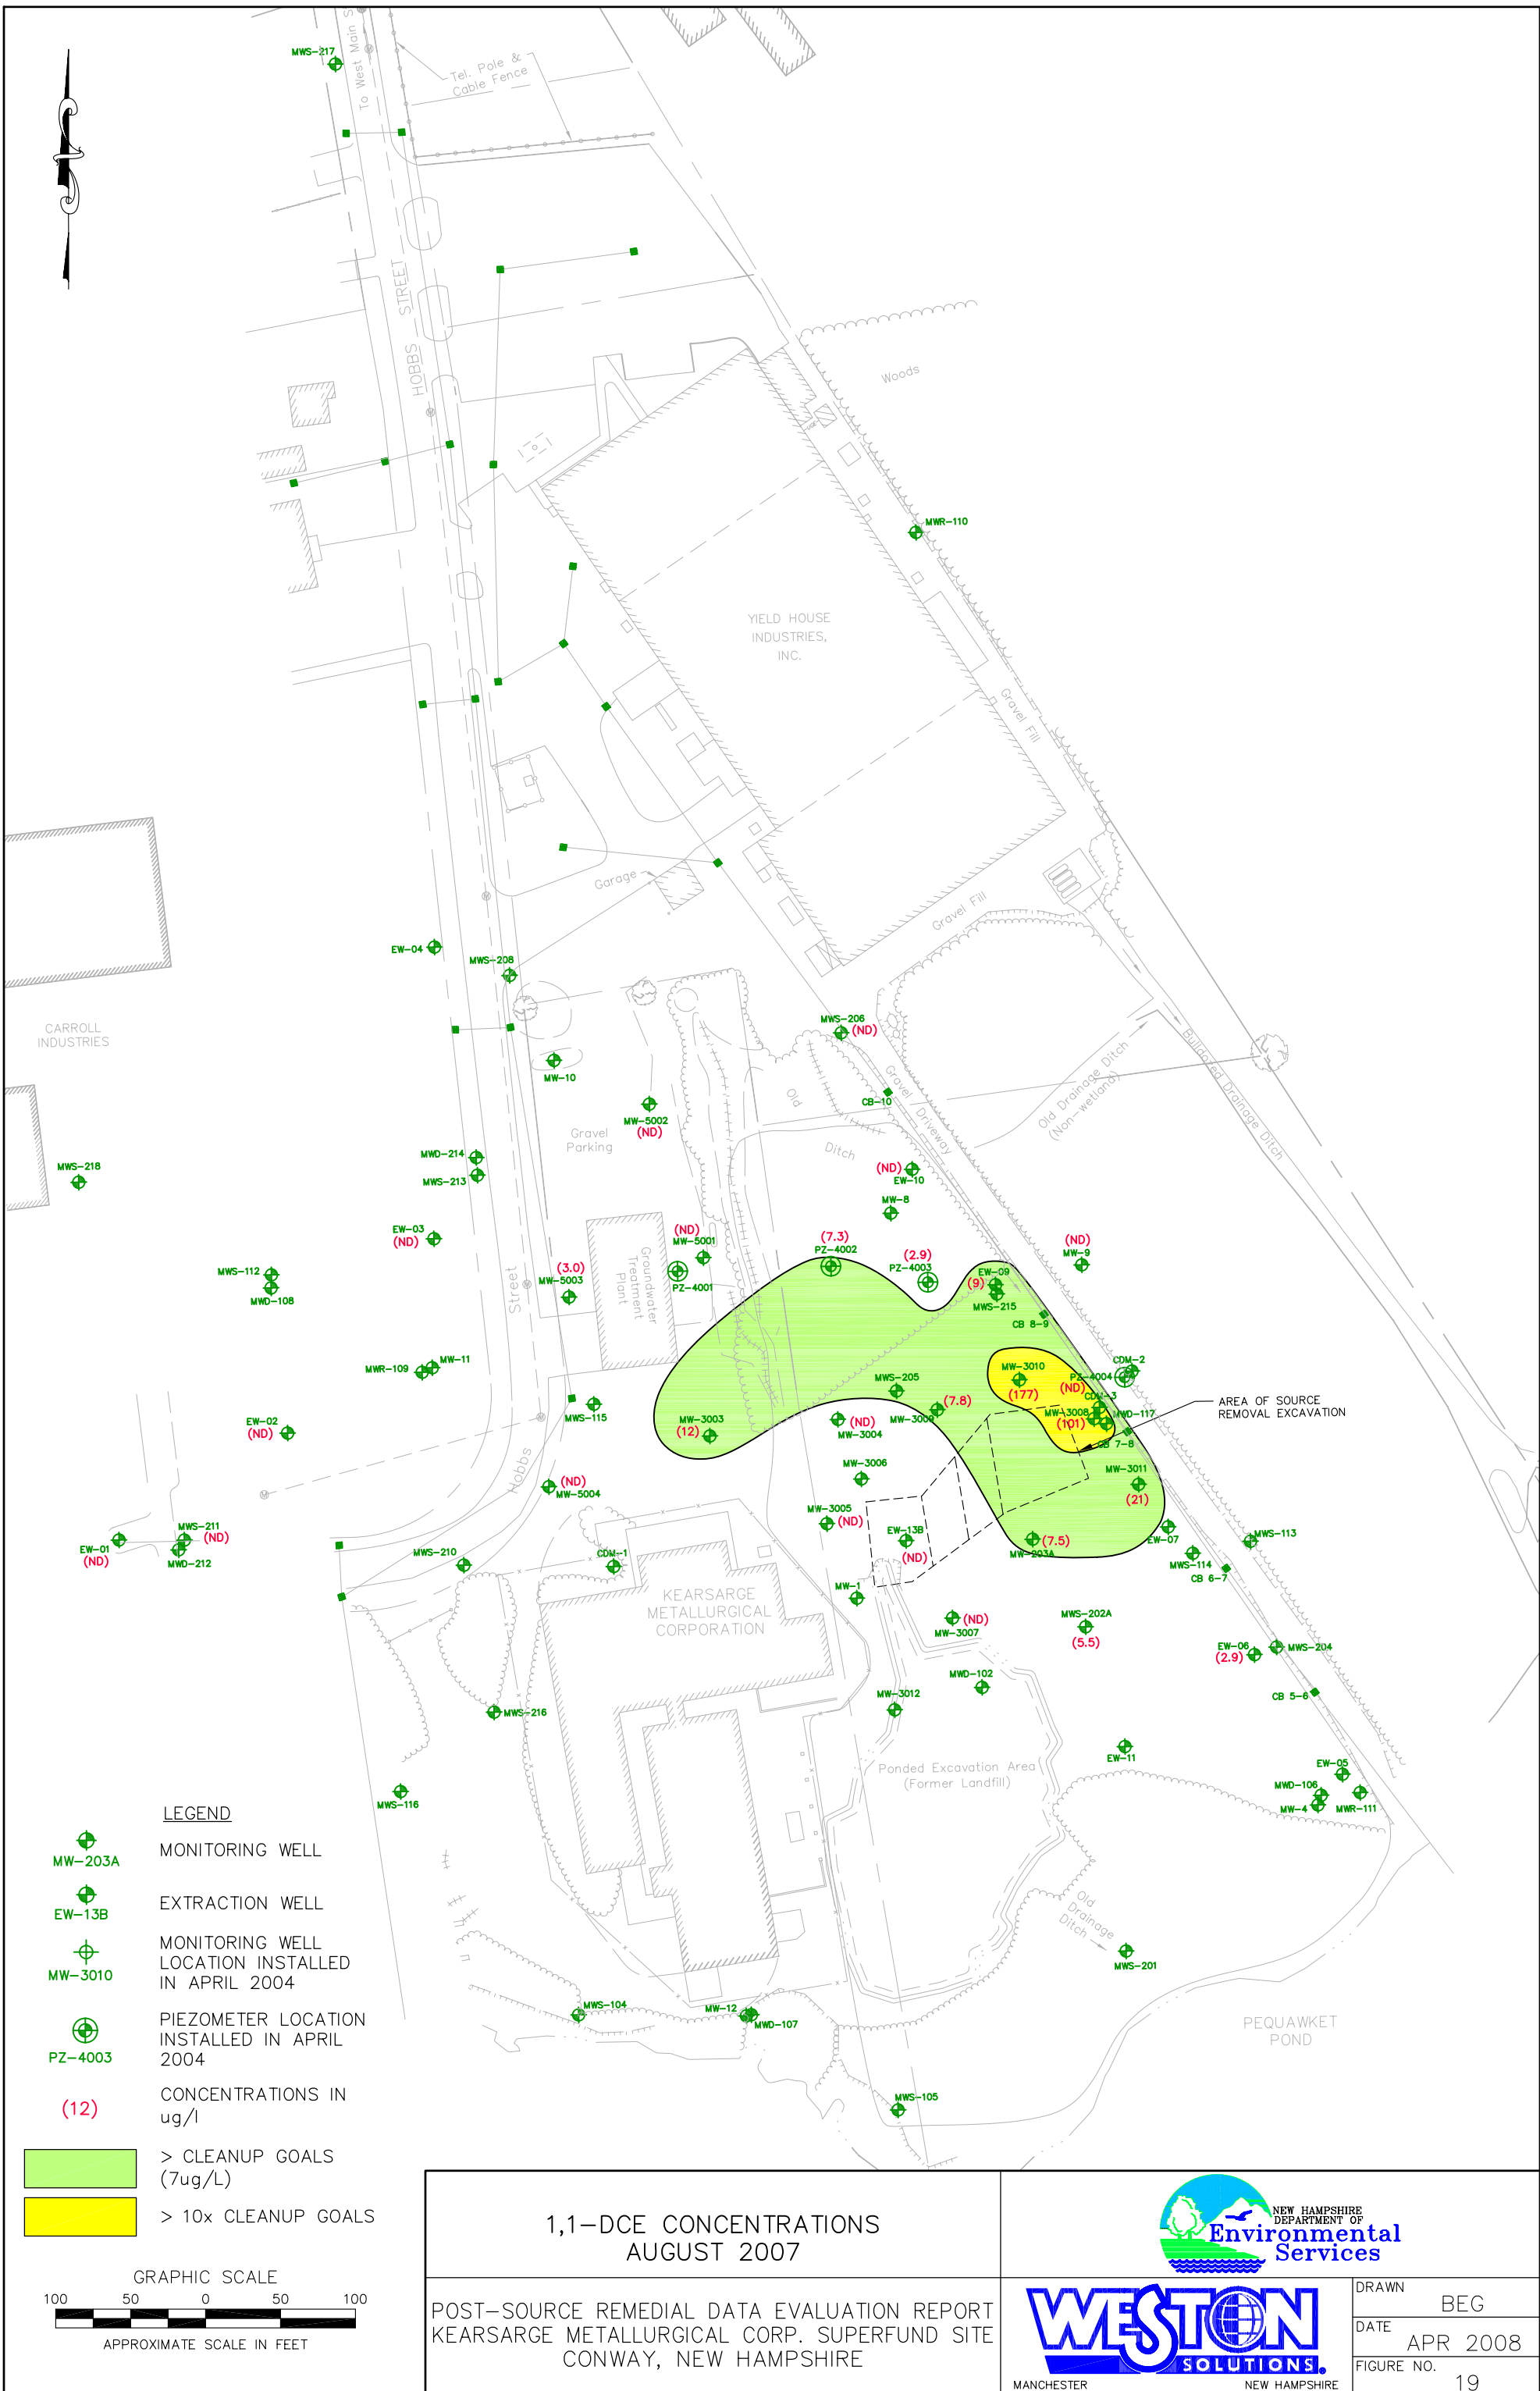
<p>DRAWN: BEG DATE: APR 2008 FIGURE NO.: 19</p>

<p>1,1-DCE CONCENTRATIONS AUGUST 2007</p>		 
<p>POST-SOURCE REMEDIAL DATA EVALUATION REPORT KEARSARGE METALLURGICAL CORP. SUPERFUND SITE CONWAY, NEW HAMPSHIRE</p>
