MEMORANDUM

Date: May 15, 2009

Subject: Summary/Update Regarding Site Conceptual Model
Kearsarge Metallurgical Corporation Superfund Site, Conway, New Hampshire

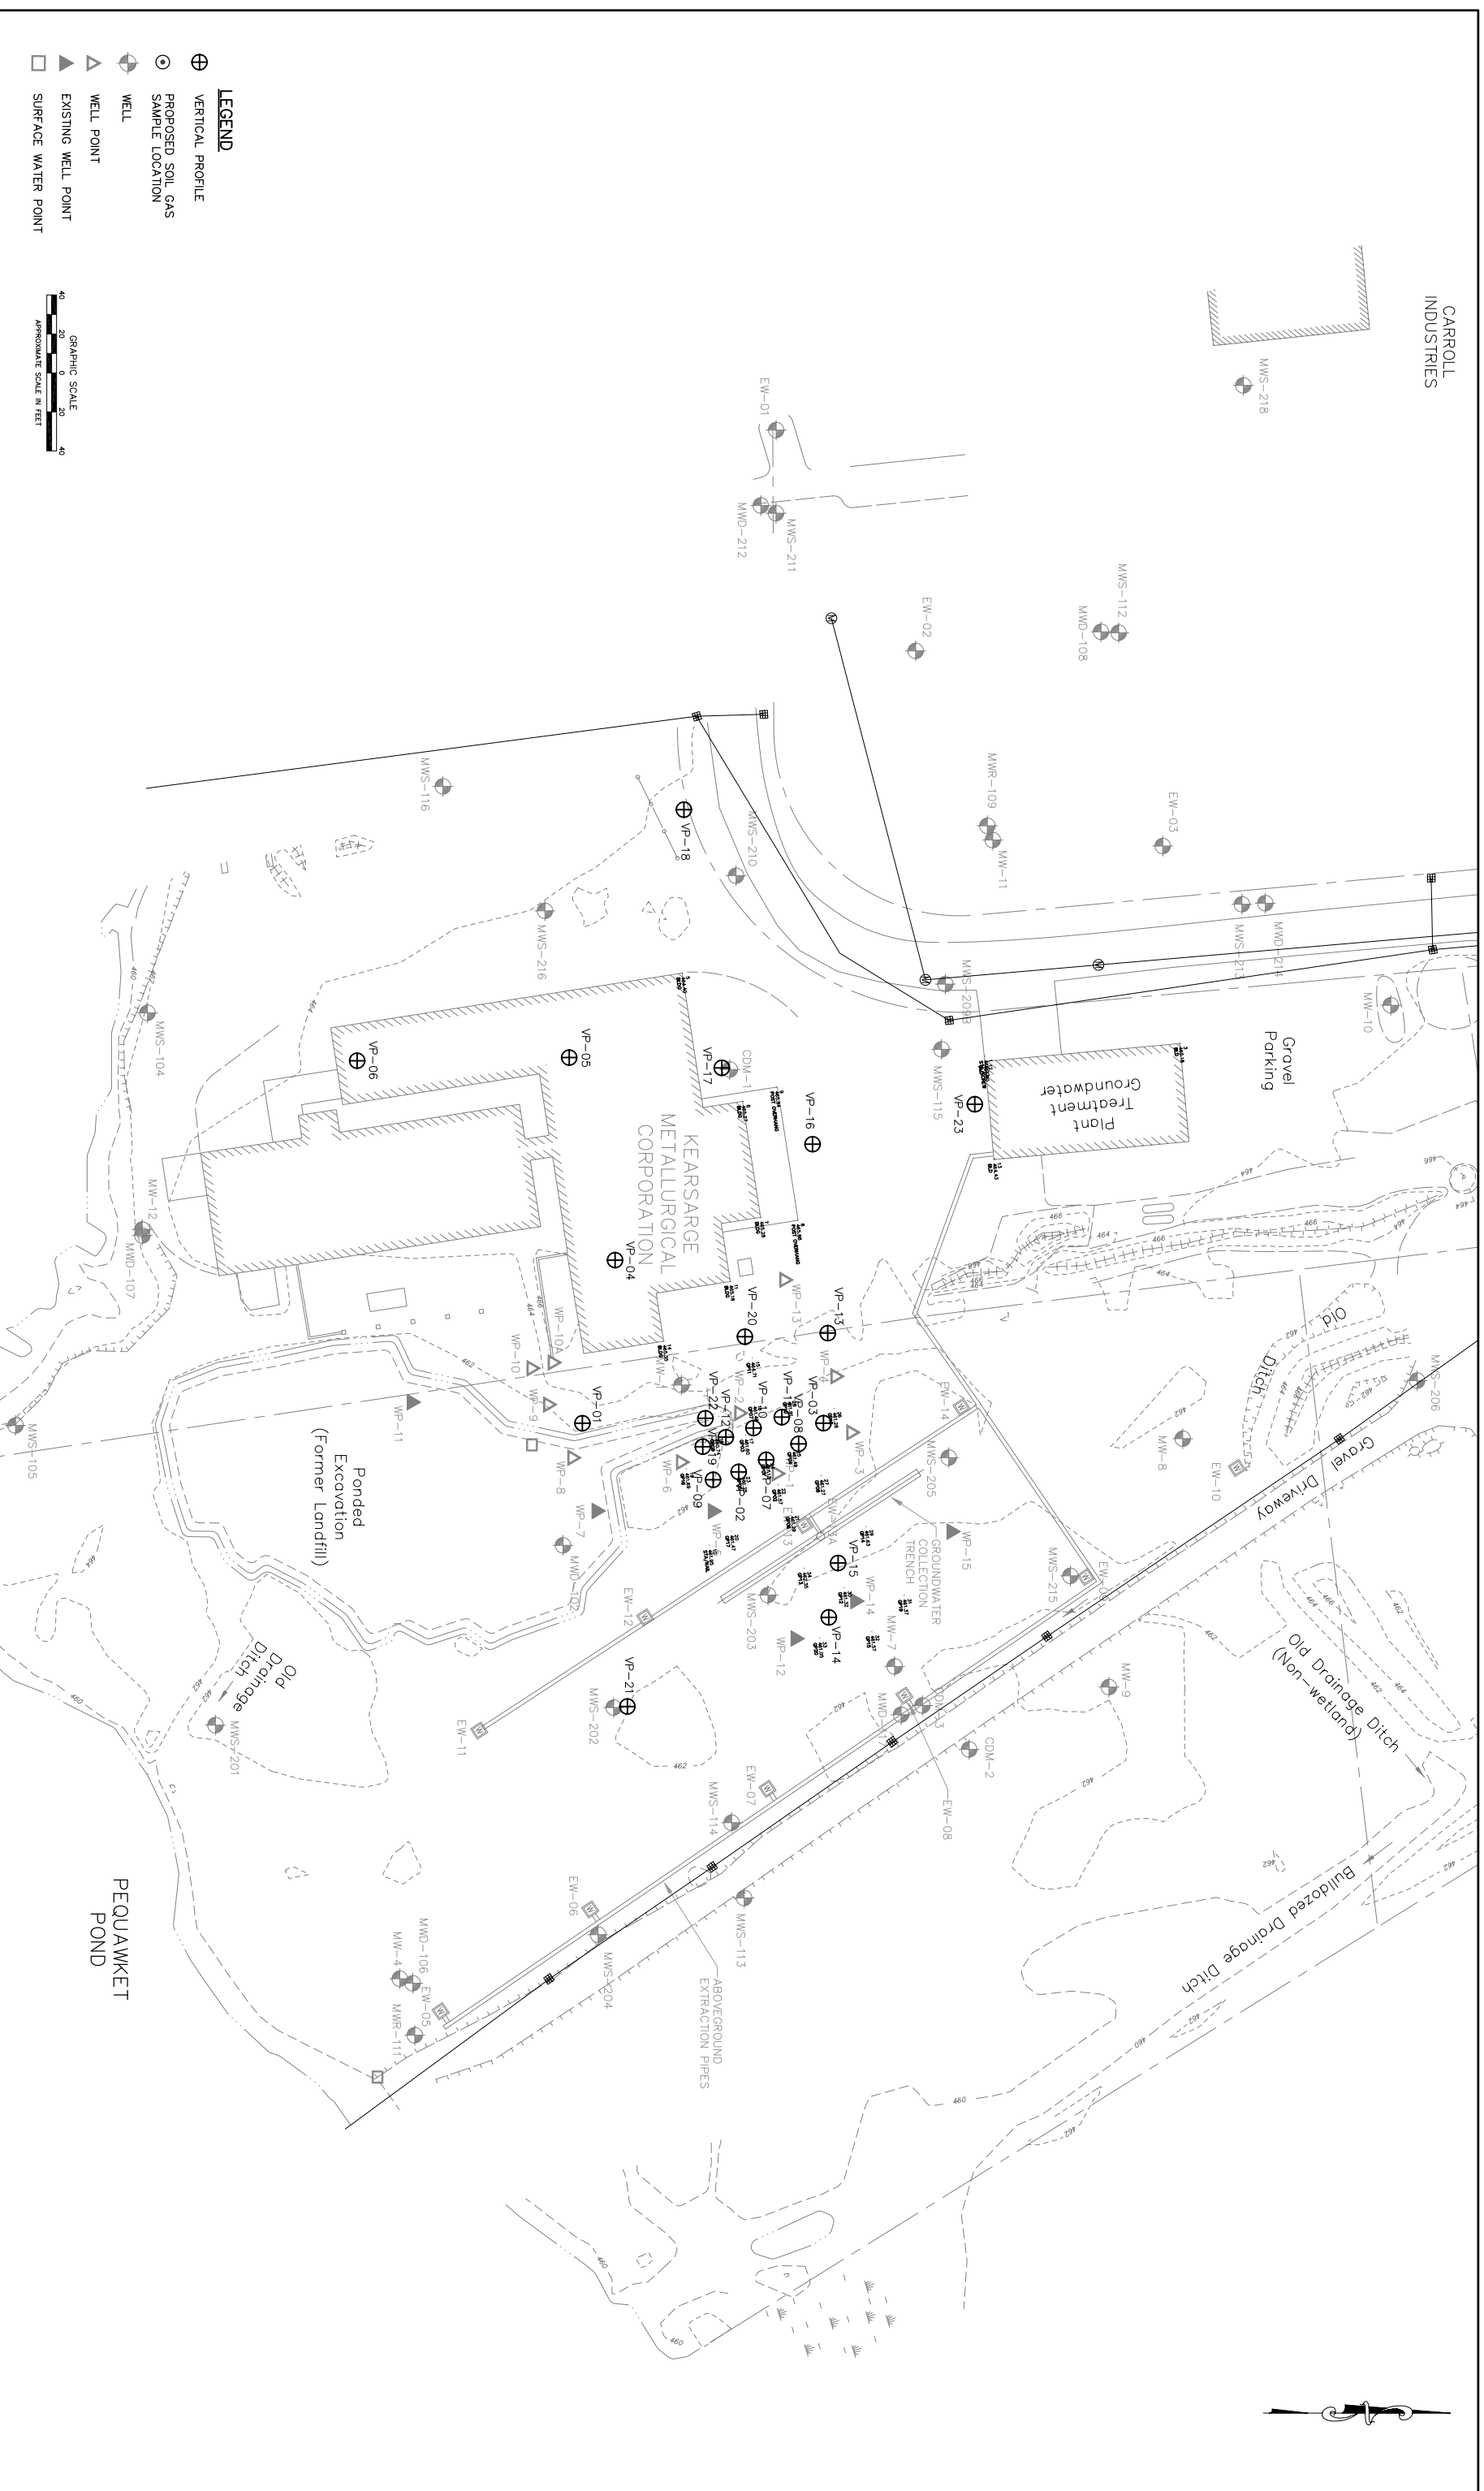
NO. NO.: 01395-022-007
 DATE: 01/31/2003
 DWG. NO.: FIG. 1
 SHEET: 1 OF 1
 REV. NO.:

VERTICAL PROFILING LOCATIONS

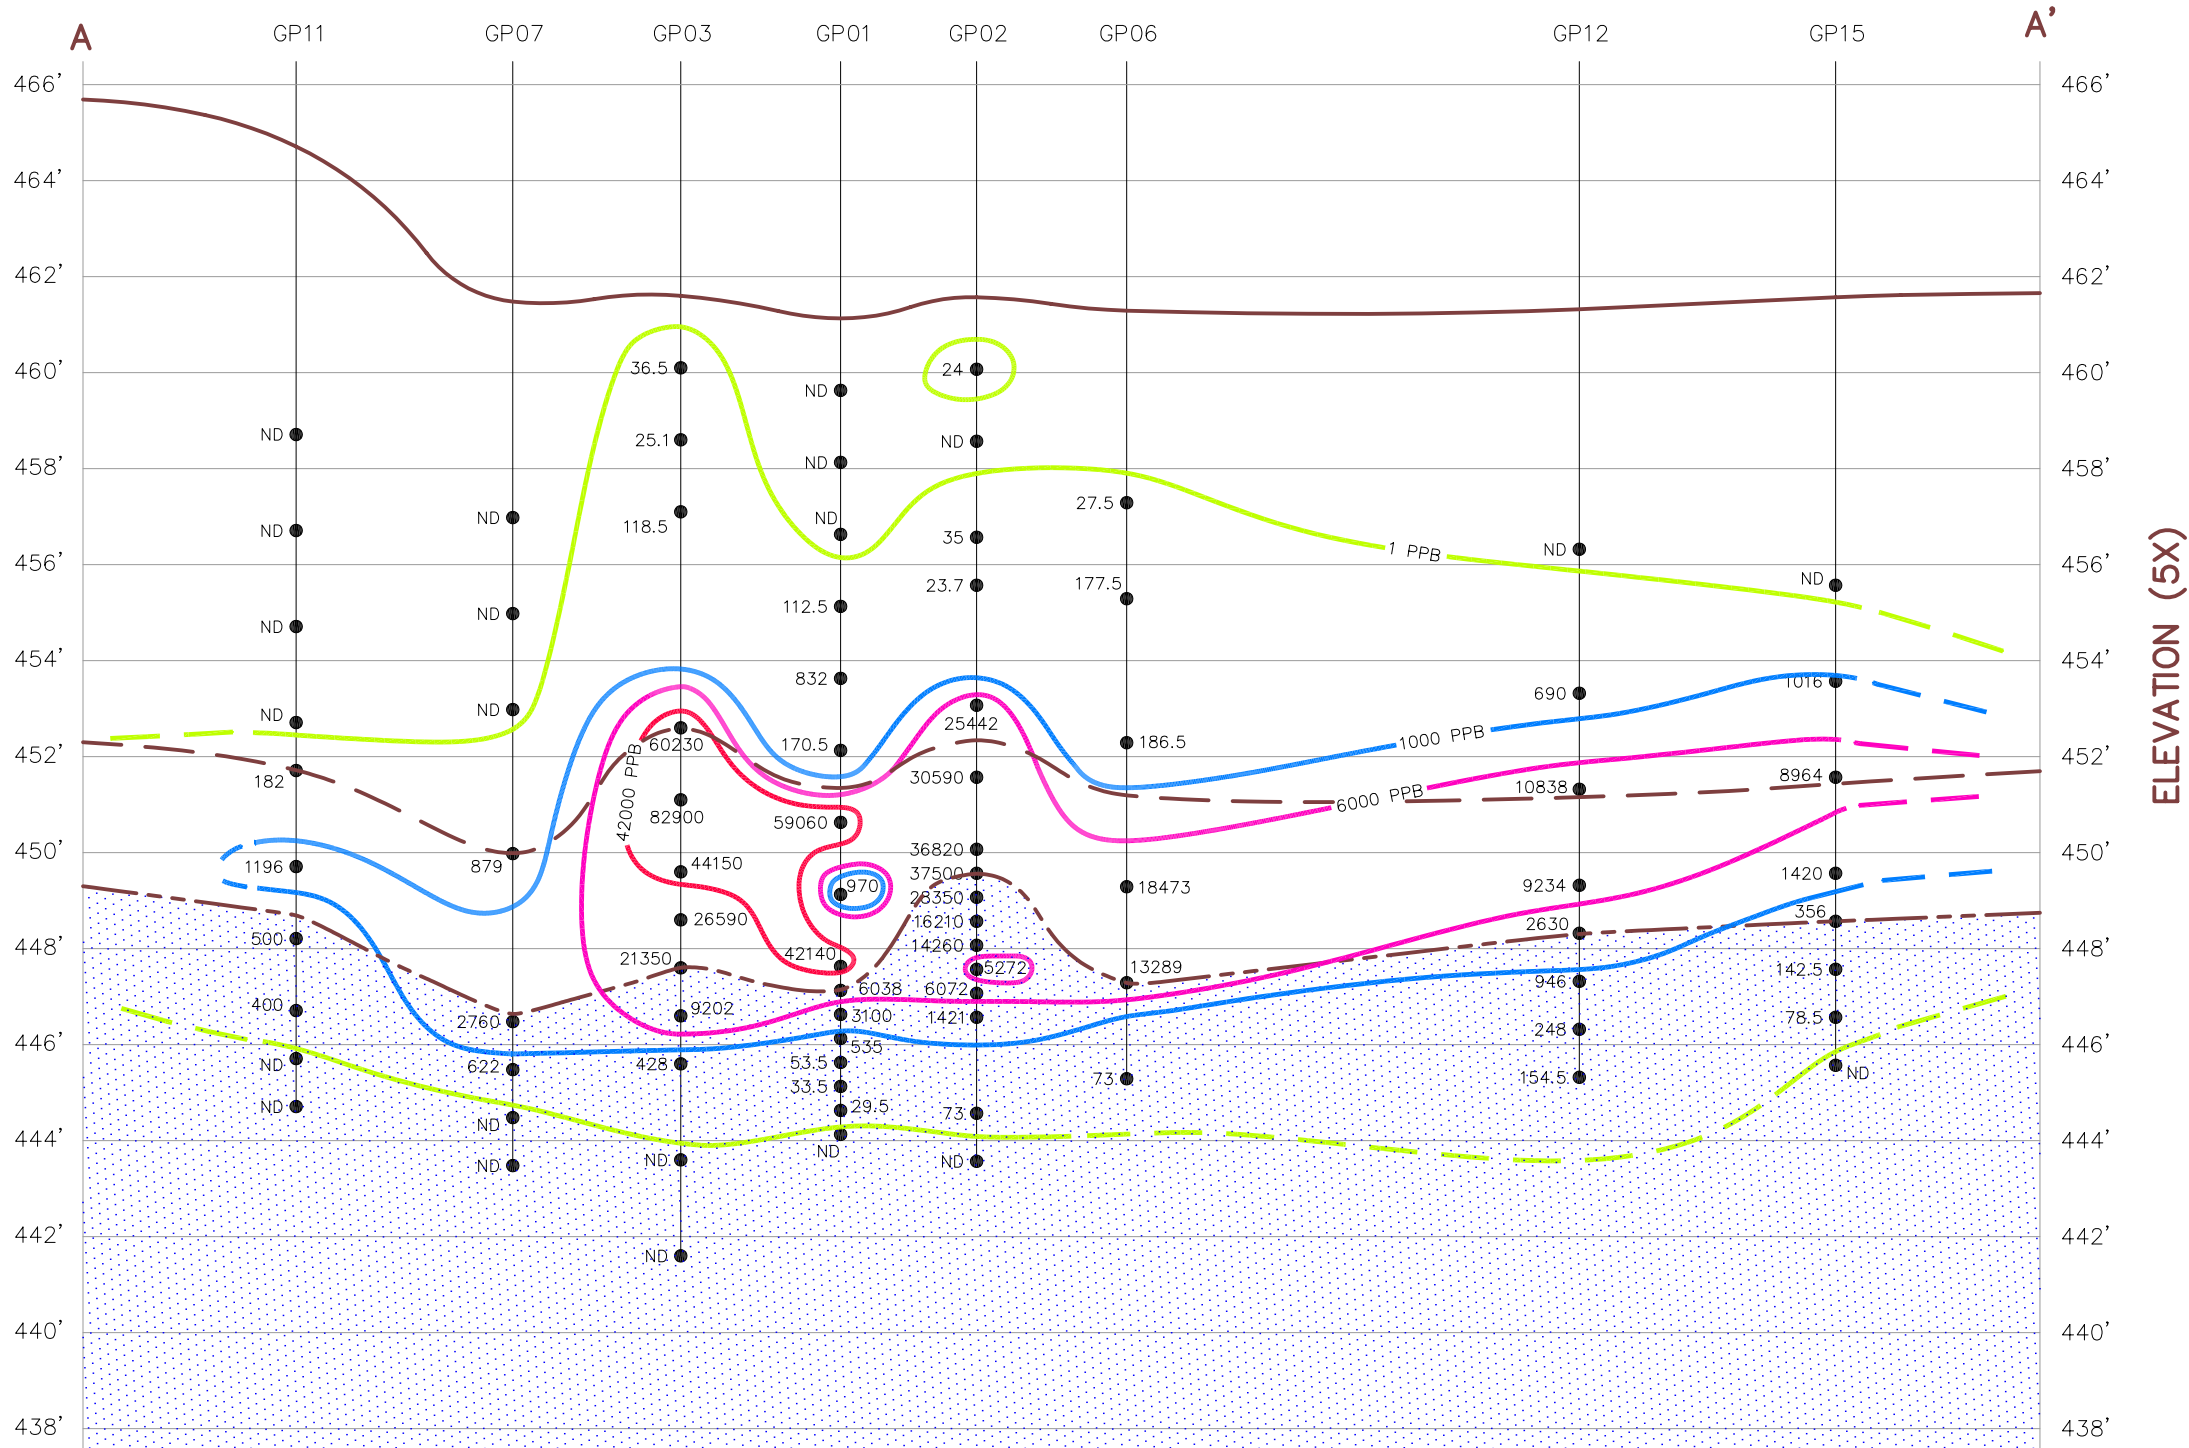
- 1.40 ● VOC SAMPLE WITH TOTAL VOC CONC. (UG/L)
- APPROXIMATE ELEVATION OF TOP OF GREY SILT AQUITARD
- GROUND SURFACE ELEVATION
- APPROXIMATE ELEVATION OF TOP OF TAN SILT AQUITARD

CROSS SECTION A-A'			
DRAWN	BEG	DATE	DEC 2002
SCALE	AS SHOWN	W.D. NO.	01395-022-007
DWG. NO.	FIG. 7	REV. NO.	
SHT.		OF

A key feature of site stratigraphy is a silt layer with low permeability that is shallower on the eastern portion of the site than on the western portion of the site. The material above the silt is more transmissive (i.e., sands and gravels that coarsen to the west). The top of the silt is approximately 8 to 14 ft below ground surface (bgs) in the Culvert Area (i.e., the eastern portion of the site) but is more than 40 ft bgs in the Hobbs Street Area. This is illustrated on Figures 3 to 6 in Attachment B, which are cross-section figures created by Weston based on vertical profiling activities.

Figures 4 and 6 in Attachment B illustrate that, based on previous vertical profiling activities, the highest VOC concentrations have been observed at depth near the top of the silt. This is also illustrated in the immediate vicinity of the source area in Attachment C, which consists of Figures 6 and 7 from Appendix D of the Weston Report dated 4/21/08. Clean water from precipitation recharges the shallow groundwater, and as groundwater diverges from this area, relatively clean water remains in the upper portion of the sand, while more impacted groundwater remains in or immediately above the silt. Variability in the top elevation of the silt (e.g., dipping, troughs, and valleys) likely plays a role in the direction of groundwater flow and the direction of contaminant transport.

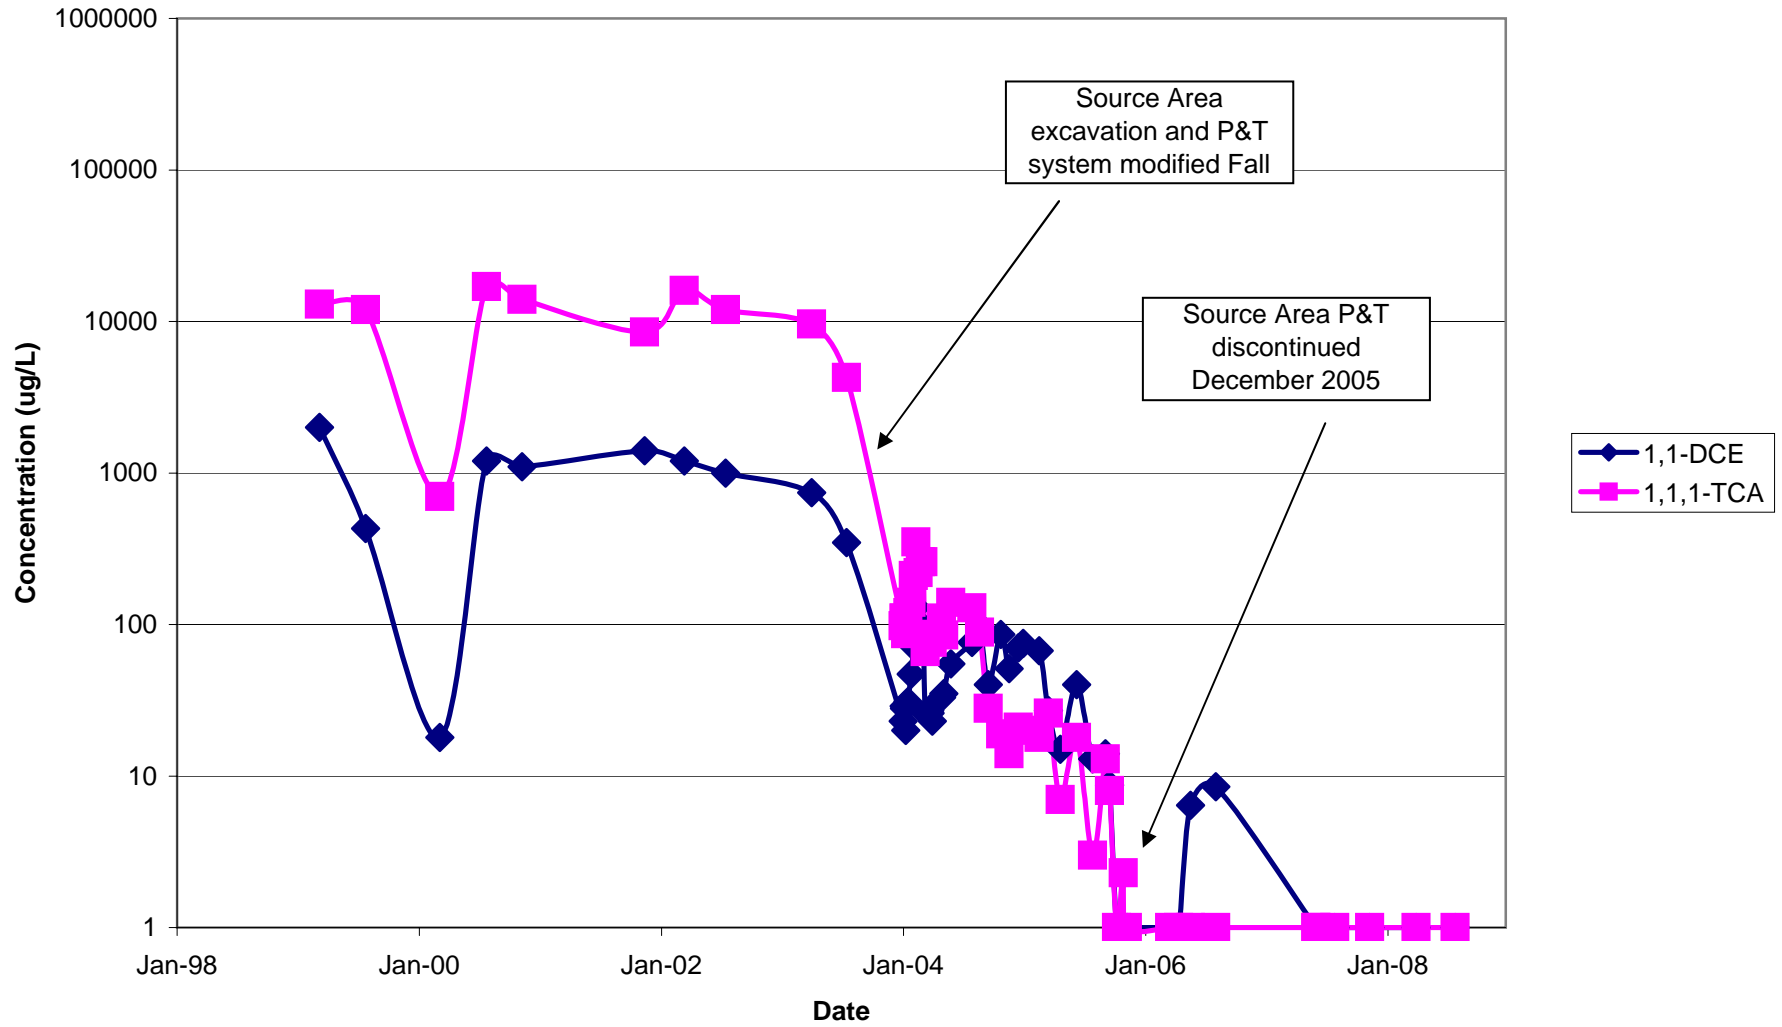
1,1,1-TCA and 1,1-DCE Concentration Trends at EW-13/13B

EW-13 and replacement well EW-13B are located within the source area and historically exhibited high concentrations (e.g., 1,1,1-TCA approximately 10,000 ug/L through April 2003 and 4,000 ug/L through August 2003). In the fall of 2003 the source area was excavated and P&T was subsequently conducted from the backfilled trench using EW-13B as an extraction well. Concentrations of 1,1,1-TCA declined sharply by the next sample in January 2004 and continued to decline to below 10 ug/L. A similar trend is observed for 1,1-DCE. P&T was discontinued in December 2005 and concentrations remained low at EW-13B, presumably due to contamination removed from this area by the excavation.

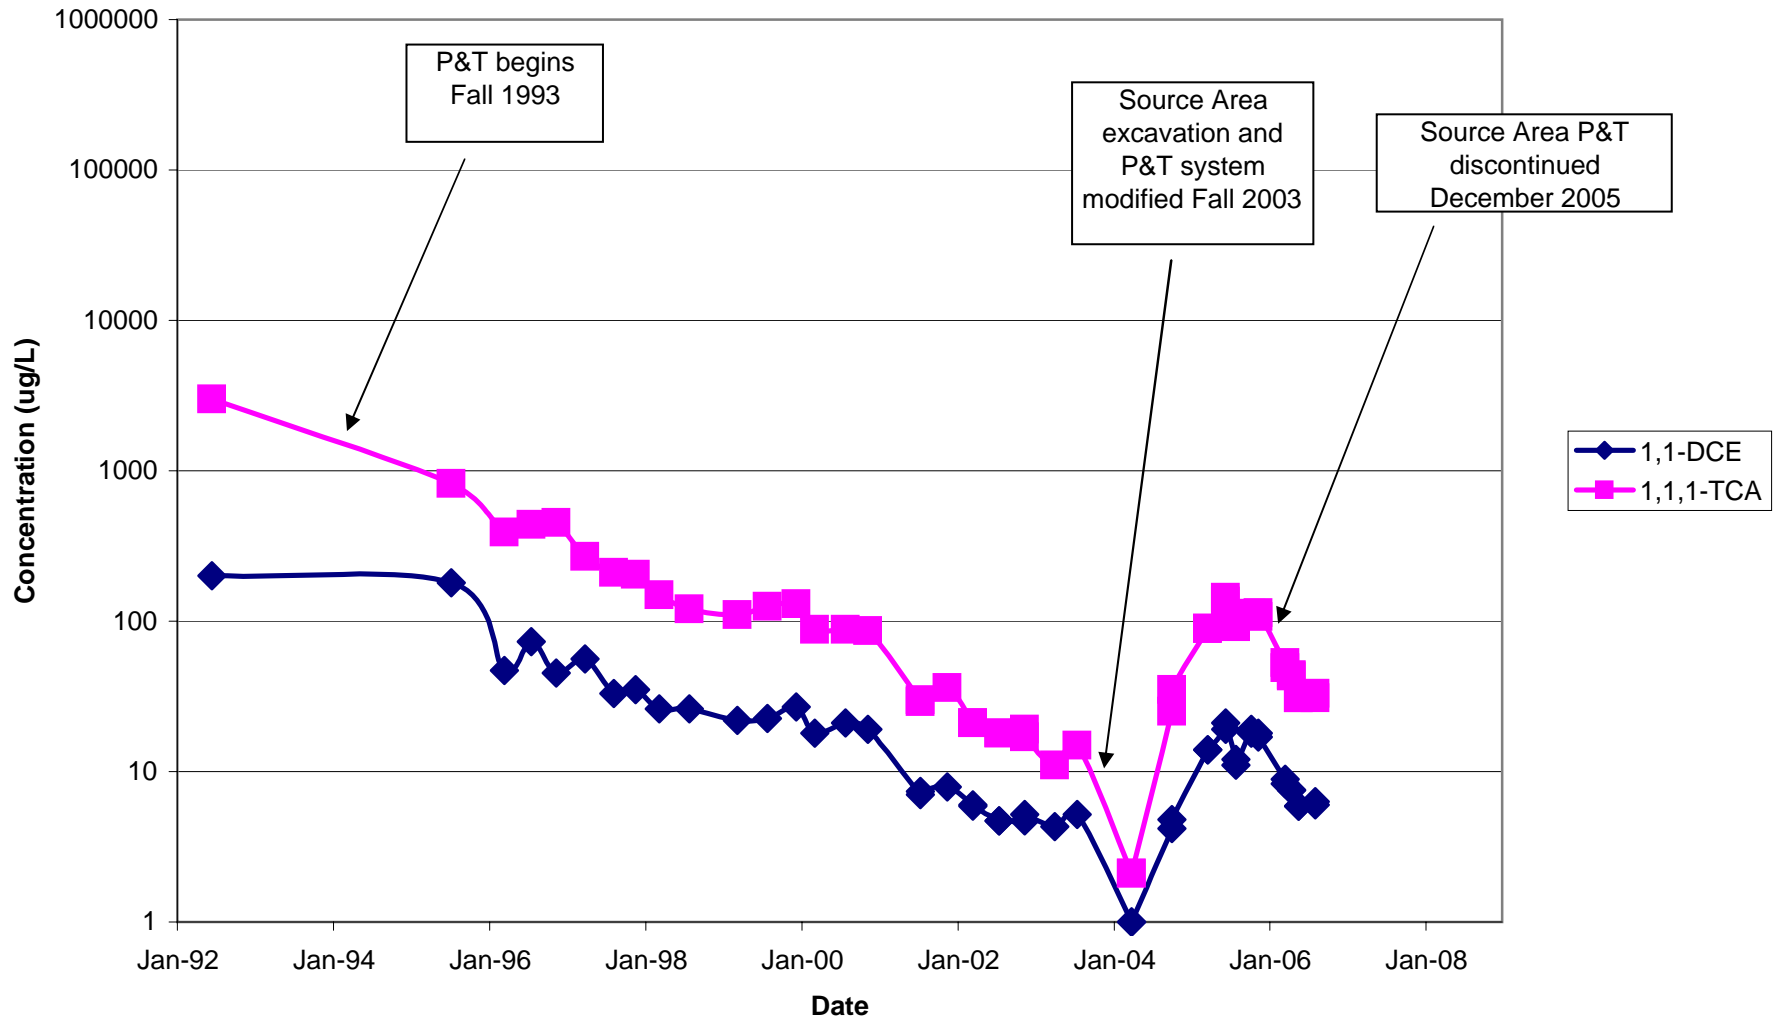
1,1,1-TCA and 1,1-DCE Concentration Trends at MWS-205

MWS-205 is approximately 100 ft north of the western portion of the source area, in an area where the underlying silt is shallow (approximately 14 feet bgs) and within the northerly groundwater flow path from this western portion of the source area (in the absence of remedy pumping). Concentration of 1,1,1-TCA was approximately 3,000 ug/L in 1992 and began declining when P&T began in Fall 1993, and declines continued through April 2004 (after source area excavation and P&T modification). The P&T modification greatly increased the extent of the capture zone and modified groundwater flow directions in the area of MWS-205. Increases in the 1,1,1-TCA and 1,1-DCE concentrations through November 2005 (during pumping at EW-13B) are likely the result of “pulling back” contamination through the area of MWS-205 toward EW-13B or an otherwise similar change in the direction of contaminant transport caused by the remedy extraction. Concentrations of 1,1,1-TCA remained below the cleanup level of 200 ug/l, but concentrations of 1,1-DCE increased above the cleanup level of 7 ug/l. Concentrations then began decreasing again when P&T was discontinued in December 2005, such that concentrations of both 1,1,1-TCA and 1,1-DCE were below cleanup levels in the last two samples (June 2006 and August 2006). No samples have been collected from MWS-205 since August 2006. Given the observed trends, in the absence of pumping it is expected that future concentrations at this well would continue to decrease, or stabilize below cleanup levels.

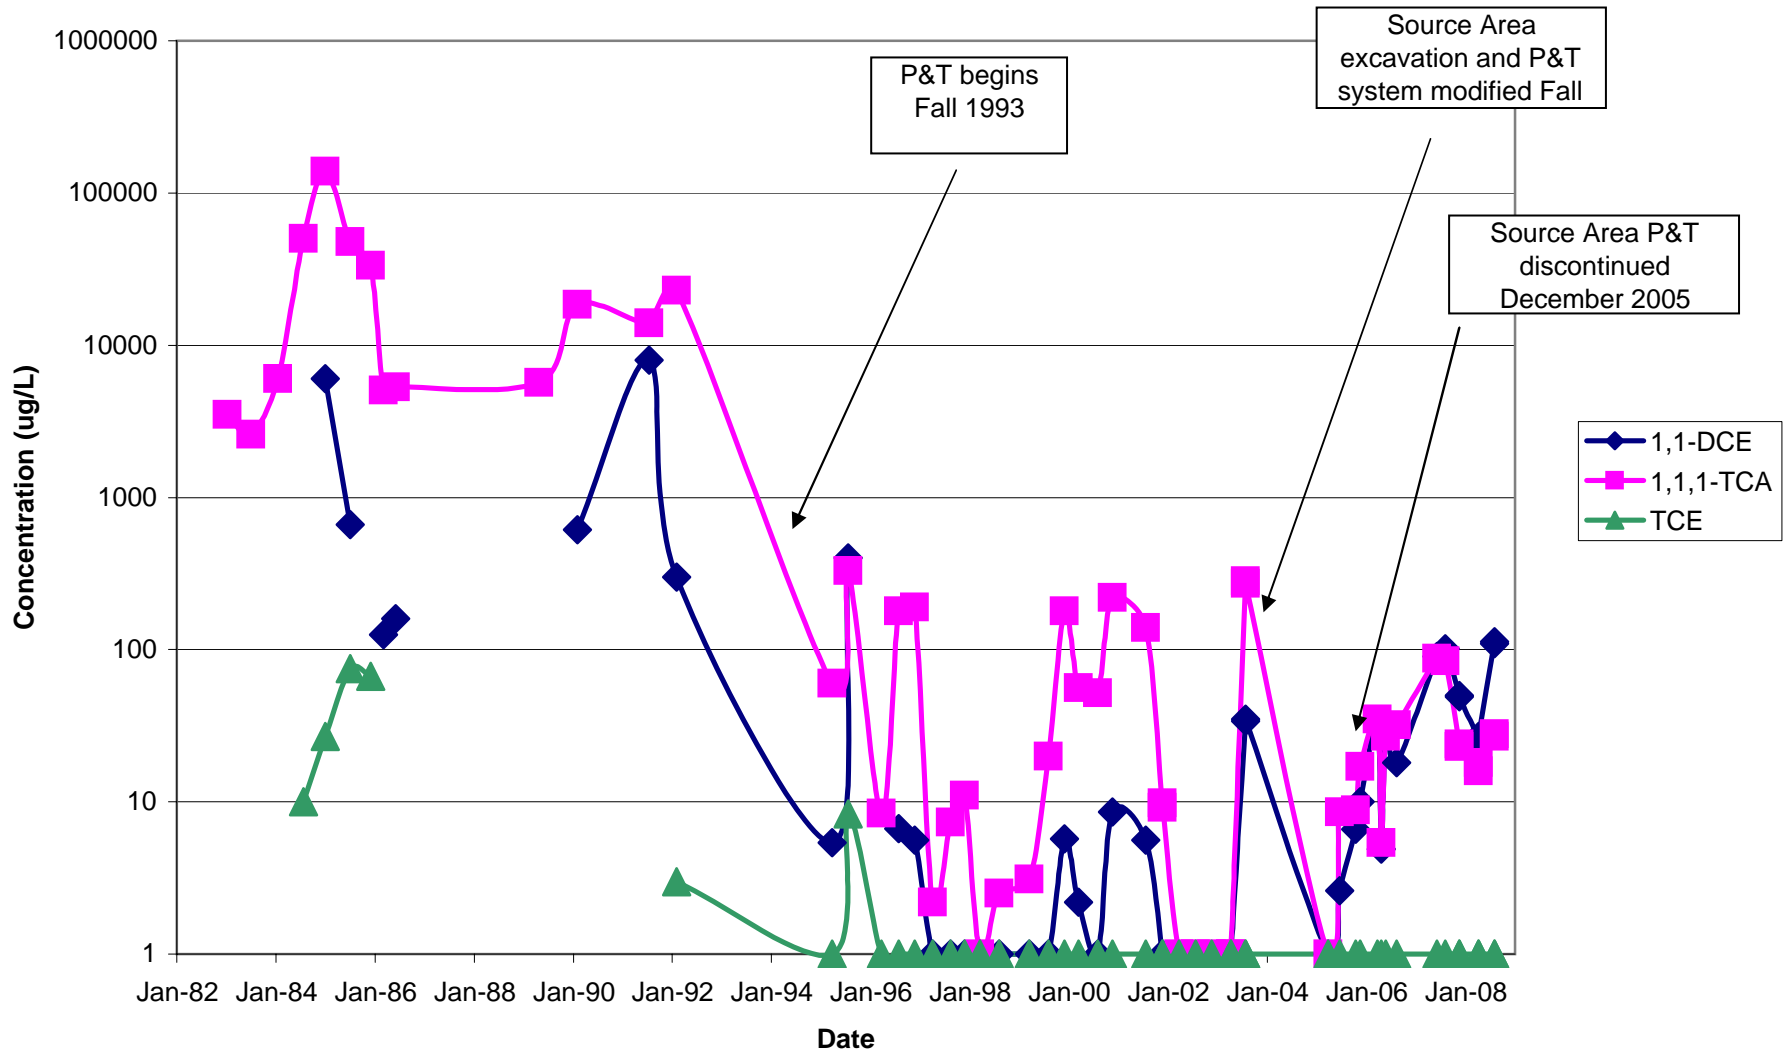
1,1,1-TCA and 1,1-DCE Concentration Trends at MW-7/MW-3008

MW-3008 since April 2005

MW-7 (which was removed in 2003) and MW-3008 (which was installed in a similar location in 2005) are located east of the source area, along the drain where water discharges from the shallow sand aquifer. Concentrations were initially high (e.g., 1,1,1-TCA above 10,000 ug/L) but decreased immediately after P&T began in 1993. Concentrations then dropped and fluctuated (e.g., 1,1,1-TCA fluctuated between approximately 200 ug/L and non-detect) through 2003. The fluctuations were over a period that was approximately three to five years and did not appear to be seasonal. Given the proximity of MW-7 to an extraction well (EW-08), the fluctuations mostly likely resulted from variations in P&T extraction rates. Concentrations declined to non-detect when the source area P&T system underwent modification in Fall 2003, but concentrations have been slowly rising (as measured in MW-3008) since P&T was discontinued in 2005. 1,1,1-TCA concentrations appear to plateau at a lower concentration (e.g., under 100 ug/L) than previous peaks during original P&T operation, but 1,1-DCE concentrations (about 100 ug/L) appear to be higher than previous peaks during original P&T operation. The recent concentrations of 1,1,1-TCA are below cleanup levels but the recent concentrations of 1,1-DCE are above cleanup levels. These recent concentrations may represent a new equilibrium based on residual contaminant mass beyond the excavation limits (which represents a reduced source term than previously existed, particularly for 1,1,1-TCA).

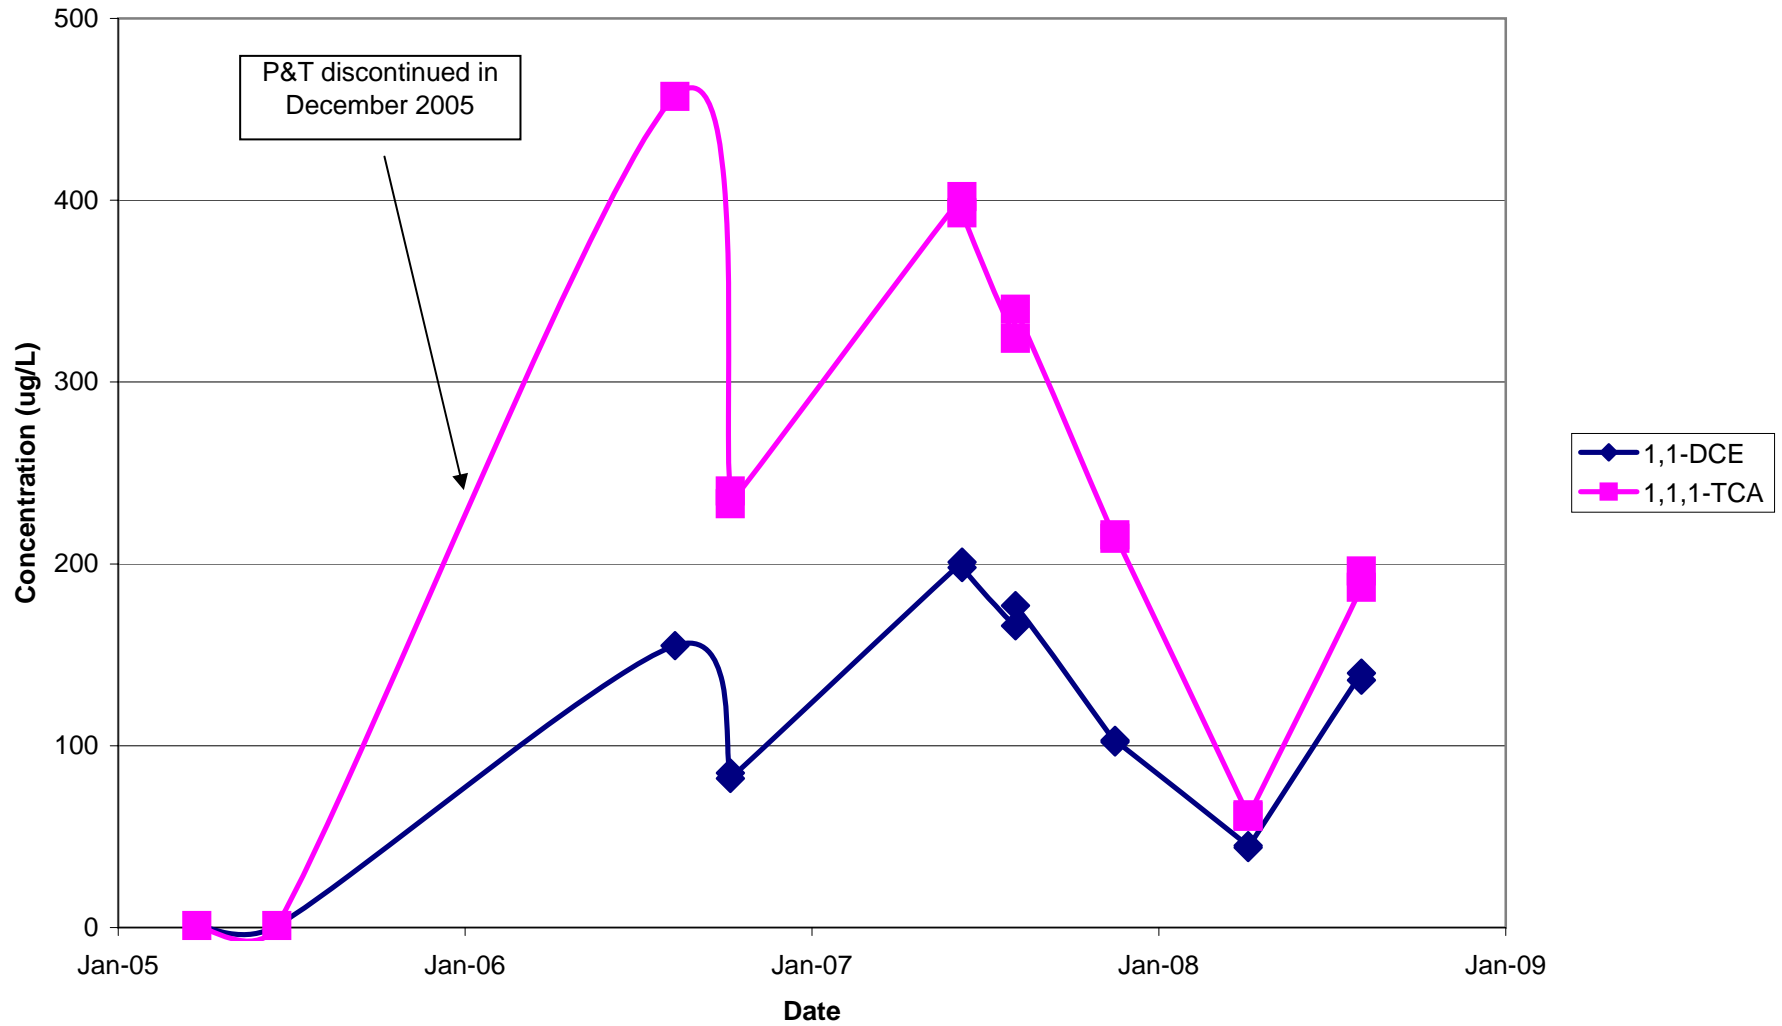
1,1,1-TCA and 1,1-DCE Concentration Trends at MW-3010

MW-3010 is located northeast of the source area and was installed in early 2005. Results from this well indicated low or undetectable concentrations of 1,1,1-TCA and 1,1-DCE during operation of the

P&T system and then a timely increase in concentrations after P&T was discontinued in December 2005. Concentrations continued to rise or remain elevated for approximately one year and then decreased through early 2008. An increase was again noted in mid-2008 in MW-3010, but it is unclear if this trend will continue, level off, or will decrease. The concentration trend at MW-3010 is similar to that of MW-7/MW-3008 since early 2005. Because of their proximity to the source area they are good indicators of the concentration levels migrating from the eastern portion of the source area. History suggests that concentration trends at these two wells react quickly to P&T from EW-13B if it is re-started. The currently observed concentrations may be representative of a new equilibrium based on reduced mass in the eastern portion of the source area.

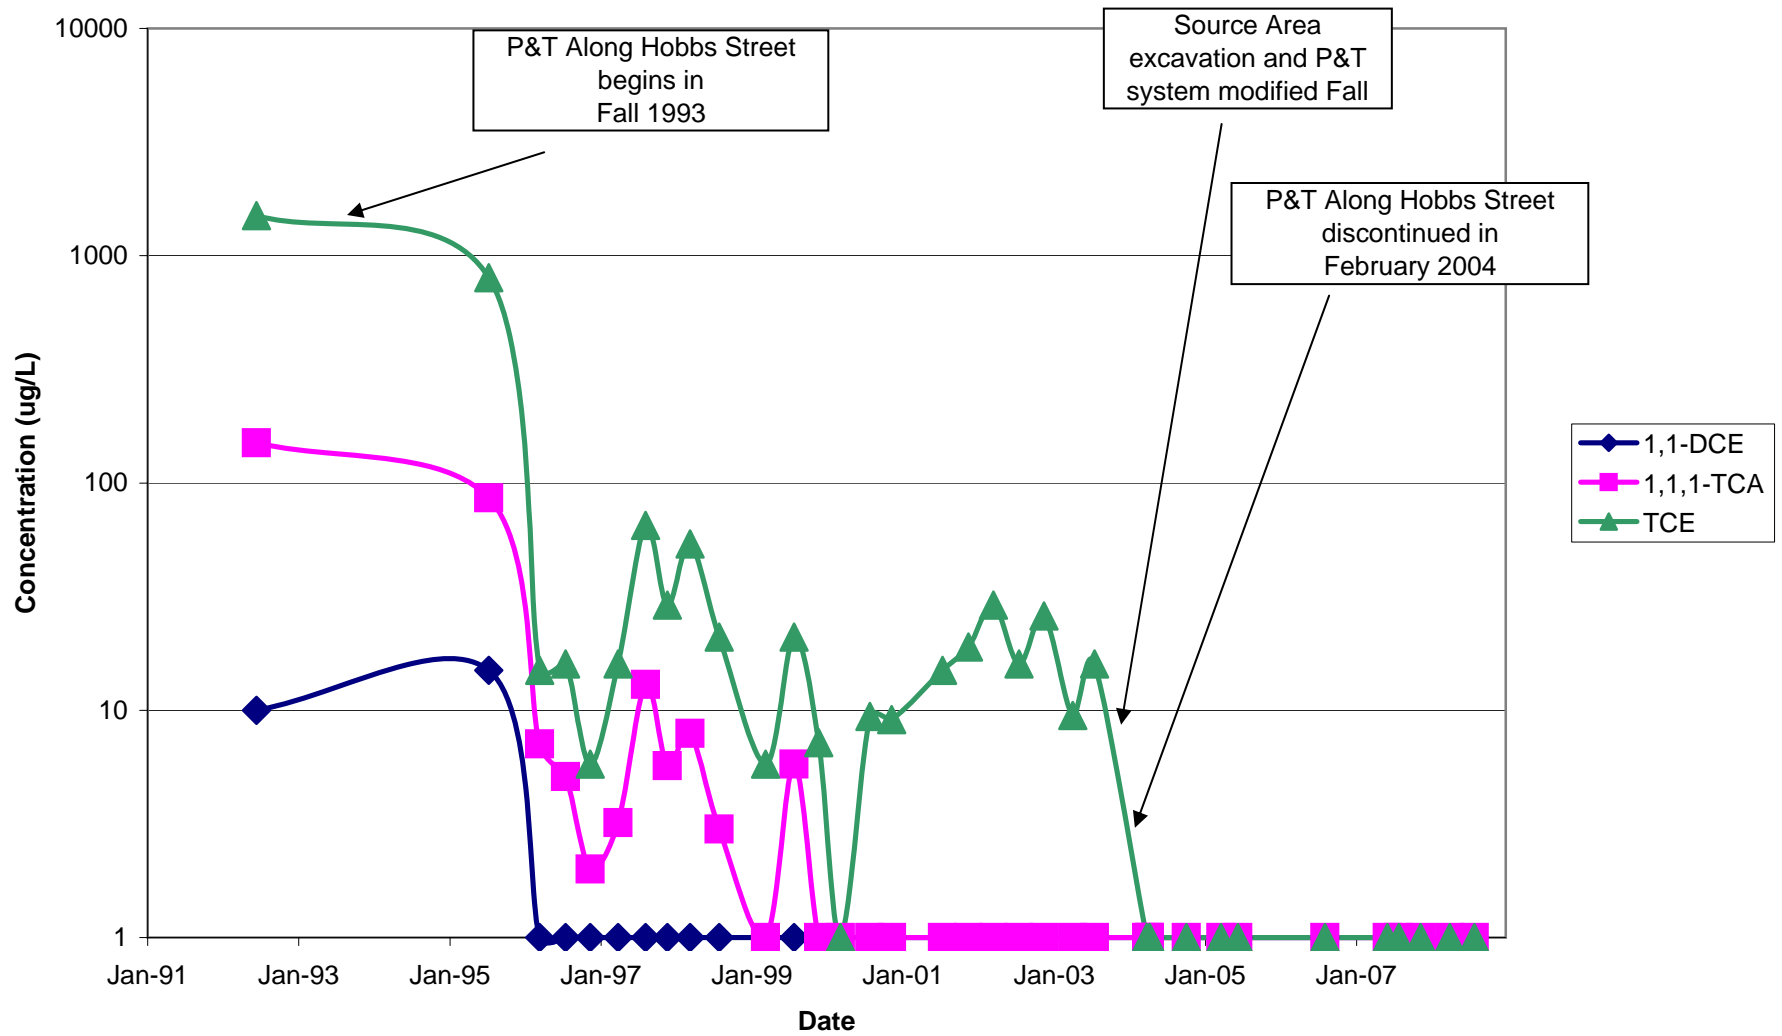
1,1,1-TCA and 1,1-DCE Concentration Trends at MW-211

MW-211 is one of the furthest points to the west and is screened from approximately 31 to 41 feet below ground surface. This location is unique in that it is the only location at the site where TCE concentrations exceeded the concentrations of 1,1,1-TCA and 1,1-DCE. The trends in the three contaminants are similar, so it is expected that they generally derived from the same location. TCE concentrations were approximately 1,500 ug/L in 1992 before P&T. When P&T began in 1993 TCE concentrations decreased to less than 65 ug/L. 1,1-DCE and 1,1,1-TCA had lower initial concentration in 1992 and decreased to undetectable concentrations in 1996 and 2000, respectively. TCE did not decrease to undetectable concentrations until April 2004, which was after P&T discontinued in the vicinity of MW-211 and also after source area excavation and P&T modification. It is noteworthy that all of the wells directly between the source area and this well had lower or undetectable concentrations of site contaminants than those observed at MW-211. It appears likely that impacted groundwater flow from the source area (which leaches to the bottom of the sand from the underlying silt) is controlled by the topography of the underlying silt layer and that the troughs in this silt layer direct impacted ground water flow north toward MWS-205, then west to MW-3003, and then either west toward MW-211 or northwest toward the MW-112/108 cluster (which also was historically impacted).

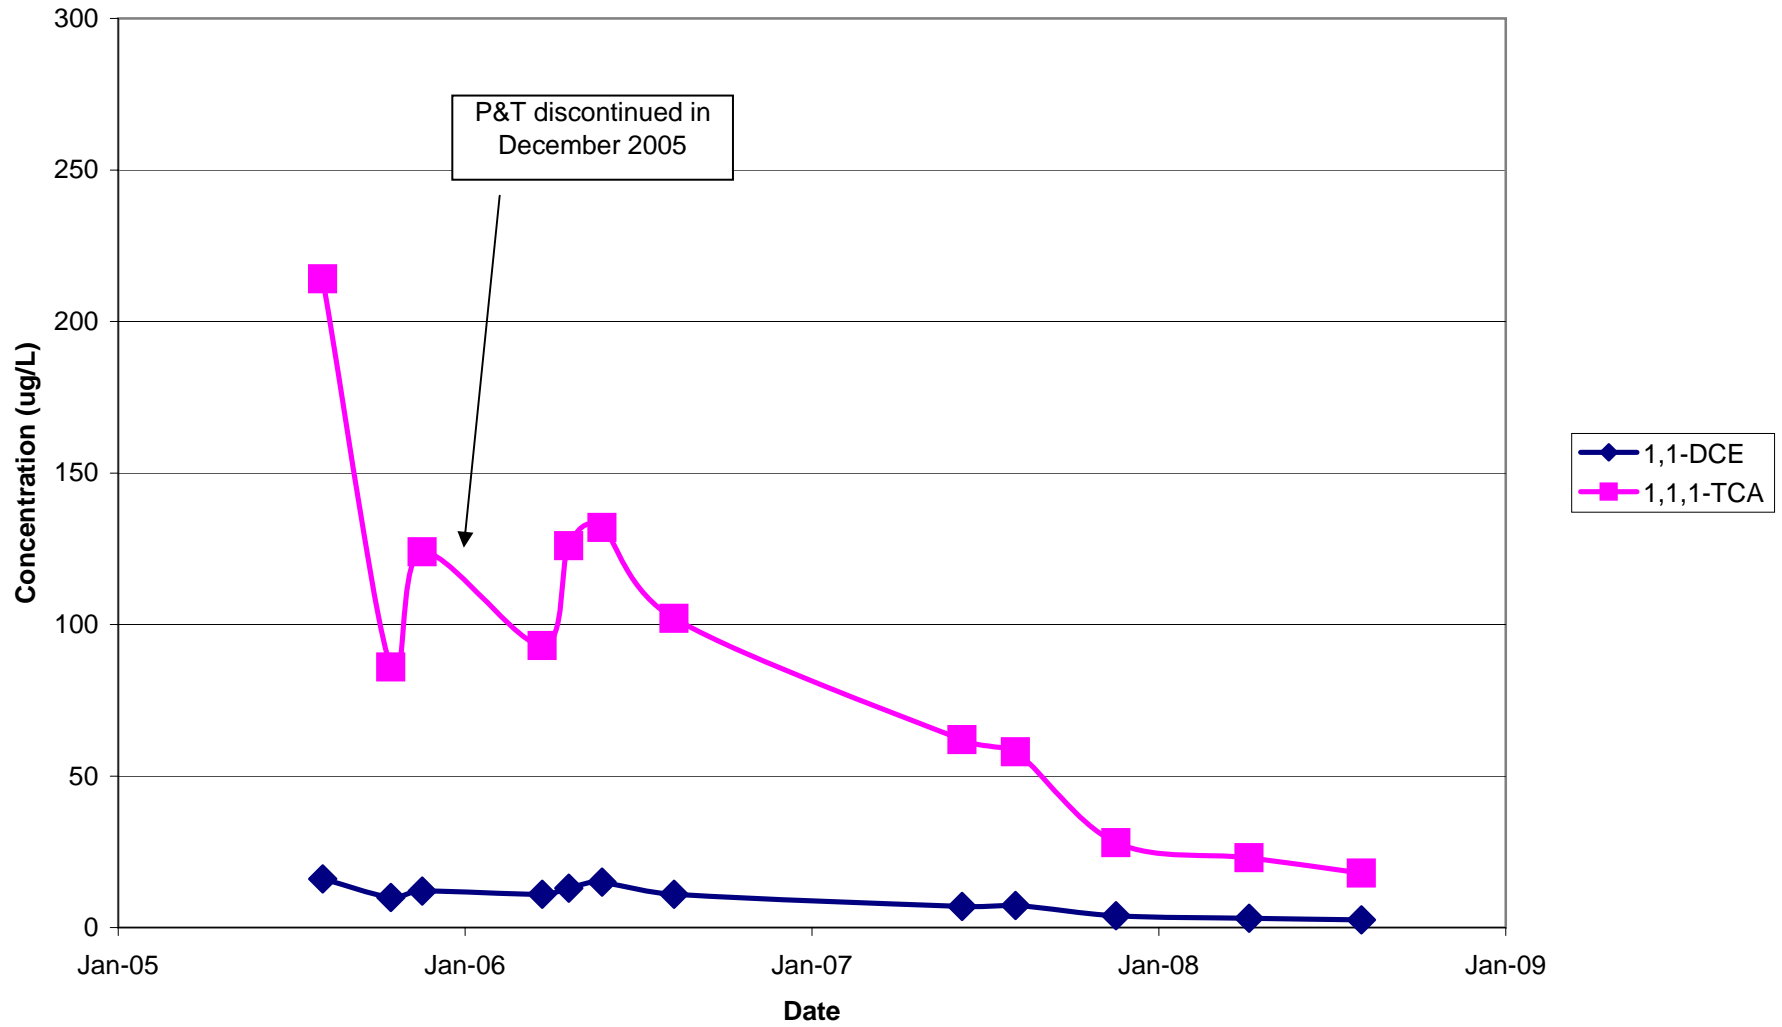
1,1,1-TCA and 1,1-DCE Concentration Trends at PZ-4002

MW-3003, PZ-4002, and MW-5003 are located north and west of the source area. MW-3003 is located approximately 150 feet northwest of EW-13B and is located in the area where the underlying silt is deep (approximately 50 feet below ground surface). PZ-4002 is located approximately 200 feet north of the source area and is located in the area where the underlying silt is shallow (approximately 11 feet below ground surface). MW-5003 is located approximately 300 feet northwest of EW-13B and is located in the area where the underlying silt is deep (approximately 50 feet below ground surface). Two predominant flows path from the source area appear to be to the north toward MW-205 and then continuing either to the north or to the west from MWS-205 to the three above-mentioned wells. Concentrations in MW-3003 have consistently risen since the discontinuation of P&T whereas concentrations at PZ-4002 have consistently decreased since the discontinuation of P&T. The sampling record at MW-5003 is too short to determine a relation to remediation efforts given that sampling began in June 2007 and concentrations have increased and then decreased. It is likely that contamination at MW-3003 (and points further downgradient) will reach a temporary high and then begin decreasing. MW-3003 appears to have been on the fringe or immediately beyond the capture zone associated with the enhanced P&T system in the source area and likely had stable or decreasing concentrations during pumping. In the absence of pumping it is reasonable that contamination previously within the capture zone can now migrate to MW-3003. Monitoring wells MW-3004, MW-3005, and MW-3006 (which are directly between the source area and MW-3003) are not impacted, but concentrations at MWS-205 appear to be significantly influenced by remedial activities. The concentration trends at MW-3003 may therefore follow those at MW-205 (with some delay to account for contaminant transport). The concentrations at MWS-205 originally increased due to enhanced P&T in the source area, which is perhaps a result of being located within the capture zone and contamination being “pulled back” from other parts of the plume. However, in the absence of pumping concentrations are declining, and as groundwater migrates from MWS-205 toward MW-
