# RYELAND ROAD ARSENIC SUPERFUND SITE

## Remediation with Ferns/Restoration/Wetland Creation

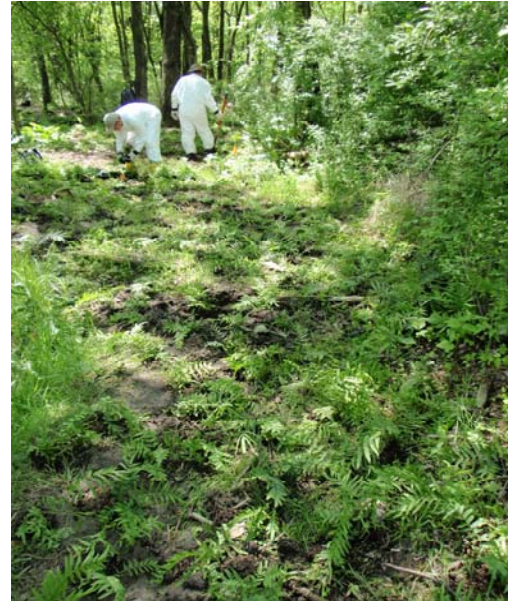
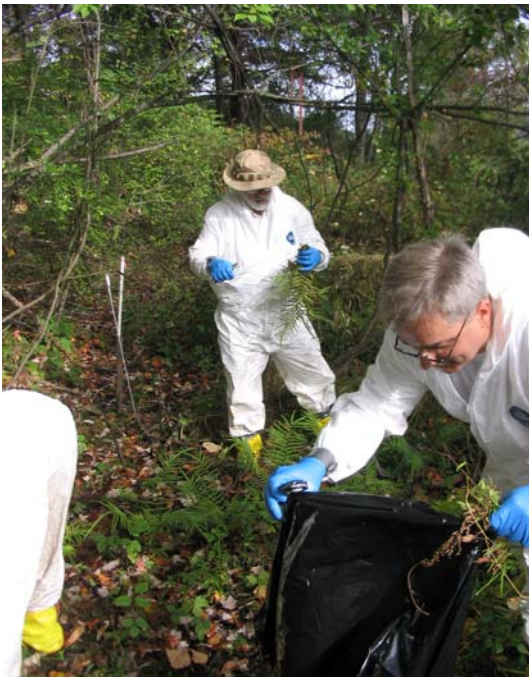
We planted 167 flats of potted ferns in the floodplain where groundwater seeps discharge to create the forested wetland. We targeted areas with high arsenic concentrations. The ferns were planted eight to twelve inches apart. Most of the areas are shaded by tree canopy. Shade cloth was erected over areas that receive too much sun for the ferns.

The ferns grew well in moist areas, but those planted directly in the springs and seeps died due to excess water. Ferns grew better under the shade cloth, primarily because it reduced the growth of other plants. Based on this observation, we intend to use shade cloth throughout the wetland where competition was a problem for the ferns.

The ferns grew until the first hard frost killed the fronds. The fronds were then harvested, analyzed for arsenic, and sent to an appropriate landfill. Wetland soil was retested to track the reduction in arsenic accomplished by the ferns. The fronds successfully extracted arsenic and the soil concentrations decreased. The planted areas were mulched with straw to overwinter as many ferns as possible. Any ferns that die will be replaced each spring. Once the soil and groundwater arsenic concentrations have declined to safe levels, the remaining ferns will be removed and the areas planted with shrubs and wildflowers native to the region's forested wetlands.

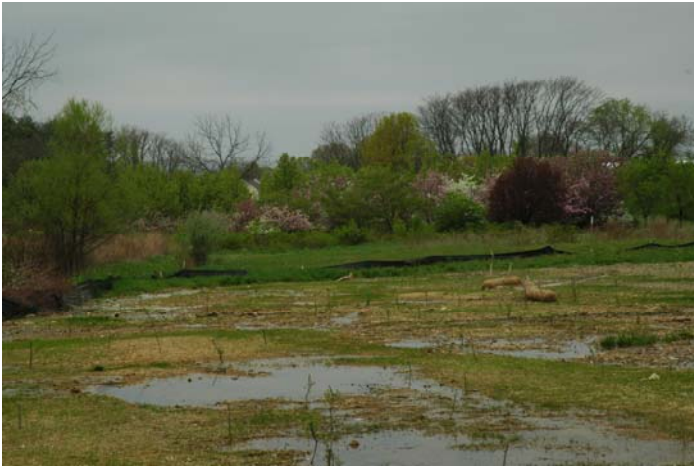
We seeded the former pond and excavation area with a native wet meadow mix in spring 2009. We also planted 600 native shrub stakes of seven species along the spring and within the wetland. We modified some of the channels to increase the dispersal of the spring water throughout the wetland.

In fall 2009, we observed many of the plants in the mix were flowering or producing seeds. The shrub success was highest along the spring and surrounding pooled

water. Despite being adapted to drier soils, numerous shrubs extending back from the pools did not survive. The shrubs are being browsed heavily by deer, so we may need to treat them until they become established. We will monitoring the wetland each growing season to make sure that enough plants survive to create good habitat.
