Green Remediation Focus

A Profile in Using Green Remediation Strategies

California Gulch Superfund Site
Leadville, Colorado

Update: July 2024

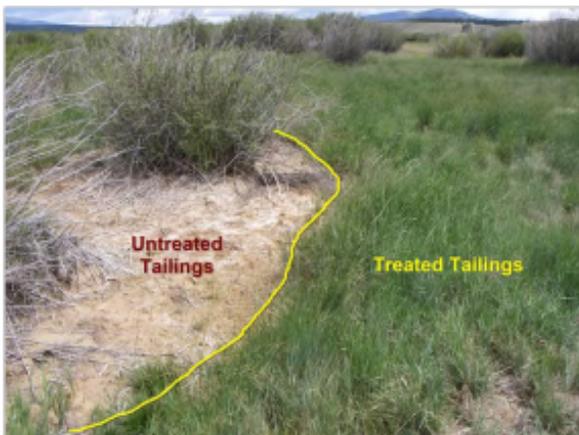
Early field work involved applying biosolids and conventional agricultural lime to a depth of 4-12 inches below ground surface.

- Conducted a field demonstration involving soil amendments containing conventional agricultural lime plus biosolids from a wastewater treatment plant; results were used to plan full-scale application of soil amendments containing organic-rich material with a longer lifespan

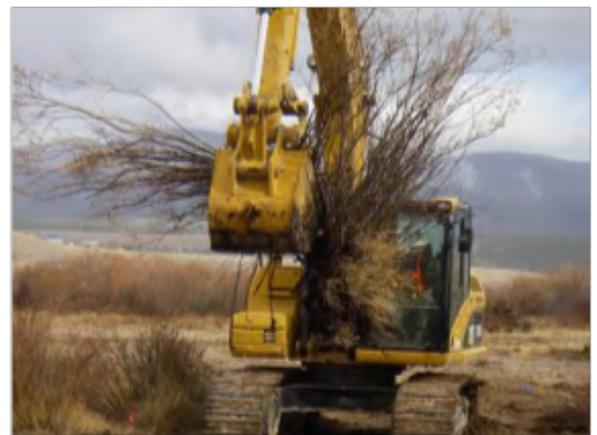
Healthy willows from distant parts of the floodplain were salvaged prior to full-scale application of soil amendments and transplanted along the river to help stabilize banks.

- Salvaged onsite timber and native plants from floodplain areas for use in bank stabilization prior to full-scale amendment operations
- Used sugar beet lime (obtained from a former sugar beet process plant undergoing cleanup as a brownfield) rather than conventional quarried lime to raise soil pH and increase microbiological activity in the soil, consequently fostering plant growth; when compared to applying conventional dry lime, application of the sugar beet lime resulted in less dust generation and greater ease of application due to its high (approximately 20%) moisture content

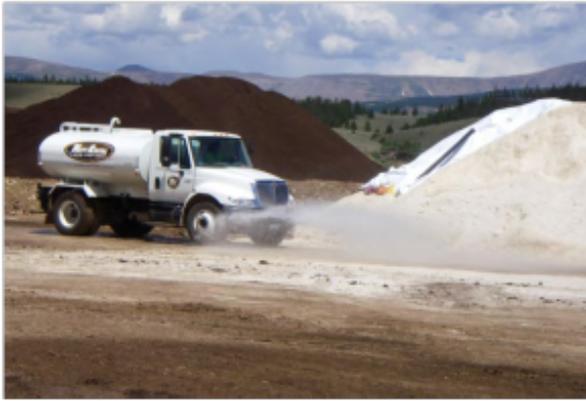
Approximately 7,000 tons of sugar beet lime was mixed into the soil prior to compost application. A precision hydraulic mixer was used to assure coverage along uneven boundaries and around large (up to 12-inch) rocks.

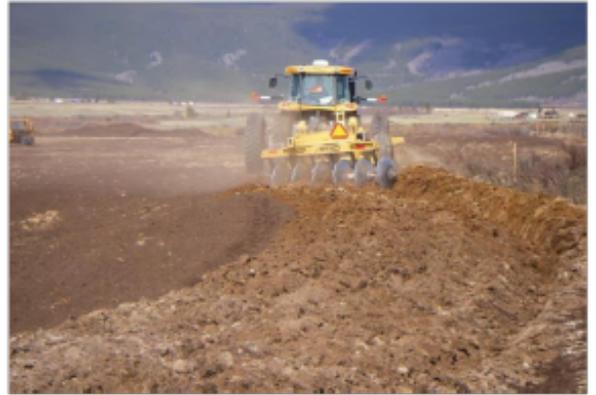
Approximately 14,000 tons (23,000 cubic yards) of compost were mixed directly into the upper soil.

- Performed full-scale organic amendment of the soil through use of compost consisting of livestock manure mixed with wood waste
- Mixed the amendments directly into soil on 153 acres of irrigated meadow through use of a tractor-pulled plow extending to the full depth of contamination (< 12 inches below ground surface) rather than through non-surgical excavation of soil for ex situ mixing

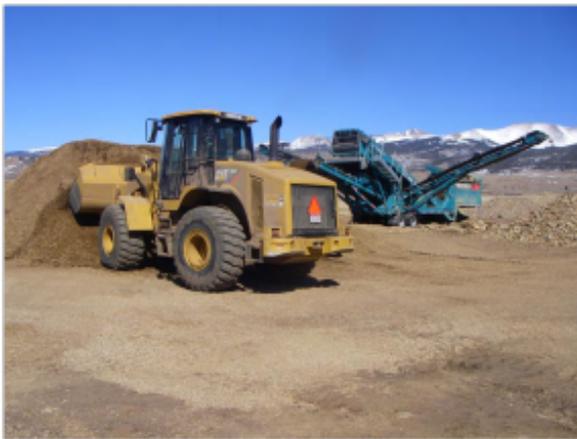
Rocks and soil were segregated for reuse in road construction and backfill.

- Used local borrow soil and rock, including large rocks segregated during in situ soil mixing, rather than imported materials for backfill as needed

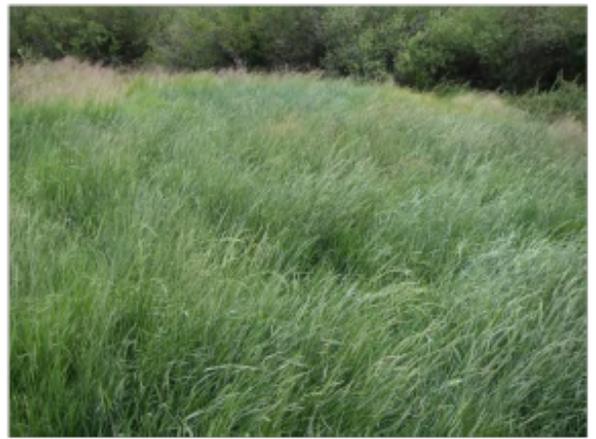
Vigorous grasses cover nearly all of the formerly denuded tailings area.

- Selected native species and non-invasive hardy grasses for re-seeding purposes throughout the soil amendment areas, which covered a total of approximately 170 acres

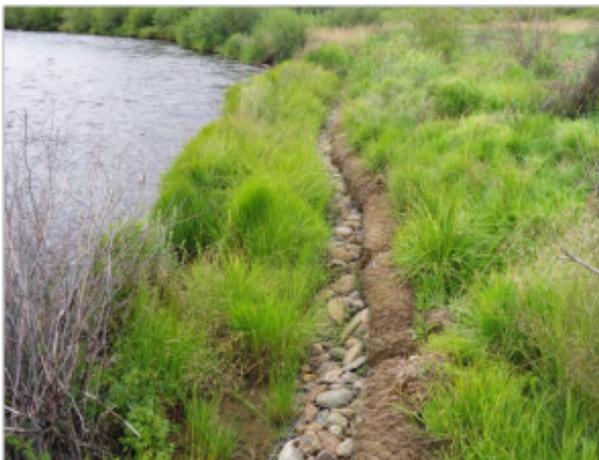
Two tiers of *Carex* spp. (*sedge*) and *Salix* spp. (*willow*) supported by bendway weirs now thrive in target areas along the Arkansas River; prior to 2009 soil treatment, the denuded areas stretched along approximately nine miles of the river.

- Installed bendway weirs (low-profile rock sills) and root wads to protect riverbanks and enhance fish habitat in selected locations, rather than constructing armored banks with riprap or gabion baskets more likely to alter the natural flow of water

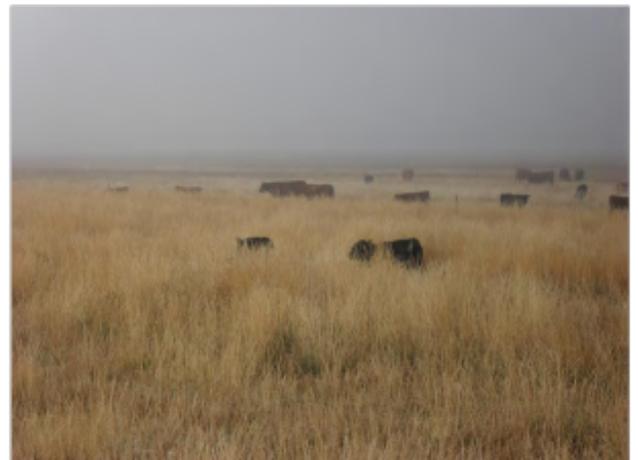
Nearly all onsite acreage formerly used for grazing has recovered, after more than 80 years of non-vegetated conditions due to past mining and ore processing.

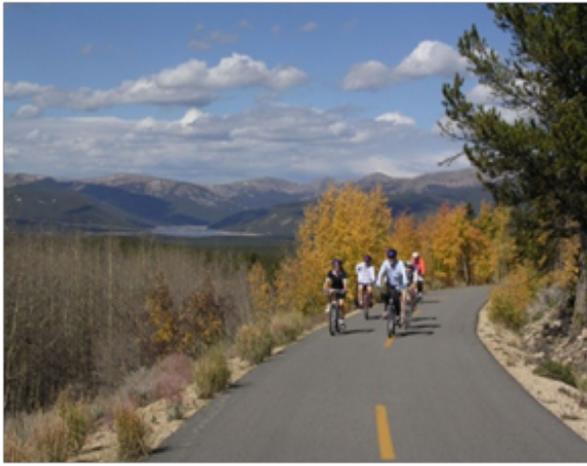
Formerly mine-scarred land of California Gulch now constitutes a portion of the Mineral Belt Trail, a 12.5-mile paved bike path looping around historic mining artifacts and through the city of Leadville. Colorado's State Trails Committee recently nominated the trail for National Recreational Trail status.

- Began evaluating other methods for material or waste reuse at other operable units. For example, slag-contaminated soil was consolidated into a platform running along the site's former rail and haul-road corridor (passing through operable units 3,4,6, and 9) to provide a base for soil capping; the platform was covered with a 6-inch-thick, 12-foot-wide layer of gravel followed by a 6-inch layer of asphalt that now serves as a recreational trail surface
