Green Remediation Focus

A Profile in Using Green Remediation Strategies

Upper Arkansas River
Leadville, Colorado

Cleanup Objectives: Address heavy metals contamination, including cadmium, copper, lead, manganese, and zinc, caused by past mining activities along an 11-mile stretch of the Upper Arkansas River.

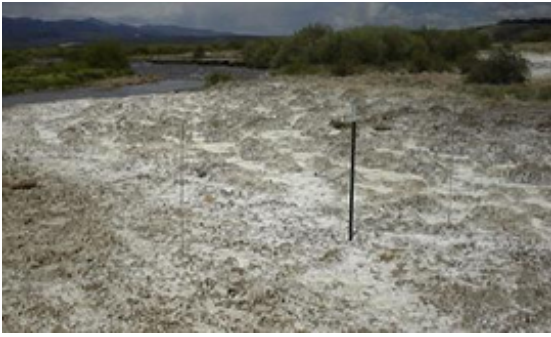
Due to the fluctuating water table and acidic conditions, Zn and Pb form soluble salts and wick to the surface of soil along the river during dry seasons. These conditions cause a metal salt crust to form on surface soil, with Zn concentrations as high as 90,000 mg/kg.

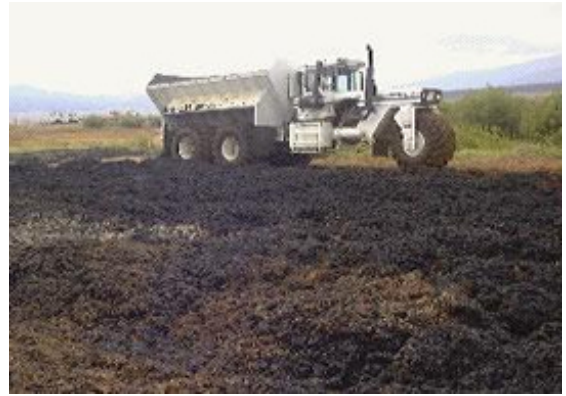
Biosolids from the Denver metropolitan area were applied at a rate of approximately 100 dry tons/acre and mixed with similar amounts of lime. Amendments were tilled into the soil to a depth of 12 inches.

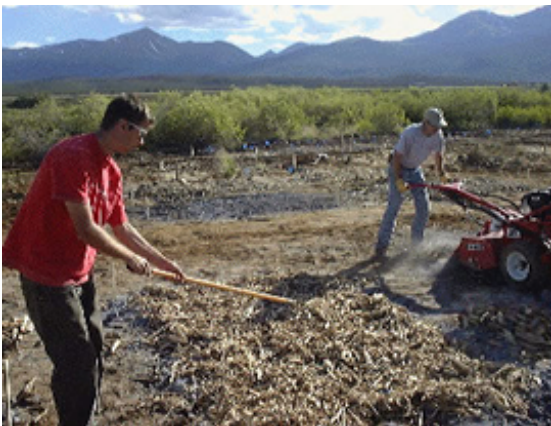
Varying amounts of woody material were mixed with the biosolids to achieve soil amendments favoring different native plant communities.

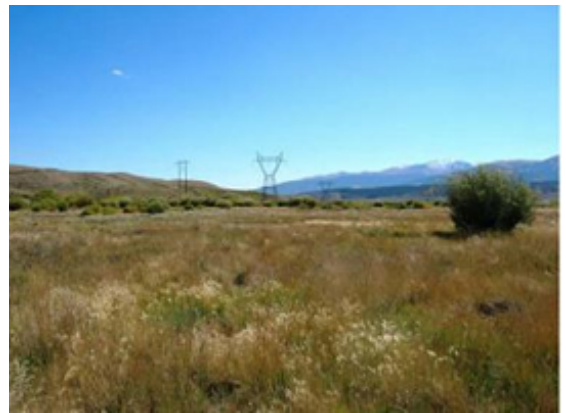
October 2008 site visits showed healthy revegetation throughout soil amended areas.

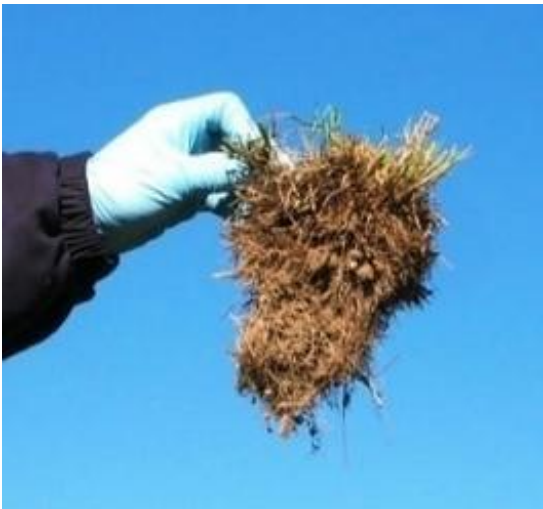
Following 10 years of growth, grasses installed in amended soil demonstrated a large root mass.

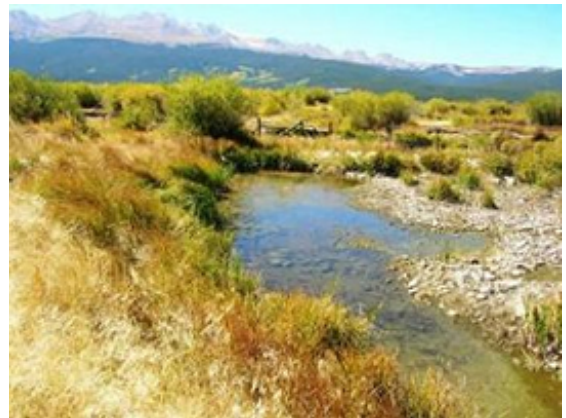
Most biosolids/lime amended stream sides now exhibit 100% vegetative cover.
