# Green Remediation Focus

## A Profile in Using Green Remediation Strategies

**Upper Arkansas River**  
Leadville, CO

**Superfund Removal**

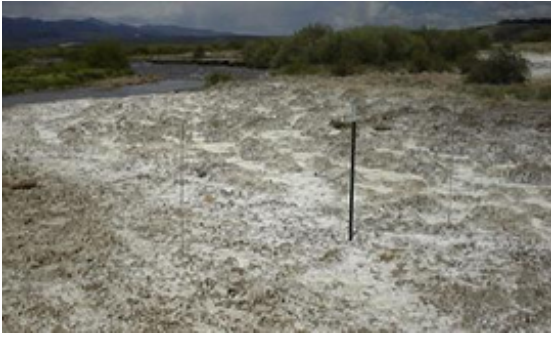
*Due to the fluctuating water table and acidic conditions, Zn and Pb form soluble salts and wick to the surface of soil along the river during dry seasons. These conditions cause a metal salt crust to form on surface soil, with Zn concentrations as high as 90,000 mg/kg.*

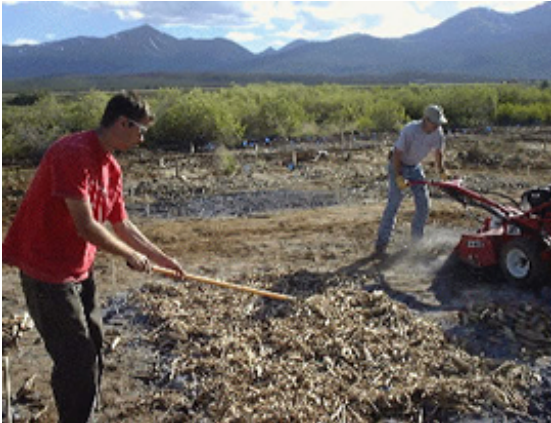
*Varying amounts of woody material were mixed with the biosolids to achieve soil amendments favoring different native plant communities.*

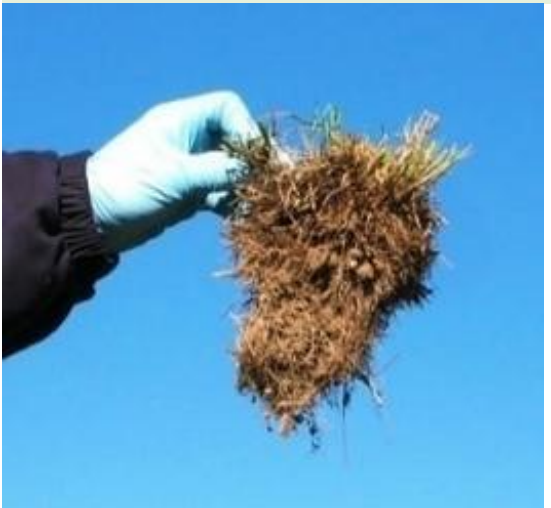
*Following 10 years of growth, grasses installed in amended soil demonstrated a large root mass.*

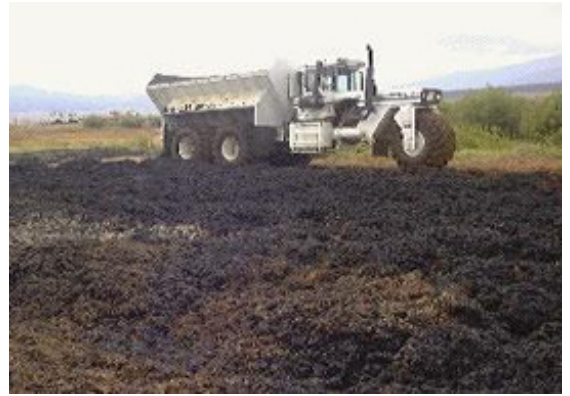
*Biosolids from the Denver metropolitan area were applied at a rate of approximately 100 dry tons/acre and mixed with similar amounts of lime. Amendments were tilled into the soil to a depth of 12 inches.*

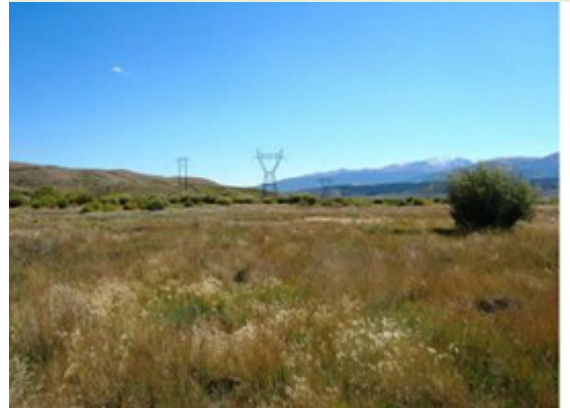
*October 2008 site visits showed healthy revegetation throughout soil amended areas.*

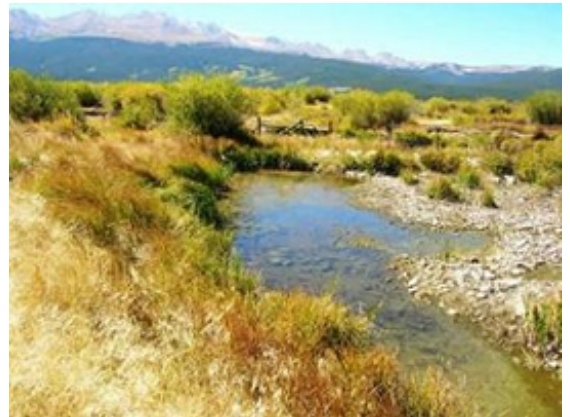
*Most biosolids/lime amended stream sides now exhibit 100% vegetative cover.*
