Bunker Hill Mining and Metallurgical Complex, Idaho, Superfund Case Study

Revitalization of the Bunker Hill Hillsides and Wetlands

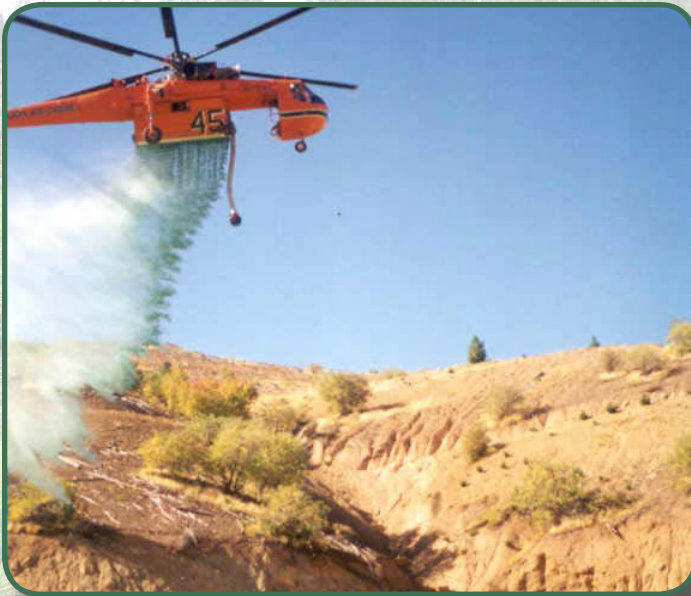
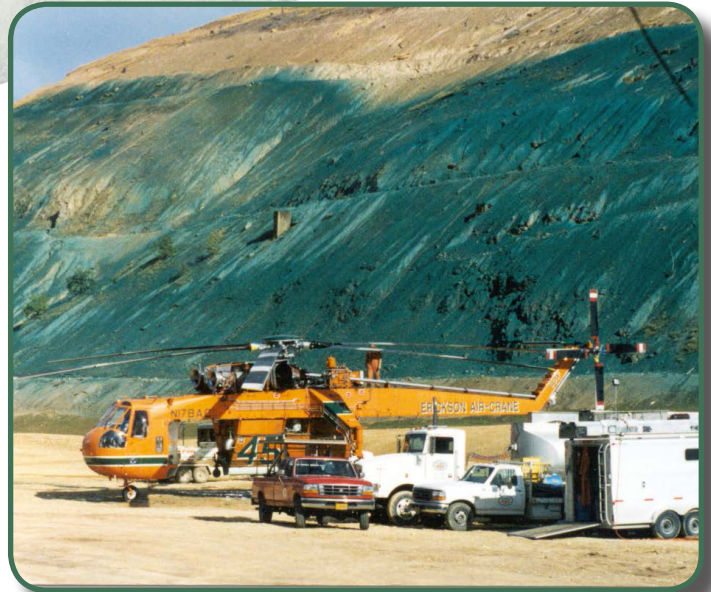
Hillsides aerial hydroseeding ~1998

- Sikorsky S-64 air crane helicopters were used for aerial hydroseeding and liming.
- Soil amendments were applied to 371 acres in 2000 and 132 acres in 2001, followed by tree/shrub planting. The 2001 work represented the final, large-scale revegetation operation on the hillsides.

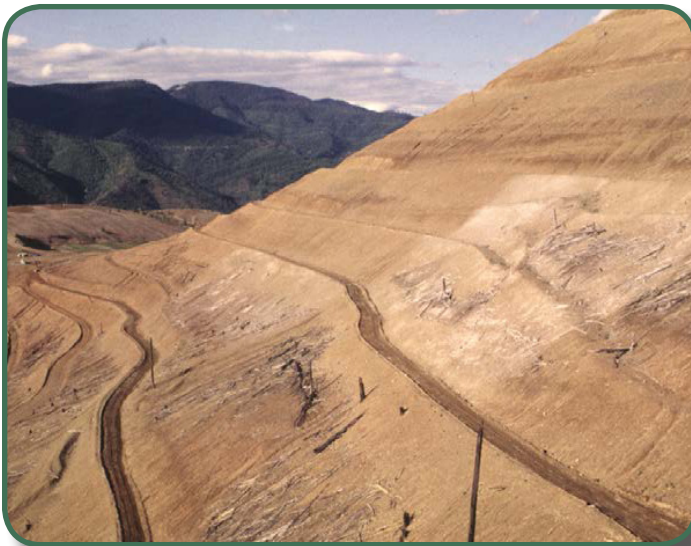
Hillsides 1993

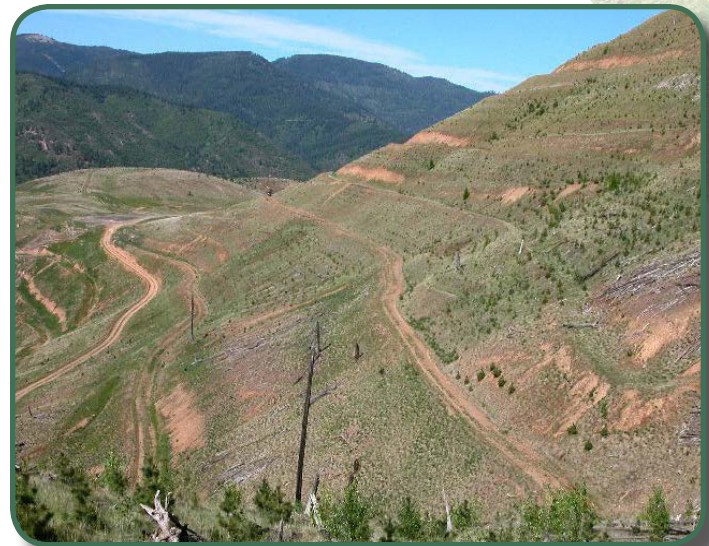
Hillsides 2003

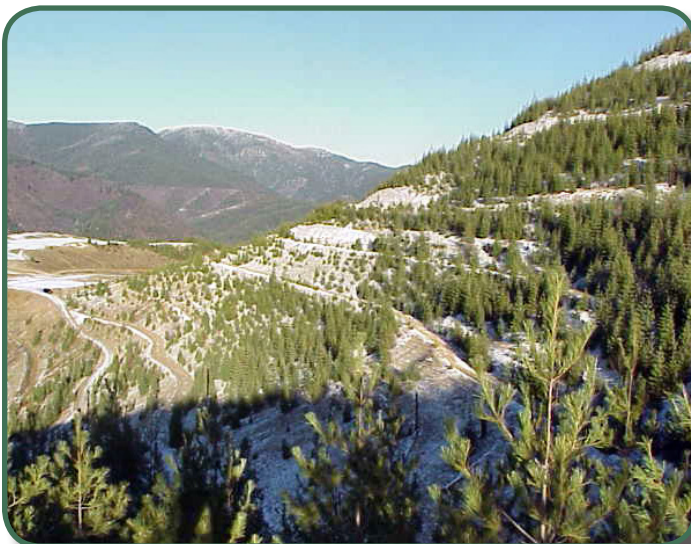
Hillsides 2014

- As of 2014, vegetation had been fully established at all but a few isolated rocky sites.
- Using native herbaceous plants, such as penstemon, and trees, such as woods rose, at this site helped create an attractive habitat for wildlife and pollinators.

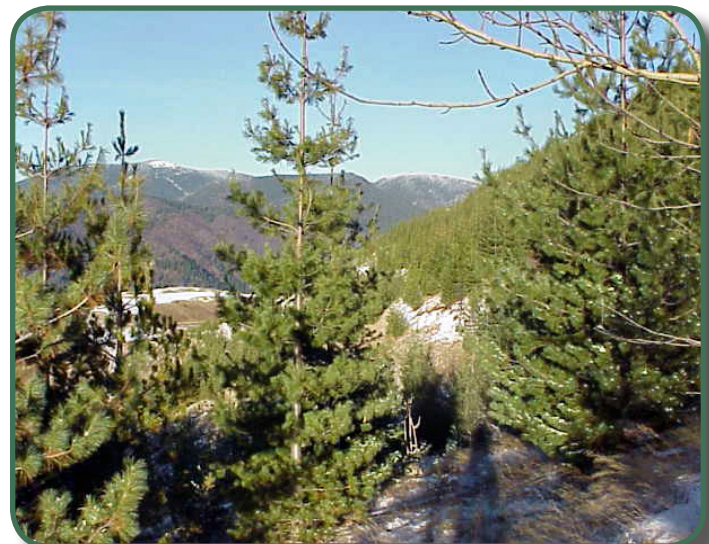
2014 Hillside vegetation growth
