# Role of Modeling in the Remediation of the WP14/LF15 Chlorinated Solvent Plume at Dover Air Force Base, Delaware

2019 Federal Remediation Technologies Round Table | May 22 | Reston, Virginia

Presented By:  
**Scott Morgan, PG**  
 AECOM, Newark, DE, USA

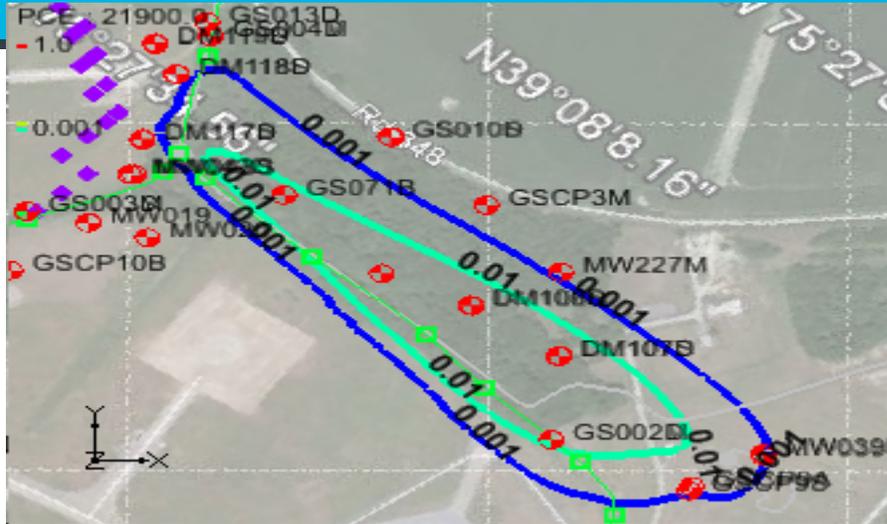
# Simulated PCE Plume Assuming no Source Area

T = Present (1994), source removed

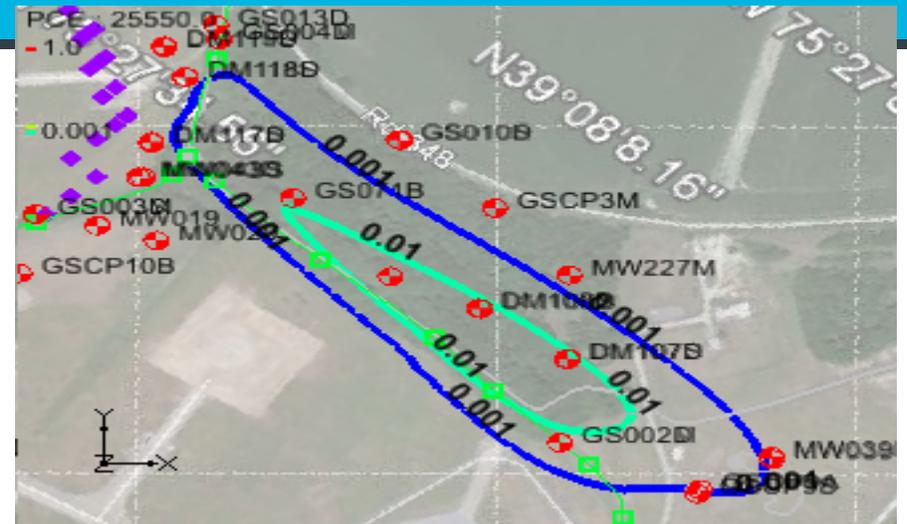
T = Source removed + 10 years

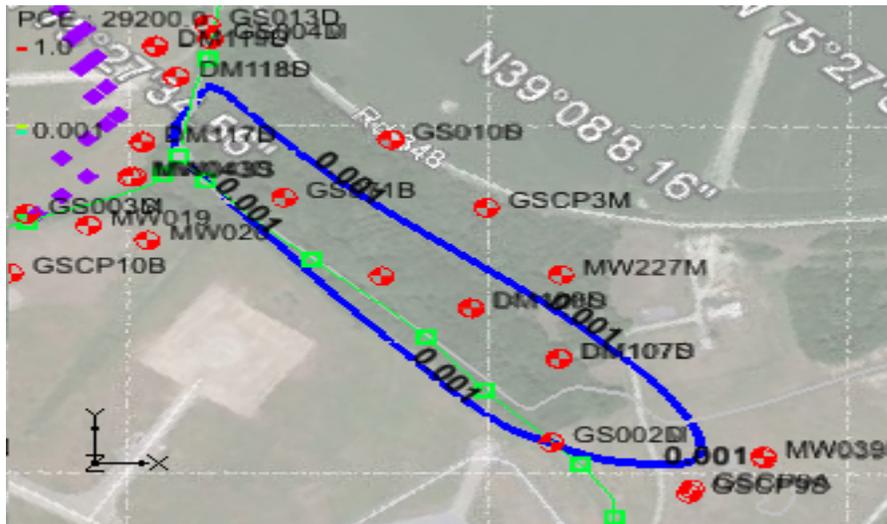
T = Source removed + 20 years

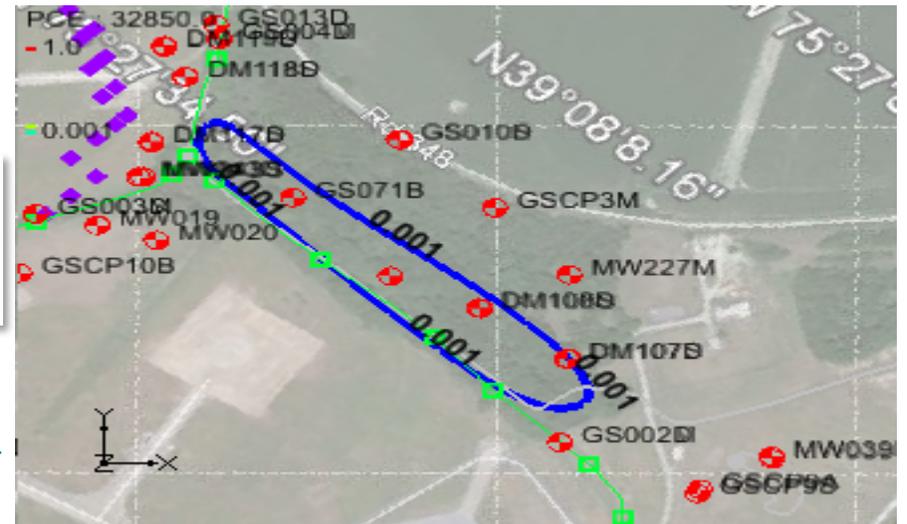
T = Source removed + 30 years

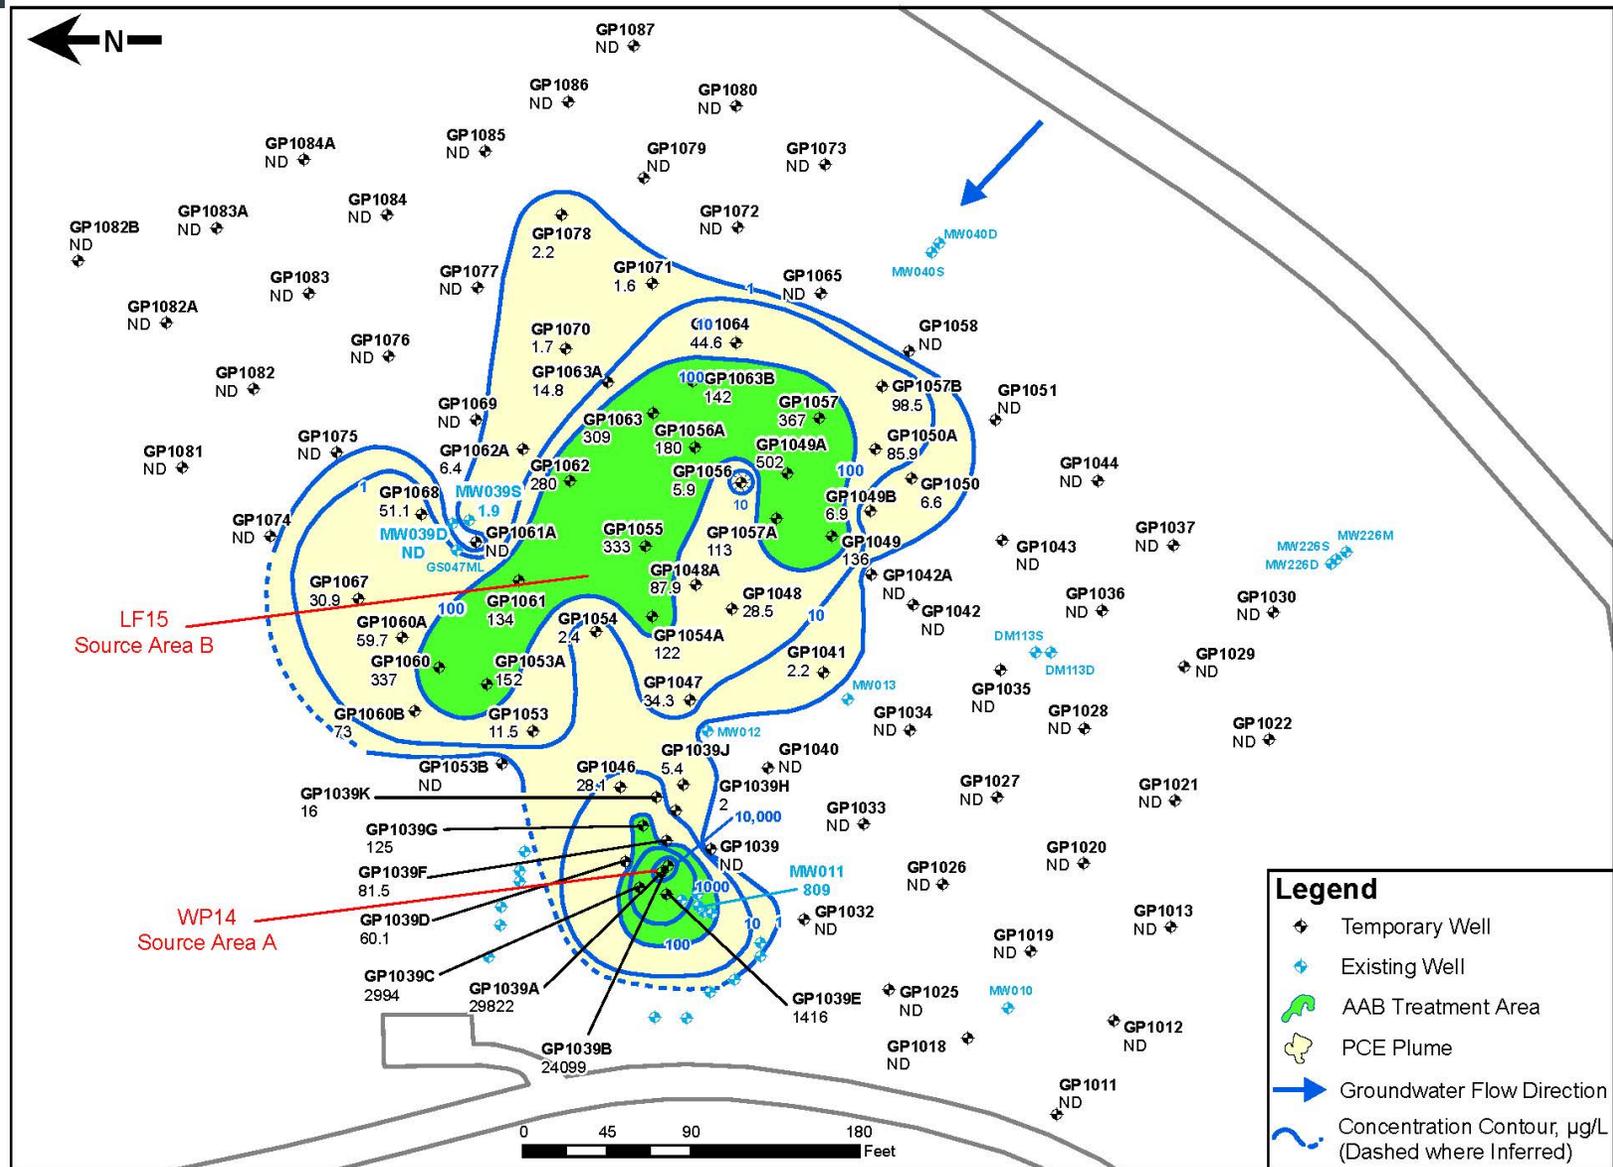
# Source Delineation and Treatment

- 77 locations across WP14 and LF15
- Evidence of previously unknown source material
- Highest PCE Concentration = 29,822 µg/L
- Carbon injections in AAB treatment area in 2015

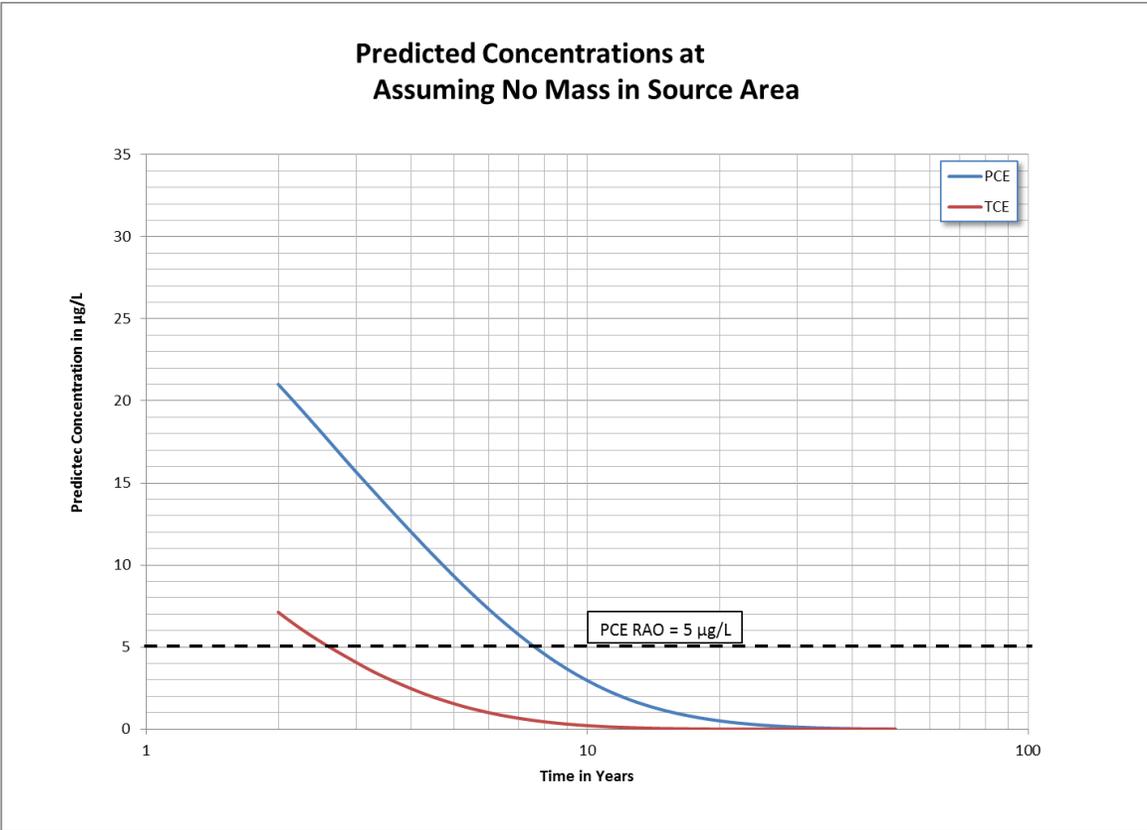
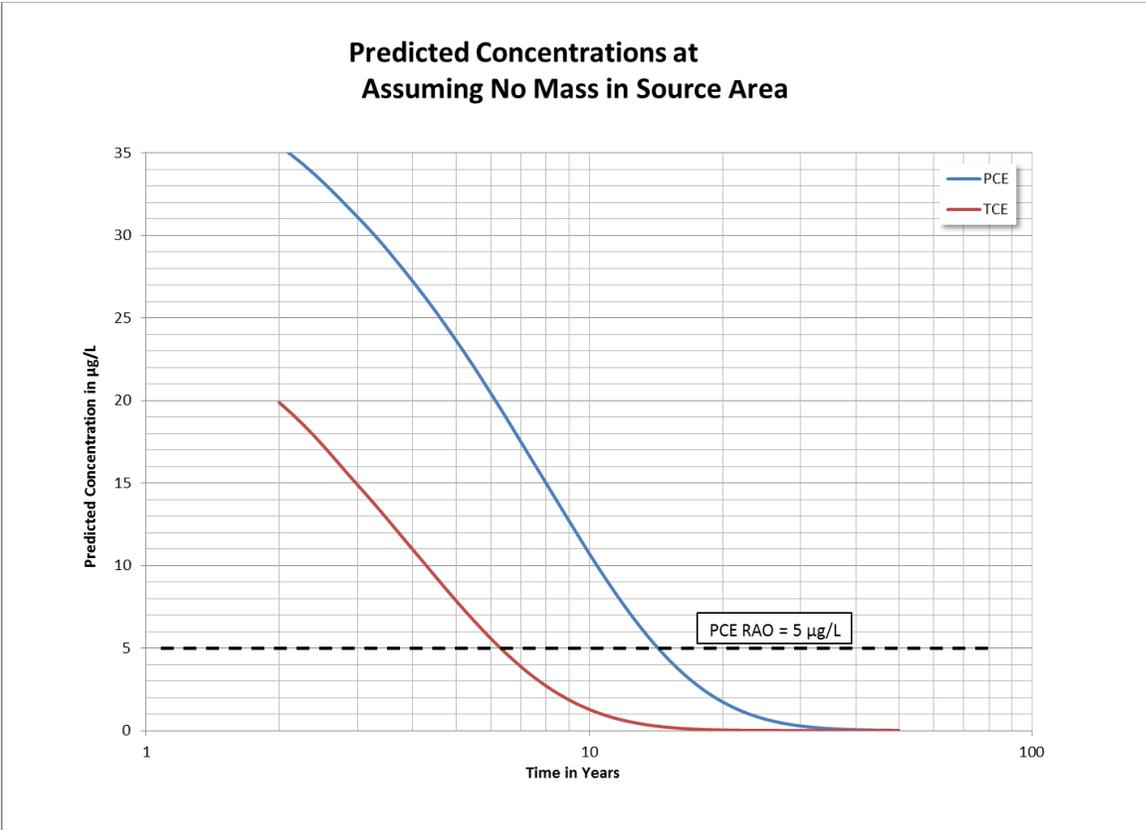
# Updated Simulated Concentrations over Time

Simulated concentrations drop below RAOs in approximately 15 to 20 years

- Graphical trend analysis has been used for plume monitoring since 2003.
- More robust numerical modeling was performed, starting in 2013, to provide information on the fate and transport of COCs and time to reach RAOs.
- Site data were used to calculate site-specific degradation rates. Degradation rates were refined through iterative model runs to best fit observed constituent distributions using both reactive (RT3D) and non-reactive (MT3DMS) model codes.
- At WP14/LF15, graphs of COC trends in source area wells were used to predict when source area concentrations would fall below RAOs.
- Model runs with calibrated parameters and assuming no continuing source were used to estimate when the dissolved plume areas would fall below RAOs.
- Modeling indicated that total time to reach RAOs 20+ years after source area is remediated (about 15 years estimated from trend charts).
