FINAL REPORT

Analysis of Long-Term Performance of Zero-Valent Iron Applications

ESTCP Project ER-201589

DECEMBER 2018

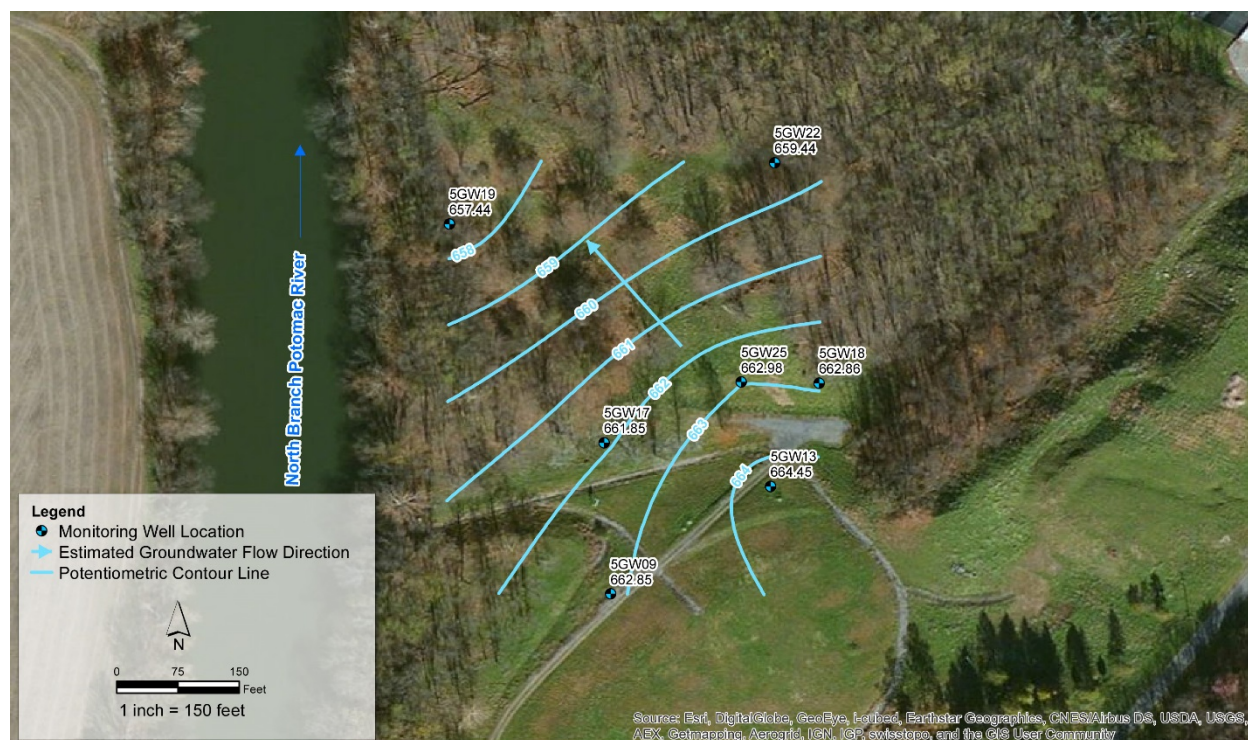
Figure 4-2. ABL Site 5 Groundwater Contour Map (August 2012)

Site 5 is located on a terrace above the North Branch Potomac River. The Site 5 topography gently slopes toward the North Branch Potomac River, then becomes steeper immediately adjacent to the river. Site 5 is underlain by unconsolidated alluvial deposits of fill, silty clay, and clayey gravel (alluvium) and predominantly shale bedrock. The depth to bedrock at Site 5 is approximately 15 to 20 feet below ground surface (bgs). Depth to shallow groundwater is between 1 to 12 feet bgs. Shallow (alluvial) groundwater flow is northwestward, subparallel to the river (**Figure 4-2**). Alluvial groundwater velocity downgradient of the landfill was estimated to be 0.81 foot per day, or 293 feet per year. Groundwater level data in the vicinity of the wall collected as part of this investigation is summarized in Section 5.

The groundwater potentiometric surface observed during this study was slightly inconsistent with the historic groundwater potentiometric surface gradient direction (**Figure 4-2**). This variation in flow direction is not believed to impact current remedy effectiveness, as concentrations are very low cross-gradient on the west side of the wall where migration potential around the wall is most likely (see **Section 5.4.3**). There was no mounding observed behind the wall that would indicate plugging due to excessive mineralization of the iron.

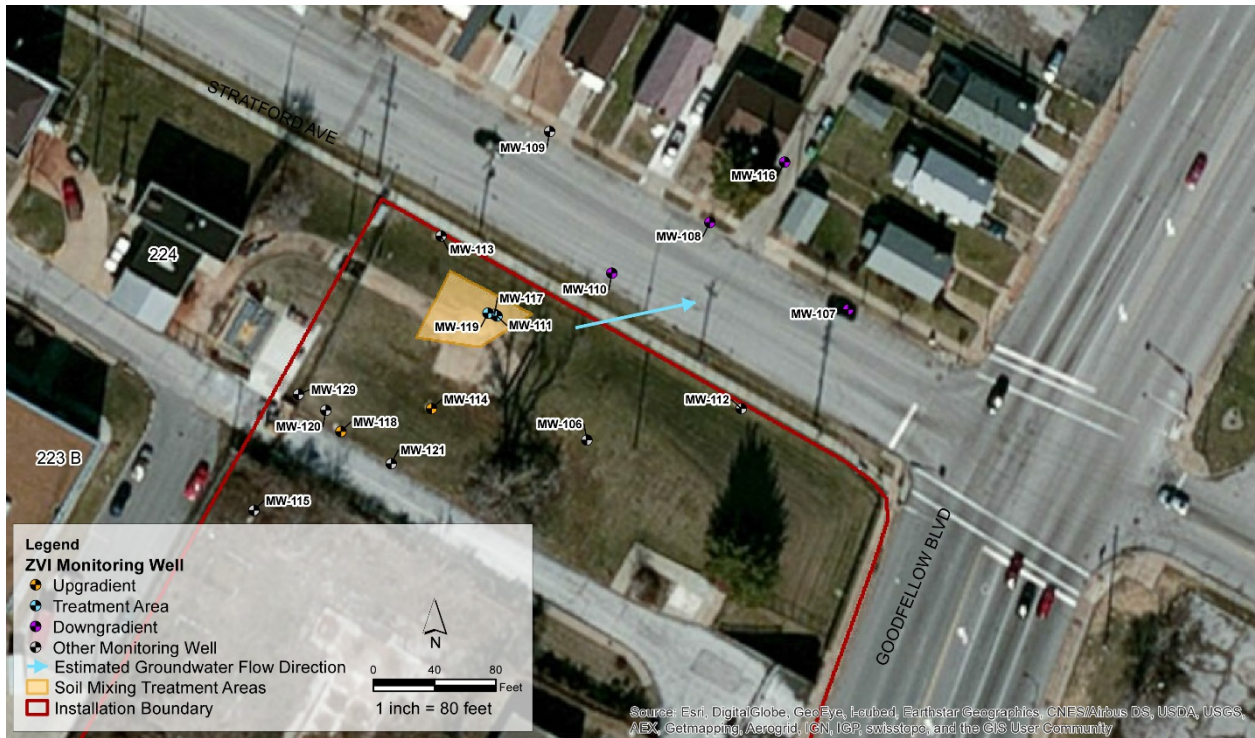
Figure 4-8. Former St. Louis Ordnance Plant OU1 Treatment Area and Wells

In March 2012, soil mixing was performed to reduce PCE concentrations in groundwater below the active treatment remediation goal of 21,000 µg/L. ZVI soil mixing occurred over an area of 1,491 square feet to an average depth of 25 feet, for a total treatment volume of 1,383 cubic yards of soil. The treatment depth was based on the depth to the weathered shale bedrock. To mix the soil, ZVI was placed directly into an open borehole advanced to the depth of each column. The column was then mixed using an auger 5 feet in diameter.

An estimated 659 pounds of contaminant mass were present in the subsurface within the treatment area: 23 pounds dissolved in groundwater and 636 pounds adsorbed to soil. The mass of contaminants dissolved in groundwater and adsorbed to the soil was estimated based on various site assumptions including estimated porosity (0.25), soil density (1.5 tons per cubic yard), average concentrations of PCE detected in soil (169 milligrams per kilogram, and maximum concentrations of PCE in groundwater (43,300 µg/L). Based on those calculations and a factor of safety of 25, a minimum ZVI dosage of 0.6 percent by mass was determined to be needed to effectively treat PCE in groundwater and adsorbed to soil. A remediation dosage of 1 percent ZVI, by mass of soil, was used. Twenty-two tons of ZVI were incorporated into 1,383 cubic yards of soil. Five hundred pounds of ZVI was introduced into each of 88 soil mixing columns (**Figure 4-8**) to distribute the ZVI evenly throughout the treatment area. Soil mixing was conducted without adding water (CH2M, 2012).

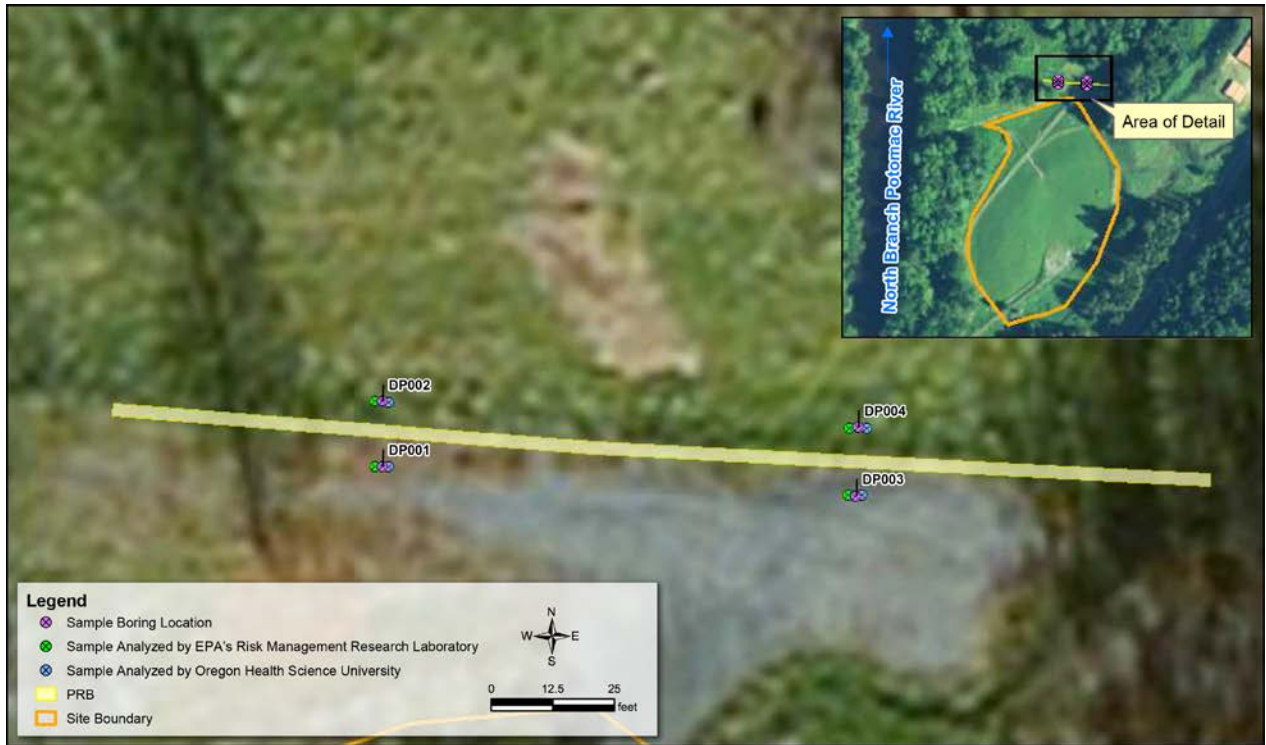
Figure 5-1. DPT Boring Locations, ABL Site 5

Profile samples of ZVI across the PRB at ABL were collected using direct push technology (DPT) drilling technology in locations shown on **Figure 5-1**. Pilot holes were installed prior to completion of cores collected for laboratory analysis to allow for logging of the ZVI contact with the native soil. Cores were collected by beginning at the ground surface and advancing the 2-inch-diameter DPT drive point diagonally into the wall. All points were completed with the boring started 5 feet from the center line of the wall. Drilling methods were adjusted to ensure the wall interface was encountered at a 67-degree angle as shown on **Figure 5-2**. The angle at which the core barrel was positioned relative to the ground was measured frequently during drilling. Because of some shifting of the angle during coring, adjustments were made in some cases to begin the core at an angle of up to 70 degrees to achieve the desired 67 degrees at depth. Once a pilot hole was installed and logged, two additional borings were completed within 1 to 2 feet of the pilot hole parallel to the wall for the purpose of collecting cores for laboratory analysis (**Figure 5-1**). The depth on the diagonal at which the iron was encountered varied from one core to the next, even when cores were only a foot or two away from one another and approached the wall at the same angle, indicating possible inconsistencies in the wall thickness. Depths on the diagonal at which iron was encountered in each core and soil descriptions are included in **Table 5-1**.

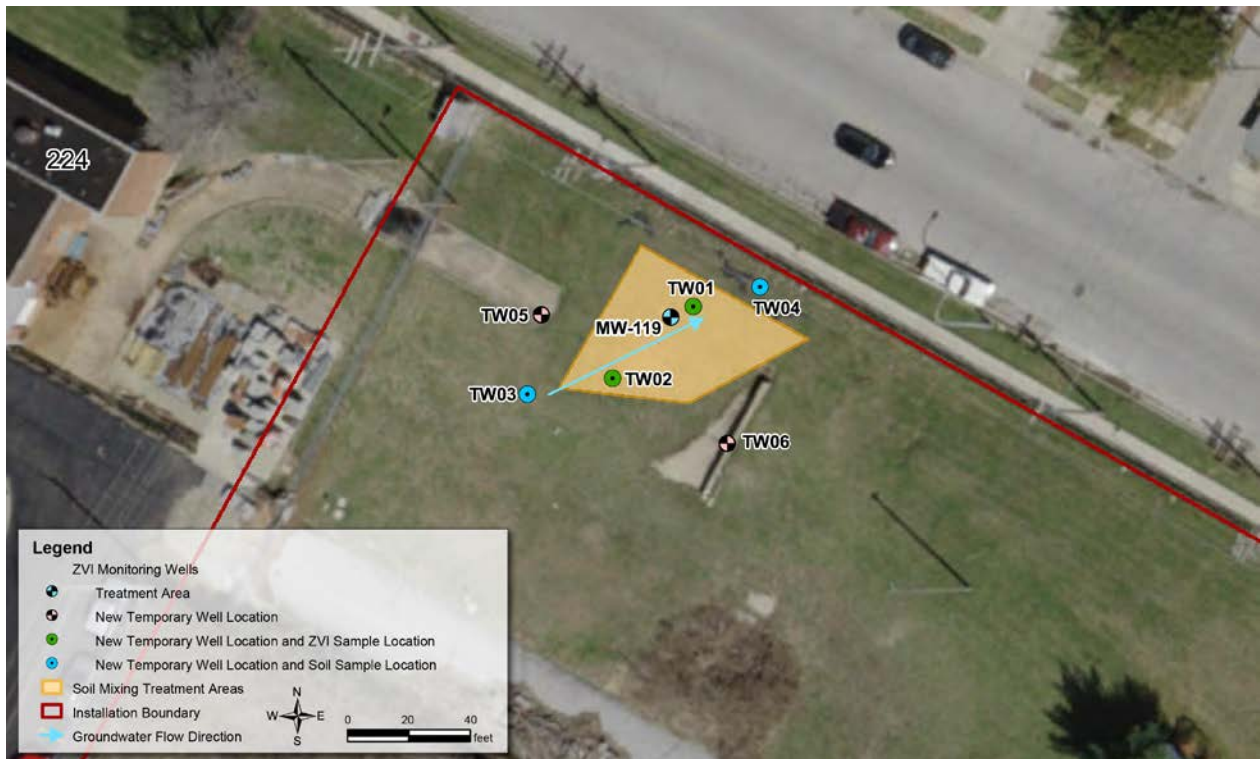
Figure 5-3. Sample Locations, Former St. Louis Ordnance Plant OU1 Site

DPT soil/ZVI cores were also collected within the ZVI soil mixing area at the former St. Louis Ordnance Plant in locations shown on **Figure 5-3**. Soils were collected from acetate sleeves and were visually inspected to evaluate lithology. Field notes are included in **Appendix B**. Boring logs are included in **Appendix C**. Cores for laboratory analysis were collected from 16 to 20 feet bgs, consistent with the depth of the middle to lower portion of the mixing zone (which extends from the water table at approximately 5 feet bgs to 25 feet bgs). Cores were collected at one upgradient, one downgradient, and two soil mixing locations. Duplicates were collected within

Six new monitoring wells were installed following collection of ZVI and soil cores at former St. Louis Ordnance Plant OU1. Wells were installed in the locations of the ZVI cores (one upgradient of the mixing area, one downgradient of the mixing area, and two within the mixing area) as well as in two locations cross-gradient of flow along the east and west sides of the mixing area as shown on **Figure 5-3**. Wells were installed using hollow-stem auger drilling

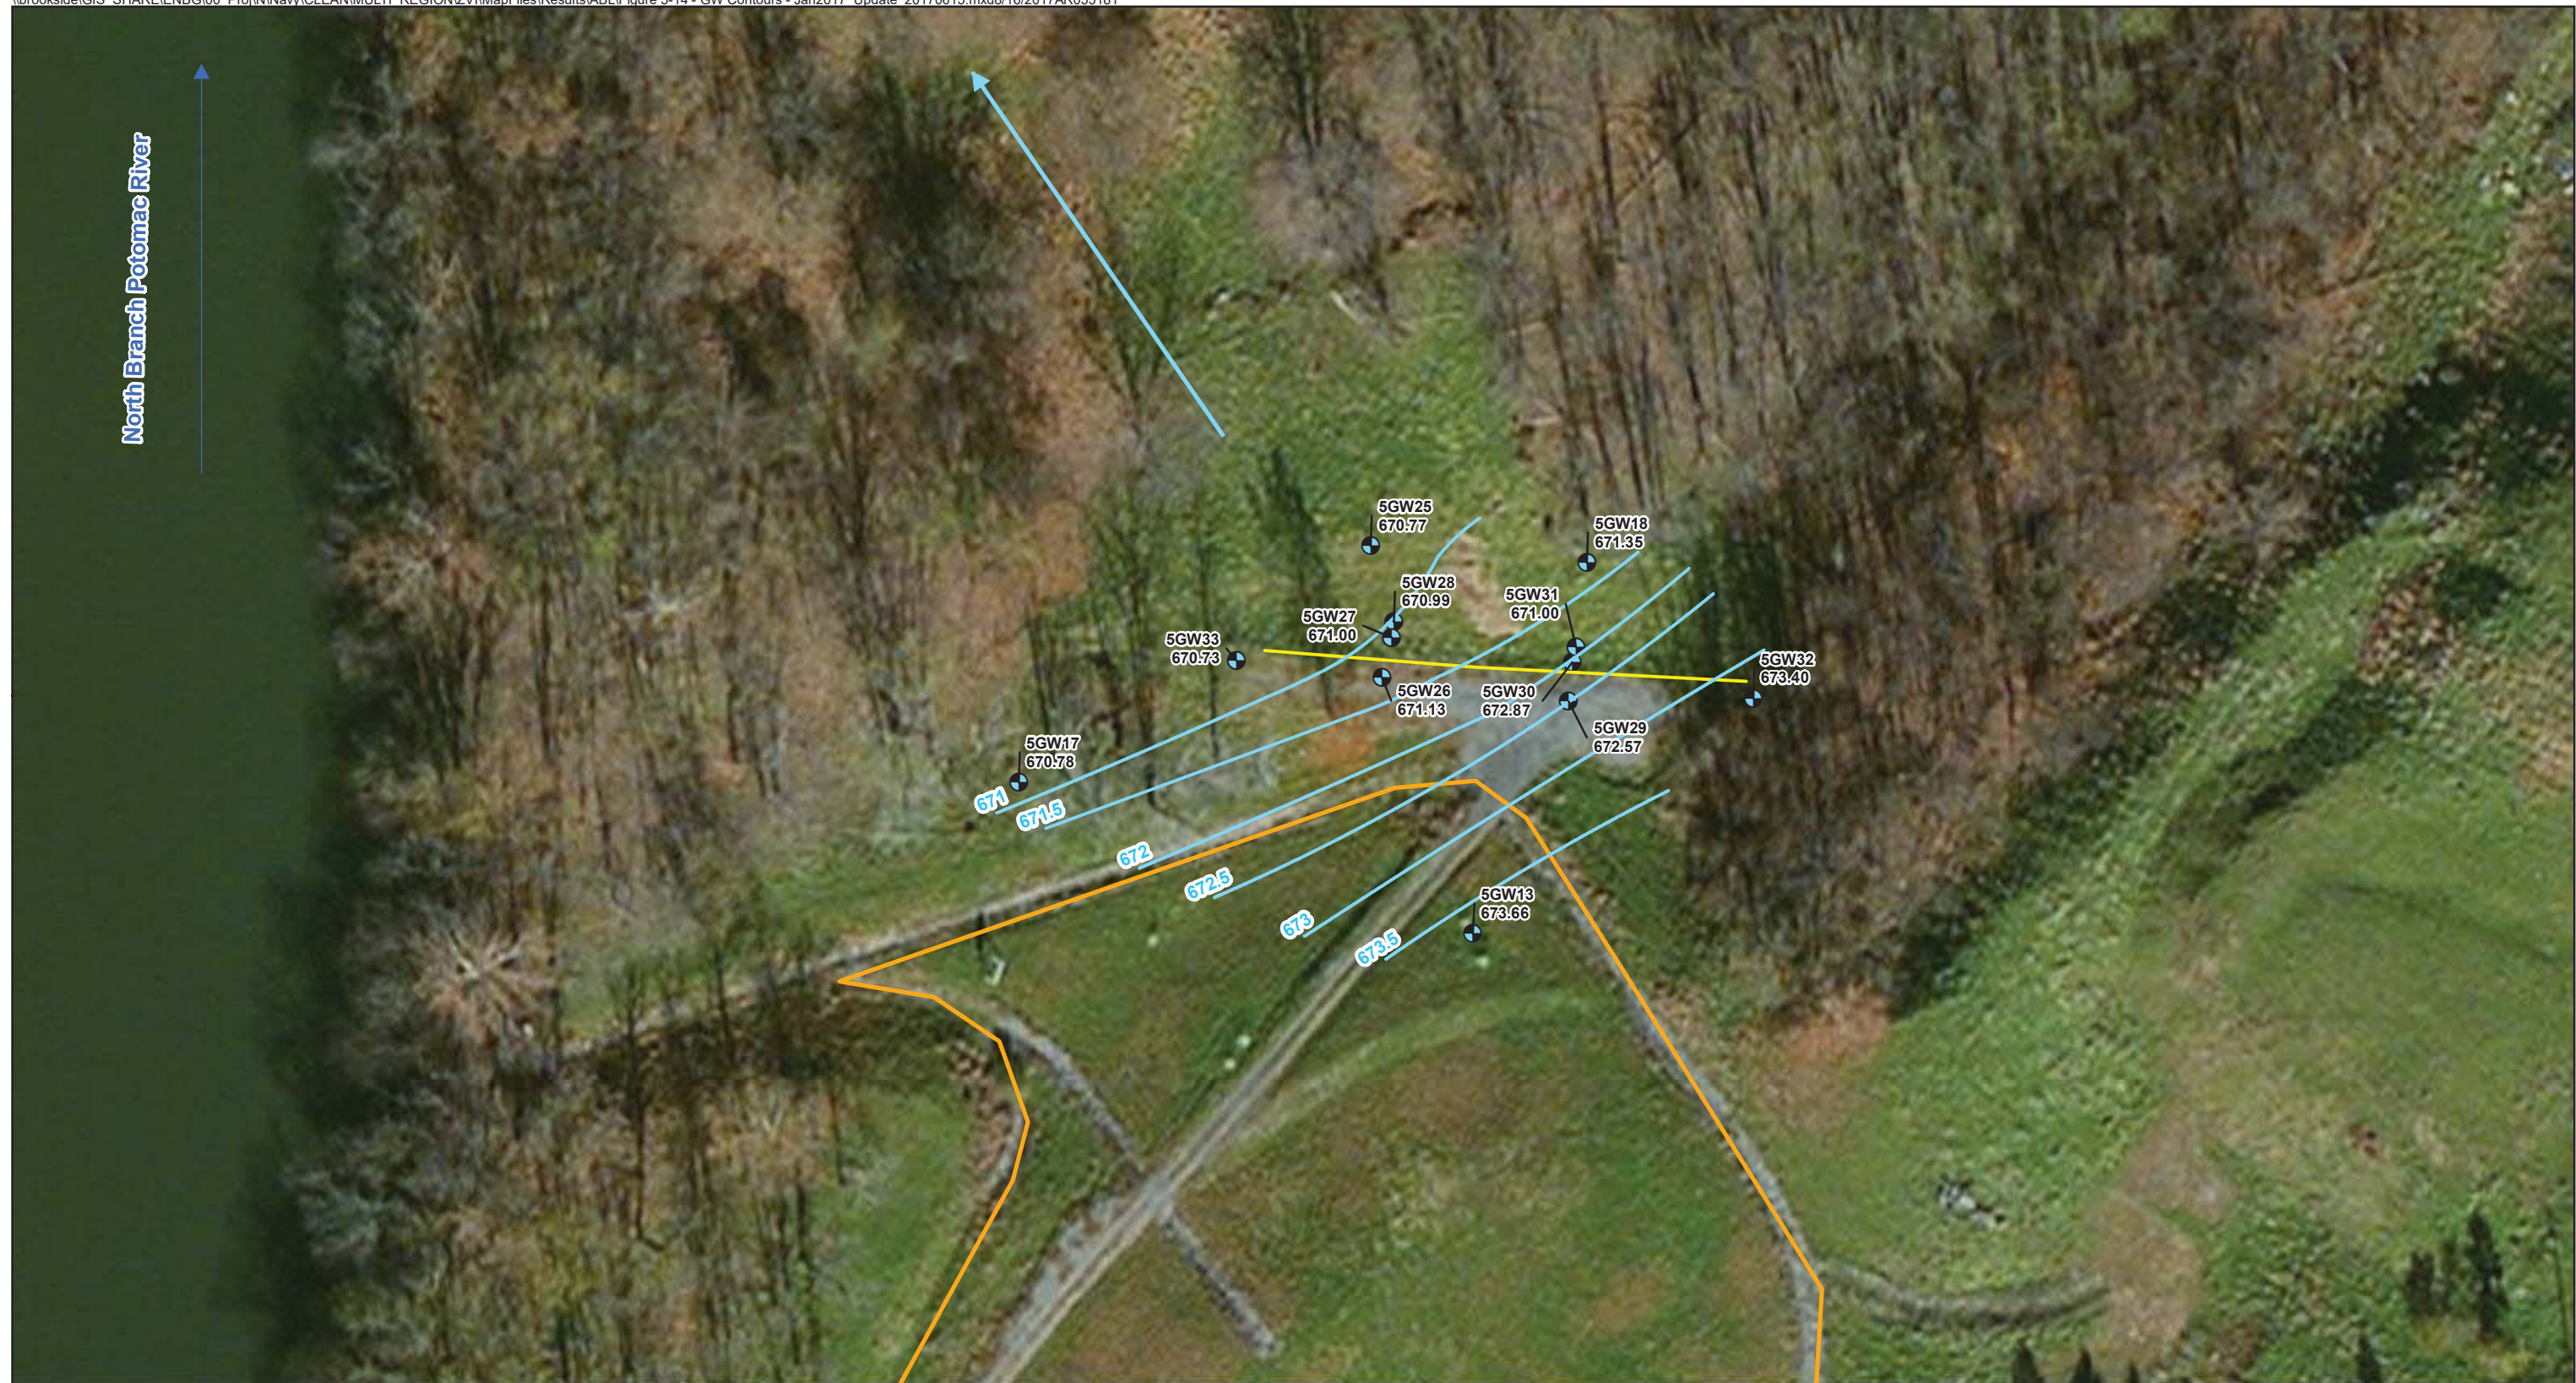
Figure 5-36
Groundwater Contours - January 23, 2017
Allegany Ballistics Laboratory Site 5
Rocket Center, WV

Results of the water level surveys at ABL Site 5 and the former St. Louis Ordnance Plant OUI are shown on **Tables 5-13 and 5-14**, respectively. Maps showing groundwater contours for each of the gauging events at ABL are presented as **Figures 5-36 through 5-38**. Because new wells within the treatment area appeared to have not fully recharged at the former St. Louis Ordnance Plant at the time of the first gauging event, maps are only provided for the last two events. Additionally, because the water levels were significantly different in the two new temporary wells in the treatment area (DP001 and DP002) in comparison to the existing well (MW-119), contours were drawn for three combinations of wells: with all site wells included, with all wells except MW-119 included, and with all wells except DP001 and DP002 included. These figures are presented as **Figures 5-39 through 5-44**.

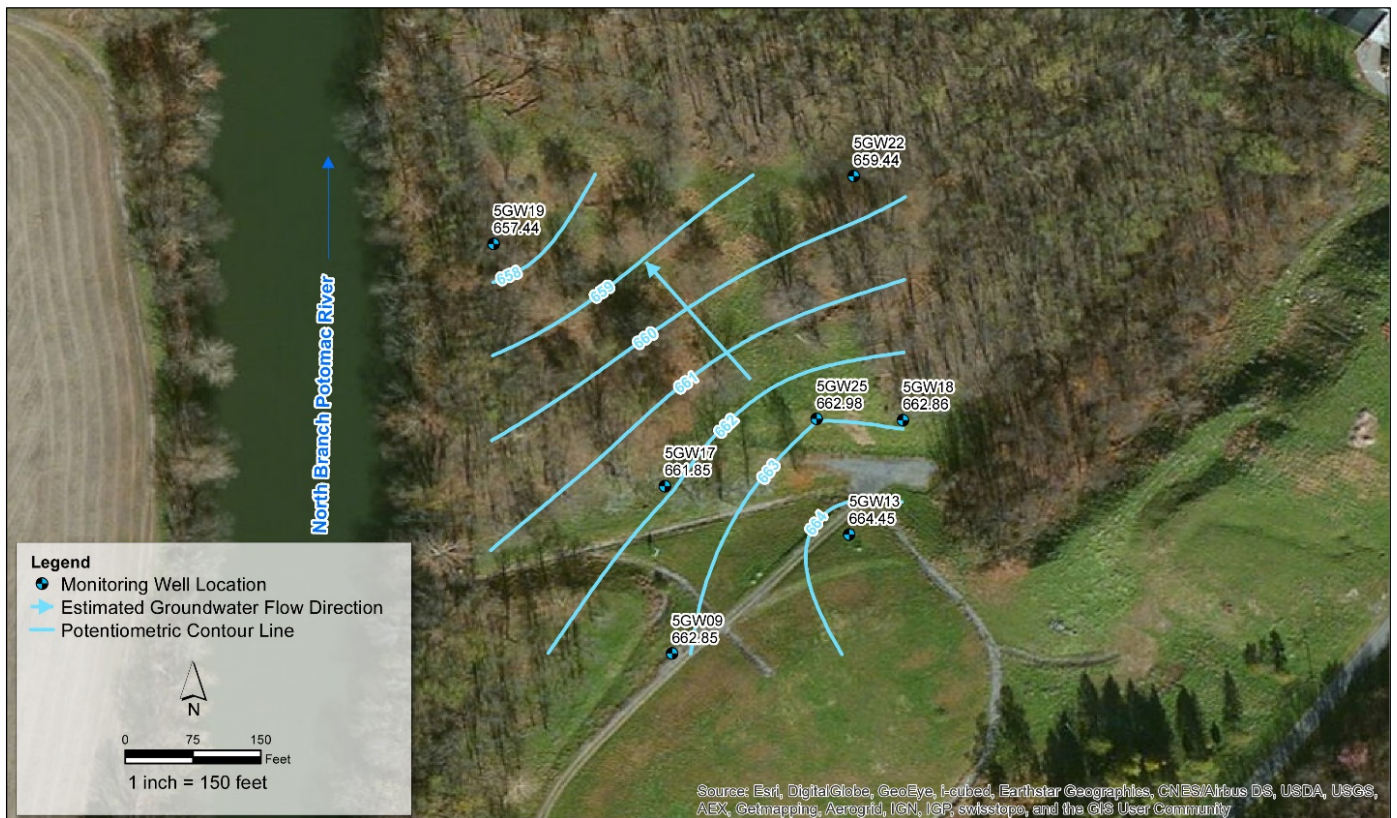
Figure AB-2. ABL Site 5 Groundwater Contour Map (2012)

Site 5 is located on a terrace above the North Branch Potomac River. The Site 5 topography gently slopes toward the North Branch Potomac River then becomes steeper immediately adjacent to the river. Site 5 is underlain by unconsolidated alluvial deposits of fill, silty clay, and clayey gravel (alluvium) and predominantly shale bedrock. The depth to bedrock at Site 5 is approximately 15 to 20 feet below ground surface (bgs). Cross sections and a conceptual site model are provided in **Appendix A**. Shallow (alluvial) groundwater flows northwestward, sub-parallel to the river, eventually discharging to the river at the northern end of Site 5 (**Figure AB-2**). Alluvial groundwater velocity downgradient of the landfill was estimated to be 0.81 feet per day, or 293 feet per year.

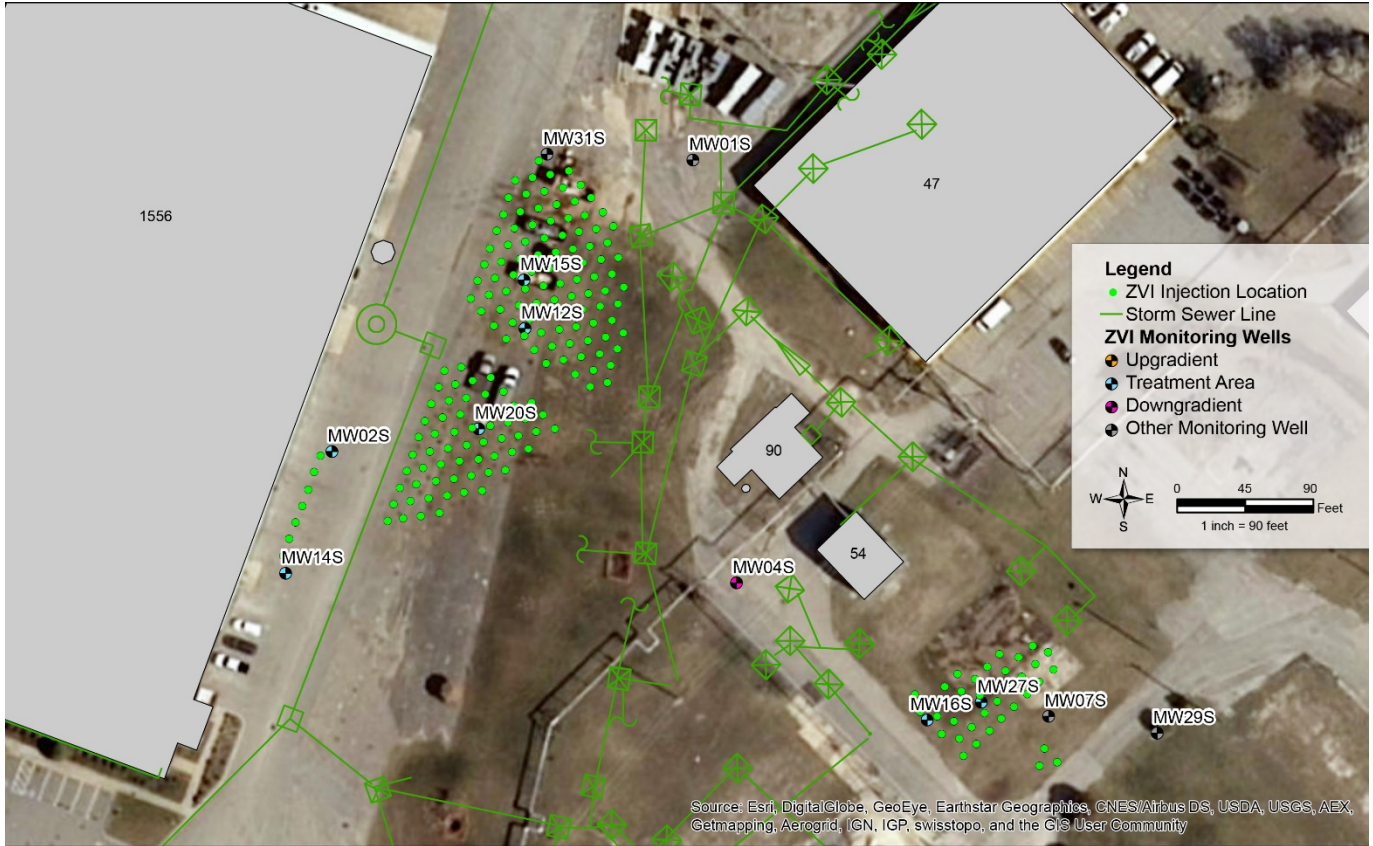
Figure SJ-4. St. Julien’s Creek Site 21 Treatment Area and Wells Included in Desktop Review

ZVI injections began on December 1, 2010 and were completed on February 2, 2011. Because of the depth stratification of the contamination at Site 21, ZVI was injected into the bottom 5 feet of the shallow (Columbia) aquifer in two areas of the site with concentrations greater than 1000 $\mu\text{g/L}$ for any of the site COCs (TCE, cis-1,2-DCE, and VC). The total areal extent of the two ZVI treatment areas was 18,500 square feet. The soil mass within the target treatment zone was estimated to be 5,365 tons (dry weight basis), assuming a soil bulk density of 116 lb/cubic foot. Based on a target ZVI dosage of 0.8 percent (lbs of ZVI per lb of soil), approximately 85,800 lbs of ZVI were determined to be needed for the site. DPT injection points were placed on 9.4-foot centers. This geometry was developed to provide complete coverage of the treated area using an assumed radius of influence (ROI) of 5.4 feet and a 13 percent overlap of treatment areas. Injection locations were placed at least 10 feet from buildings and known utility locations to avoid damage to structures and short-circuiting through preferential flow paths. Two-hundred and two temporary DPT ZVI injection points were completed, as shown in **Figure SJ-4**. The

DPT injection points extended to the Yorktown confining unit at approximately 17 feet bgs. Approximately 425 lbs of ZVI were injected per injection point. ZVI was mixed with water to create a ZVI/water slurry to facilitate injection. The ZVI slurry for injection contained approximately 3 lbs of ZVI per gallon of water. This corresponds to 142 gallons of slurry per injection point. The ZVI/water slurry was delivered using a high pressure injection process (Shaw, 2011a). Because of the potential for daylighting at the site, much of the ZVI was preferentially injected in the bottom five feet of the Columbia aquifer, just above the Yorktown confining unit, where contamination was noted to be at highest concentrations during investigations. Areas of the plume not treated with ZVI were treated with emulsified vegetable oil (EVO) to stimulate reductive dechlorination.

For this study, pre- and post-treatment data from monitoring wells located within the ZVI treatment areas were evaluated. Wells included in the review are shown on **Figure SJ-4** and listed in **Table SJ-1**. Upgradient and downgradient well results are not discussed at length for this site because they were within areas treated with EVO, making it difficult to differentiate between VOC and geochemical changes due to biological versus abiotic (ZVI) processes.

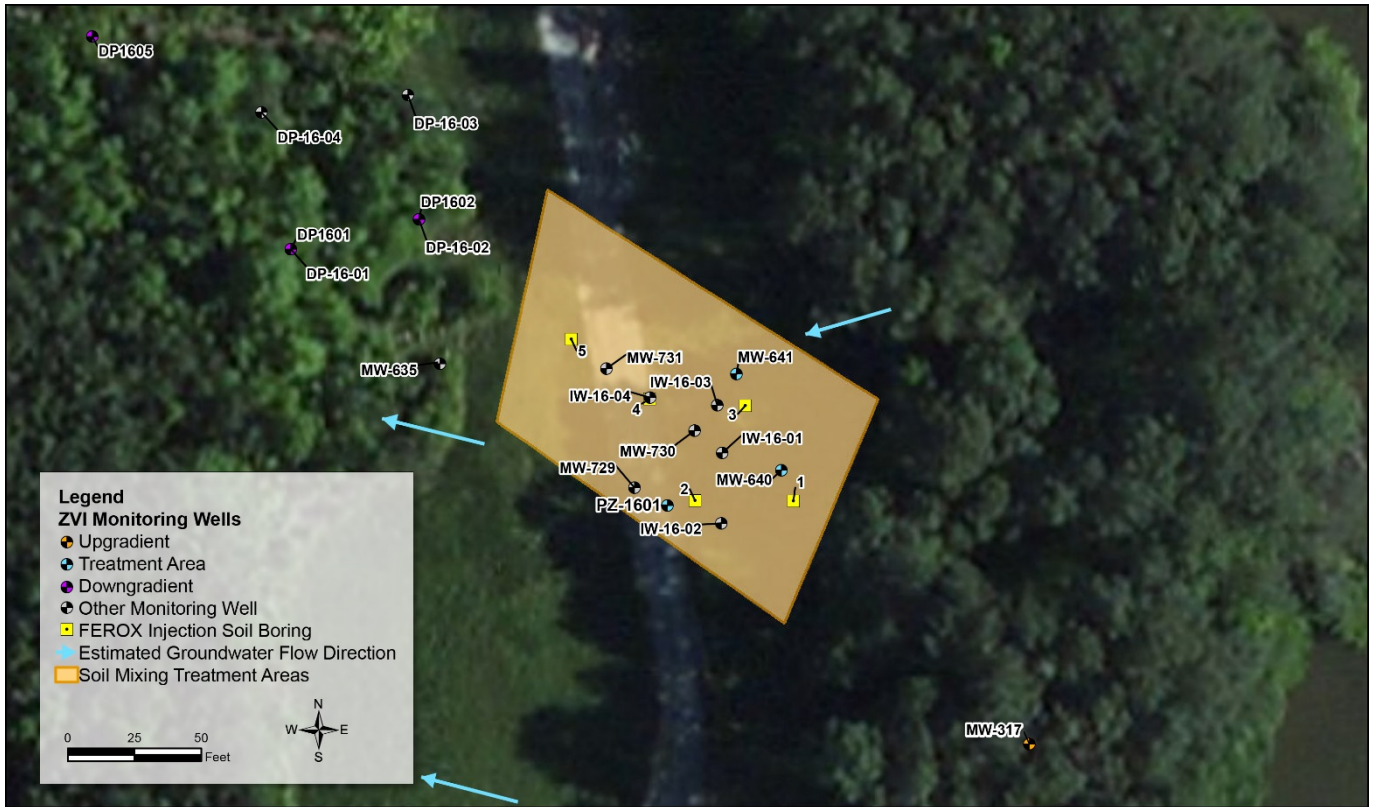
Figure AA-4. Arnold AFB SWMU 16 Treatment Area and Wells Included in Desktop Review

In 2005, a pilot-scale treatability study consisting of subsurface soil mixing with ZVI-bentonite gel injection was performed (EFS, Inc., 2006). The objective of this treatability study was to evaluate the effectiveness of the technology in destroying TCE and $\text{NO}_3/\text{NO}_2\text{-N}$ in groundwater beneath the source area. A slurry of 2376-lb ZVI and 2970-lb bentonite was mixed onsite on a slurry mixing truck to treat each 100-cubic yard batch of soil (representing a dose of 0.8 percent). Slurry material was pumped with a slurry pump through a 4-inch line mounted on an excavator to fill cells. SWMU 16 was separated in cells which consisted of 10-foot by 10-foot, 15-foot deep areas. Each cell equaled approximately 55.55-cubic yards, with a mixing overlap of approximately 1-foot. Mixing was accomplished using a Lang Tool 290-LTC In-Situ blender mounted on a hydraulic excavator (EFS, 2006). The areal extent of the soil mixing area is shown on **Figure AA-4**.

Wells included in this desktop review are included in **Table AA-1** and shown on **Figure AA-4**. Note that the Demonstration Plan indicated that MW-317 would be discussed as an upgradient well. However, this well was only sampled for VOCs, and none were detected. No field data is available for this well. As such, it has been excluded from the discussion.

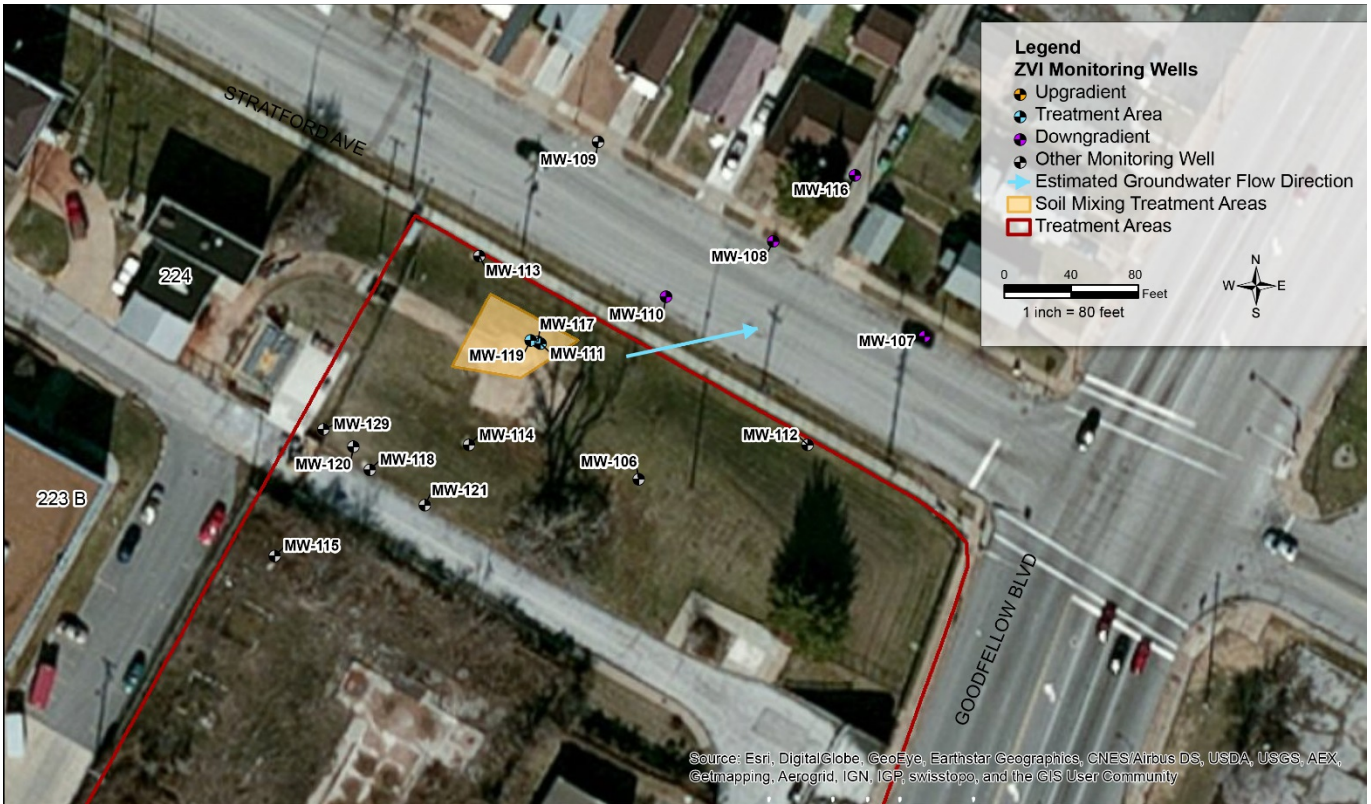
Figure SL-4. St. Louis Ordnance Plant OU1 Treatment Area and Wells Included in Desktop Review

Wells reviewed as part of this desktop study are included in **Table SL-1** and shown on **Figure SL-4**.

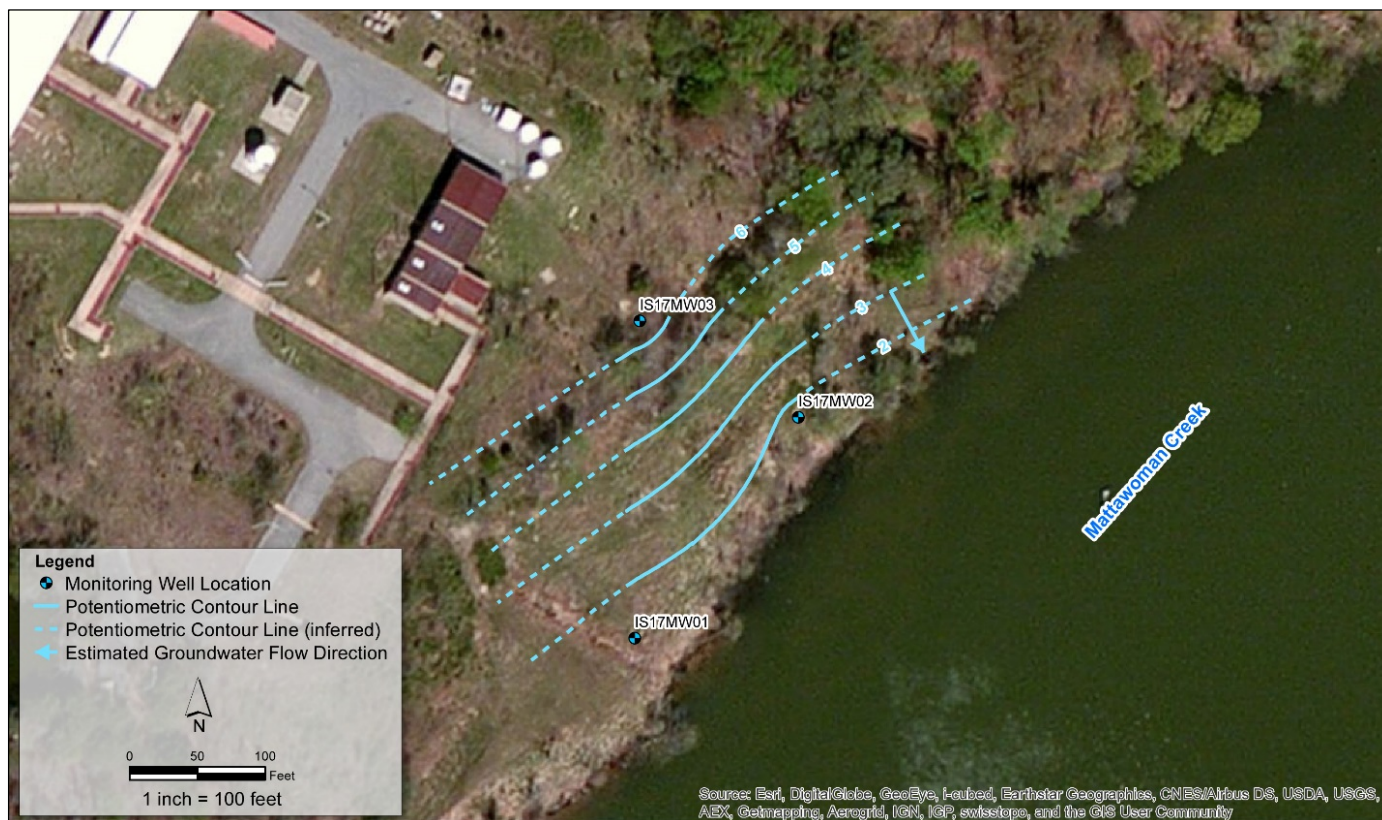
Figure IH-2. Indian Head Site 17 Groundwater Contour Map (2000)

Depth to shallow groundwater is between 5 and 15 feet bgs. Shallow groundwater generally flows from northwest to southeast towards Mattawoman Creek (CH2M HILL, 2013b) (**Figure IH-2**). Groundwater flow velocity was estimated to be between 43 and 400 feet per year (CH2M HILL, 2008c).

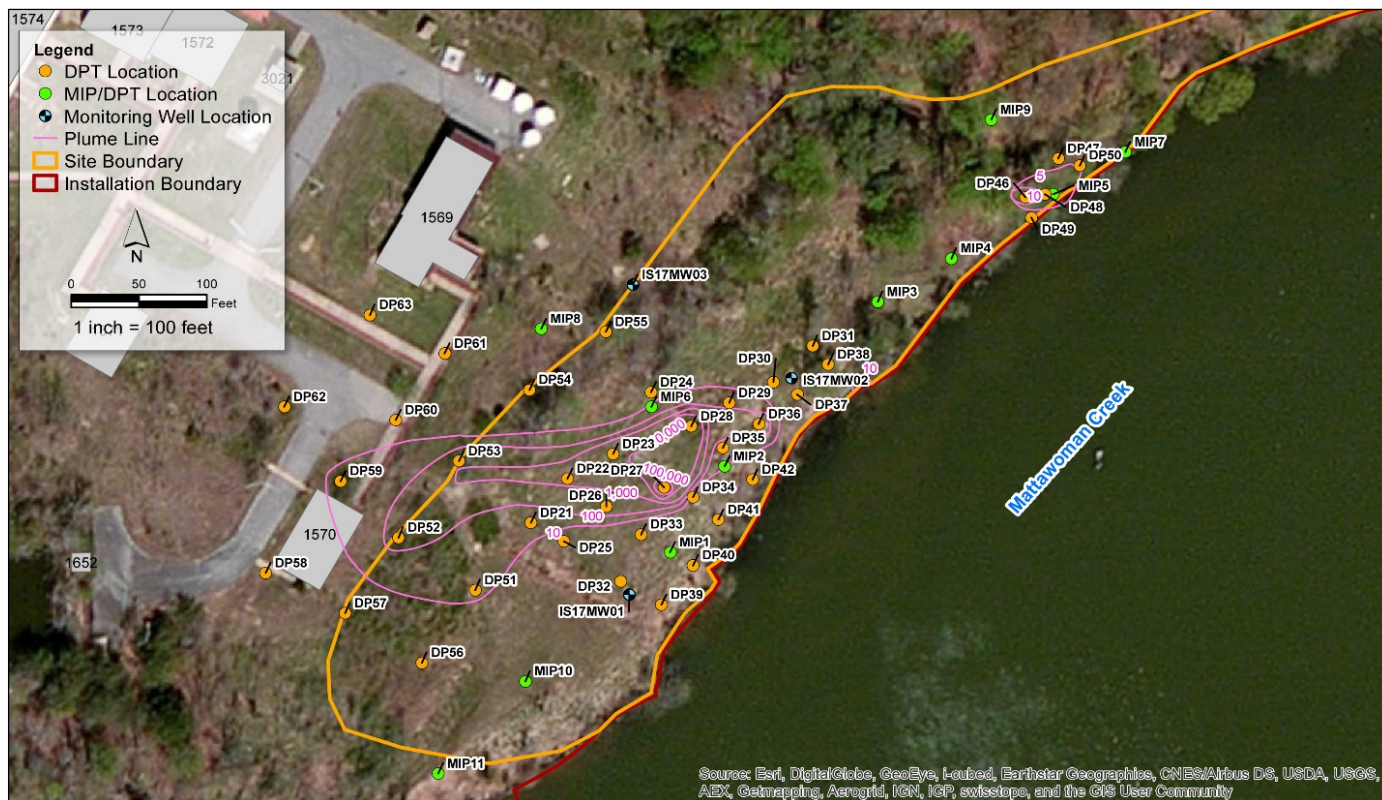
Figure IH-3a. Indian Head Site 17 TCE Plume, Upper Surficial Aquifer (2005)

TCE is the primary contaminant of concern at Site 17 with a maximum concentration of 490,000 $\mu\text{g/L}$ prior to treatment in the upper surficial aquifer and 870,000 $\mu\text{g/L}$ prior to treatment in the lower surficial aquifer (**Figures IH-3a and IH-3b**). Two distinct plumes concentration were identified at the site. The North Plume covered approximately 2,000 square feet and the South Plume covered approximately 38,000 square feet. The North Plume consists primarily of low concentrations of VOCs, while a much higher concentrations of VOCs were observed in the South Plume (CH2M HILL, 2008c).

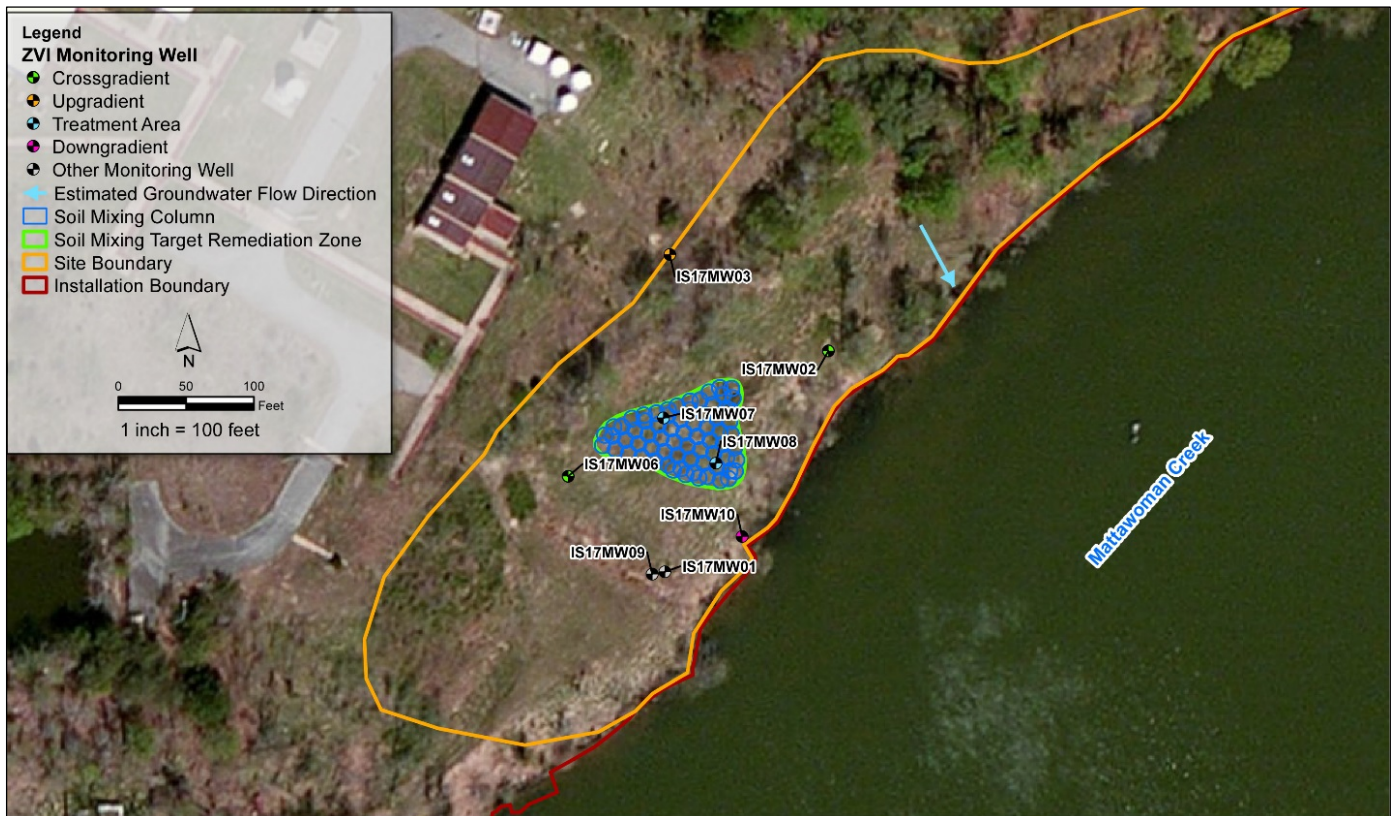
Figure IH-4. Indian Site 17 Treatment Area and Wells Included in Desktop Review

In November 2012, the RA for Site 17 groundwater was completed. ZVI-soil mixing was conducted in the area where TCE concentrations exceeded 1,000 µg/L through the depth interval of 8 feet to 18 feet bgs. The target treatment zone had a surface area of 3,500 square feet and a volume of approximately 1,296 cubic yards. A refined column layout of 70 columns was developed (**Figure IH-4**), and 9-foot augers were used for mixing. Although most of the VOC mass resided within the interval of 8 to 18 feet bgs, soil mixing occurred between 2 feet and 18 feet bgs. Bentonite slurry was mixed at a batch plant onsite and used to facilitate the drilling. A total of 30 tons of bentonite were used; approximately 16 tons were used as part of the 61,500 gallons of slurry while the remaining 14 tons were used in the spoils and top 8 inches of the soil mixing to help dry the spoils and firm up the ground surface. Once the augers had been advanced to 8 feet bgs, ZVI was also added to the slurry to distribute it throughout the treatment zone. ZVI dosing was calculated based on 1 percent ZVI (lbs of ZVI per lb of soil) and an average soil density of 118 pounds per cubic foot (lb/ft³). Between 875 and 1,050 pounds of ZVI were mixed at each typical soil column (CH2M HILL, 2013b).

Data for Site 17 are sparse, with only VOC DPT data available in the source area prior to treatment. For this study, DP27 was used for the baseline data in the treatment area, while IS17-MW07 and IS17-MW08 were used for post-treatment data. The location of IS17MW08 roughly corresponds to the location of former DP27. **Figure IH-4** shows wells to be included in this analysis as well as the location of former DP27. Some data from crossgradient, downgradient, and upgradient wells was reviewed for the purpose of determining baseline geochemistry and effectiveness downgradient, but because of infrequency in data collection in these areas, trends were not assessed.
