ESTCP Cost and Performance Report

(ER-201330)

Rapid Assessment of Remedial Effectiveness and Rebound in Fractured Bedrock

August 2017

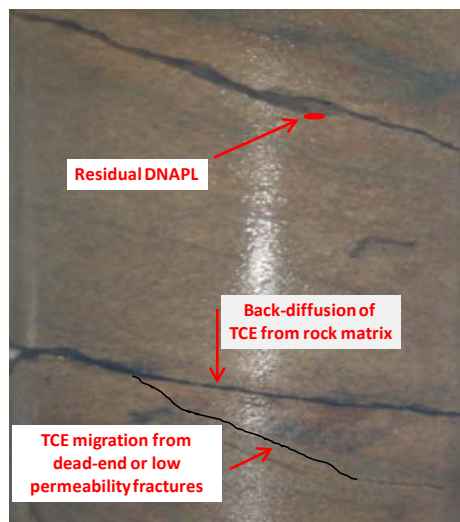
Figure 2.1. Illustration Showing Possible TCE Rebound Mechanisms in Fractured Bedrock.

There are many mechanisms that can contribute to contaminant rebound and sustained groundwater impacts in fractured bedrock aquifers. As illustrated in Figure 2.1, these mechanisms include matrix back-diffusion (Lipson et al., 2005; Sterling et al., 2005; West and Kueper, 2010), slow migration of contaminants from small or microfractures (USEPA, 2006), and/or the presence of DNAPL (Schaefer et al., 2012). For many sites, it is difficult to determine which of these mechanisms is responsible for the observed rebound (if rebound occurs), as the complexities associated with the flow field, aperture distribution, and contaminant distribution within the bedrock aquifer are difficult to quantify. Furthermore, many pilot tests are impacted by upgradient sources that migrate into the treatment area prior to evaluating rebound mechanisms, thereby preventing proper assessment of rebound during the post-injection period of the pilot test. The ability to isolate the treatment area to eliminate upgradient impacts would improve the ability to assess remedial effectiveness during pilot tests. However, approaches for comprehensively and cost effectively characterizing fractured bedrock aquifers to quantify these impacts have hitherto not been demonstrated.

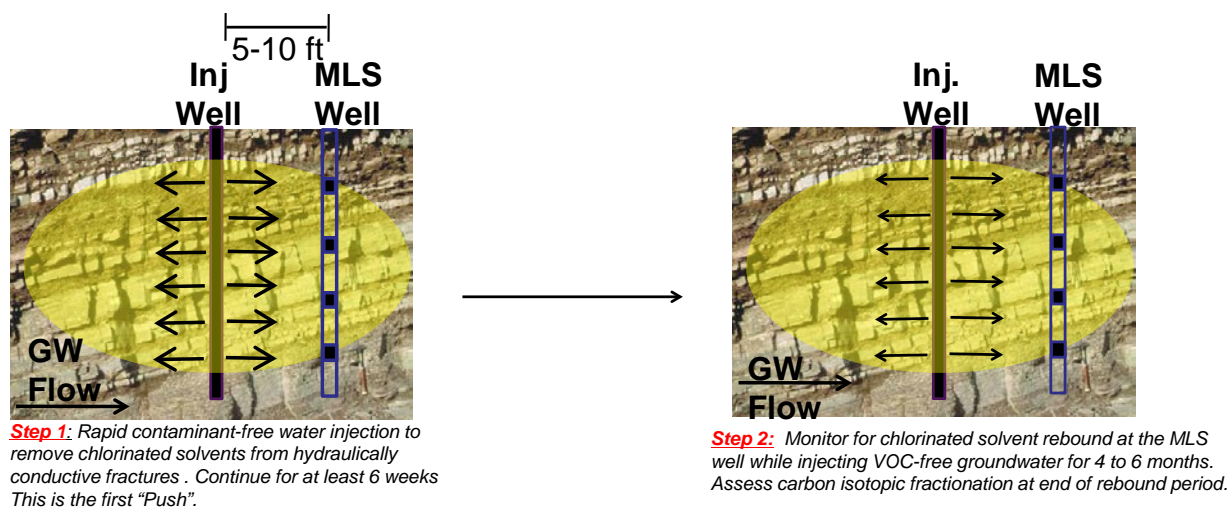
Figure 2.2. Conceptual Methodology for RA Testing.

A demonstration of a novel RA technique, coupled with the use of a multilevel sampling well and CSIA, was employed for use as a rapid and cost-effective means to assess the limits of *in situ* remediation in fractured rock systems. The overall approach is to rapidly remove TCE in conductive fractures in or near the source area, then measure the rate and extent of contaminant rebound after oxidant removal. A conceptual diagram of the process is provided in Figure 2.2. The RA technique involves the use of two wells: a standard injection well and a multi-level sampling (MLS) well located approximately 5 to 10 feet downgradient of the injection well. In the first step of the test, either a chemical oxidant (e.g., permanganate) or uncontaminated water is injected into the injection well to rapidly remove PCE/TCE from the hydraulically conductive fractures. For the NAWC site, permanganate was injected and allowed to incubate for several weeks prior to subsequent water injection to remove the permanganate. However, due to the difficulties associated with the oxidant, only water flushing was used in the subsequent test performed at CPP, as illustrated in Figure 2.2. This initial step of removing the chlorinated solvents from the hydraulically conductive fractures is the first injection phase of the test.

To illustrate the concept, a simplified homogeneous flow regime is shown. The distance between the injection and MLS well may be increased depending upon the groundwater velocity, fracture connectivity, and fracture porosity.

Once baseline sampling was complete, the field testing was started. The initial rapid flushing step (Figure 2.2) was intended to remove dissolved chlorinated solvent mass from the hydraulically conductive fractures, with a target of 99% decrease in concentration. Rapid flushing was performed by injecting potable water into injection well MW07-05R at a constant rate of approximately 300 mL/min for a total of 43 days. The two MLS well intervals (MW07-46R-S and MW07-46R-D) were monitored to assess contaminant flushing from the water bearing fractures between the wells.

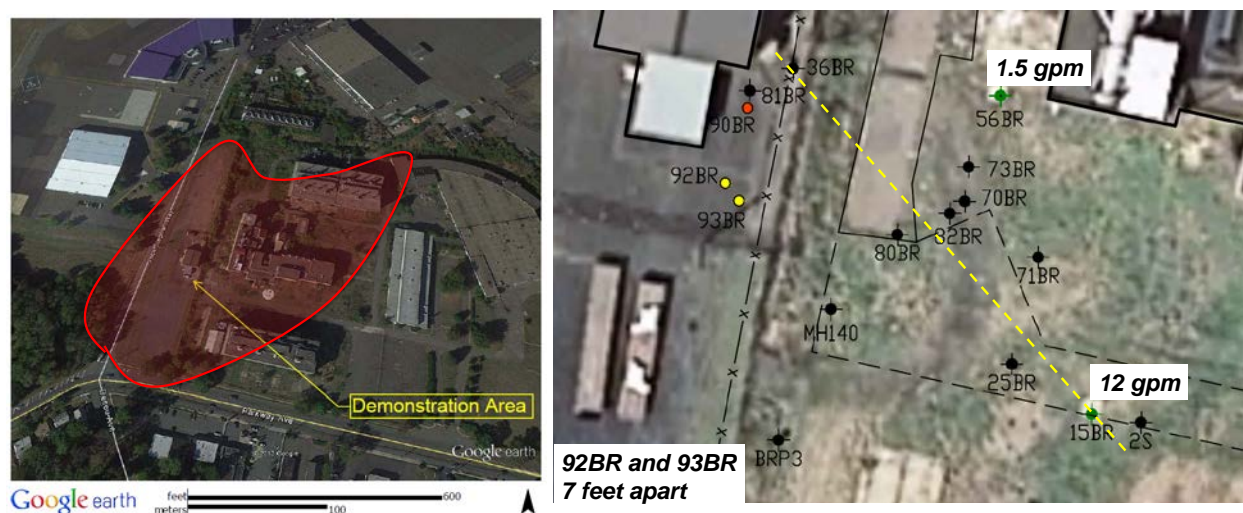
Figure 4.1. Demonstration Location at the NAWC Site.

The shaded area represents the bedrock TCE plume, where TCE is present at detectable concentrations (left). Demonstration wells (92BR and 93BR) and other local bedrock wells also are shown (right).

The NAWC, shown in Figure 4.1, is located in West Trenton, New Jersey. The approximately 67-acre site, used as a jet-engine test facility beginning in the 1950s, was decommissioned in 1998 (http://nj.usgs.gov/nawc/site_description.html). Past activities at the site lead to the release of TCE, jet fuel, and other chemicals into the subsurface. Portions of the site have been sold to commercial developers, but the majority of the site remains undeveloped.

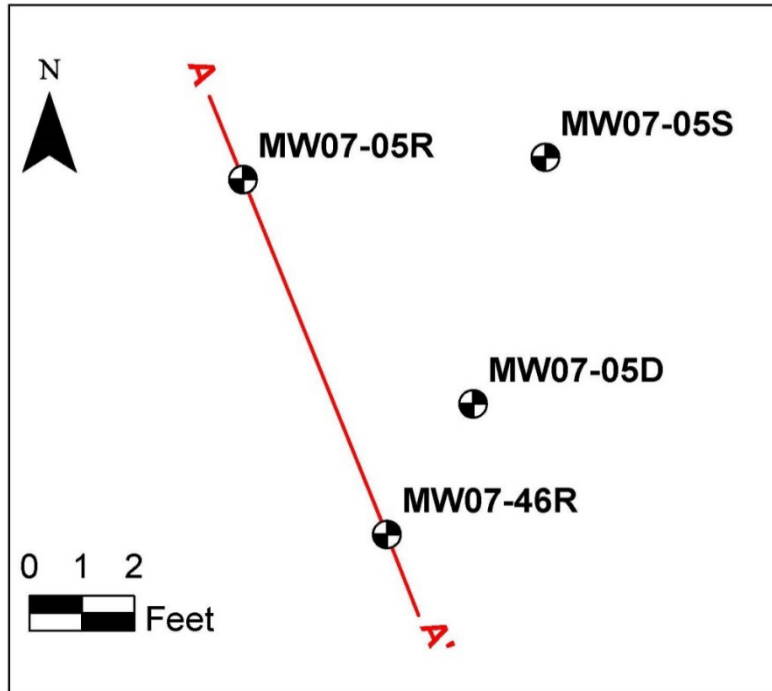
Figure 5.1. CPP Demonstration Area with location of newly installed borehole (MW07-46R) identified (approximately eight feet from existing well MW07-05R).

Characterization activities included drilling and coring one borehole located approximately eight feet downgradient from existing bedrock well MW07-05R. The newly installed open-borehole well was designated MW07-46R, and its location is shown in Figures 5.1 and 5.2.

The RA technique at CPP involved the use of two wells: existing bedrock monitoring well MW07-05R that was used as the injection well, and bedrock MLS well MW07-46R located approximately 7.5 ft downgradient of the injection well (Figures 5.1 through 5.3). The MLS well consisted of a packer system within the borehole to discretely sample two water bearing zones within the targeted treatment interval. The depth interval used for the MLS well was selected based on the anticipated fracture flow path emanating from the injection well. Monitoring of rebound at the MLS well facilitated assessment of the contaminant distribution within the treatment zone.

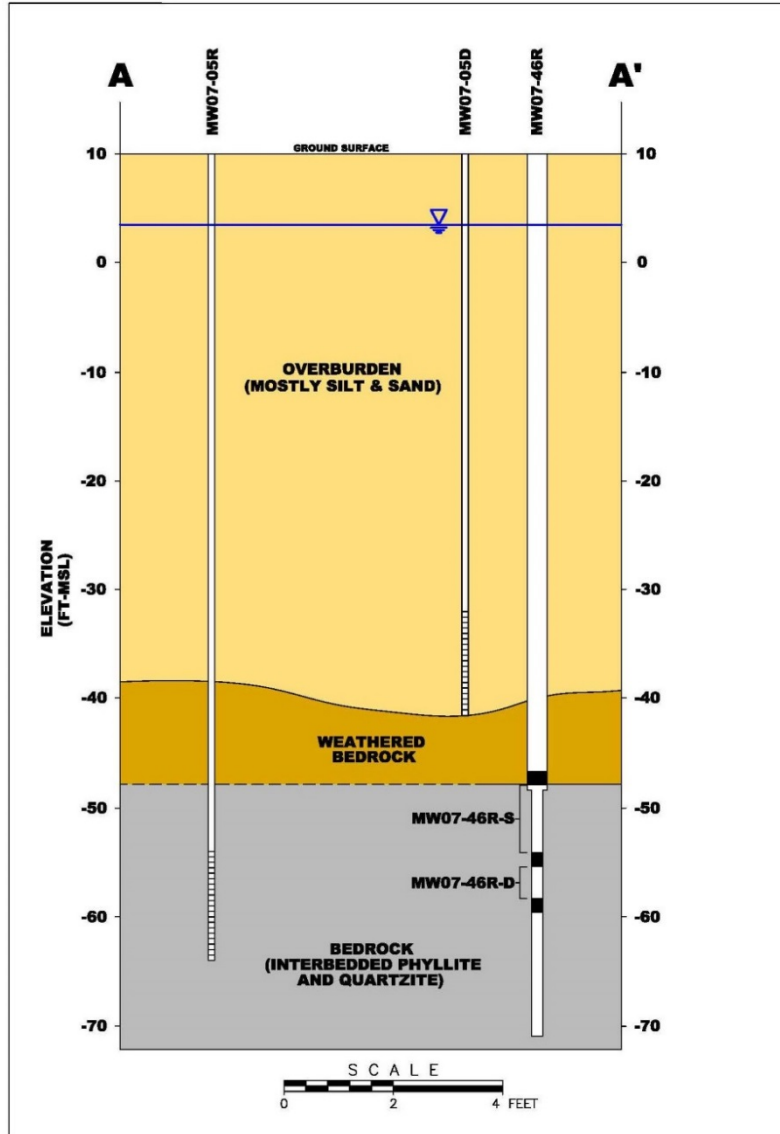
Figure 5.3. Generalized Geologic Cross-Section of the CPP Demonstration Area.

During installation of monitoring well MW07-46R, rock cores were collected in approximately five-foot lengths from 58.3 to 80.6 ft bgs using a triple tube wire line PQ Core Barrel system for the collection of minimally disturbed 3.25-in diameter rock cores. The PQ coring system created a nominal 4.8-in diameter core hole. The rock core collected consisted of interbedded quartzite and phyllite. A generalized geologic cross-section of the demonstration area is provided in Figure 5.3. Visual logging of the rock core indicated that several water-bearing fractures were located between 58.3 and 63 ft bgs, and very few fractures were noted between 63 and 80.6 ft bgs.

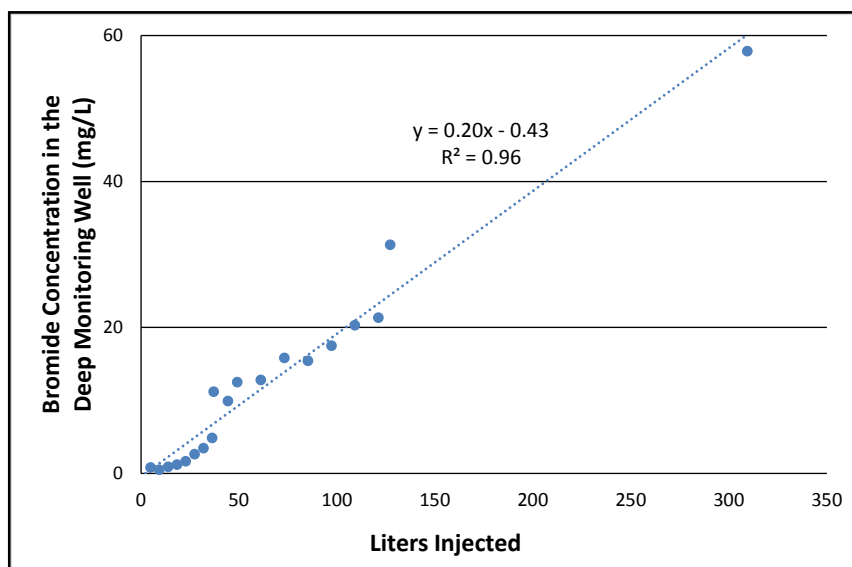
Figure 5.4. Increases in Bromide Concentration in the Deep Interval of MW07-46R as a Function of Volume Injected into MW07-05R.

Bromide data for the shallow and deep intervals for MW07-46R are provided in Figure 5.4. No measurable bromide was observed in the shallow, indicating that no significant flow path (despite observing a hydraulic connection during the short-term pumping tests) exists between the injection well (MW07-05R) and the shallow interval of MW07-46R.

The dashed line shows the linear regression to the data.

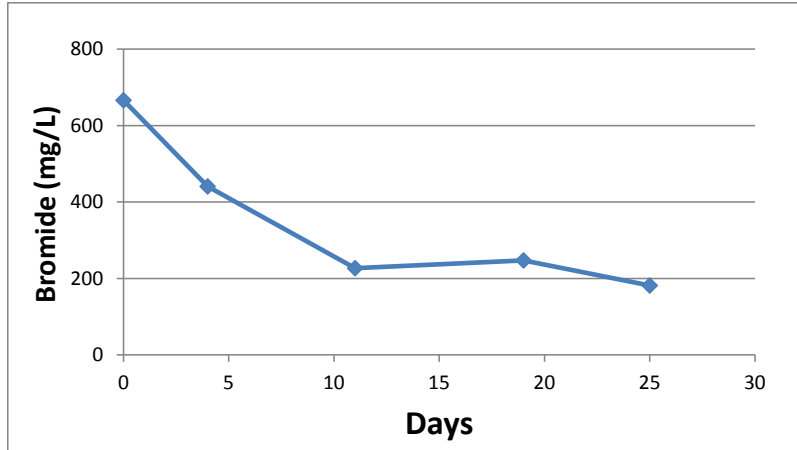
Figure 5.5. Results from the Borehole Dilution Testing Performed in the Injection Well (MW07-05R).

A borehole dilution tracer test (Pitrak et al., 2007) was performed at injection well MW07-05R to verify the ambient groundwater flow rate through the injection well. A 250 mL solution containing 8.9 grams of sodium bromide (NaBr) was added to the 11-ft interval below the packer in this well to achieve a target bromide tracer concentration in the water column of 500 mg/L. Immediately following the addition of the bromide tracer, water was recirculated within the well to sufficiently mix the bromide tracer within the interval. Bromide samples were collected from MW07-05R after recirculation (time=0), and on days 4, 11, 19, and 25. These data are presented in Figure 5.5.

The rate of decay of bromide from the injection well provides an estimate of the Darcy velocity. The Darcy velocity is calculated as follows (Pitrak et al., 2007; Nordqvist et al., 2008):

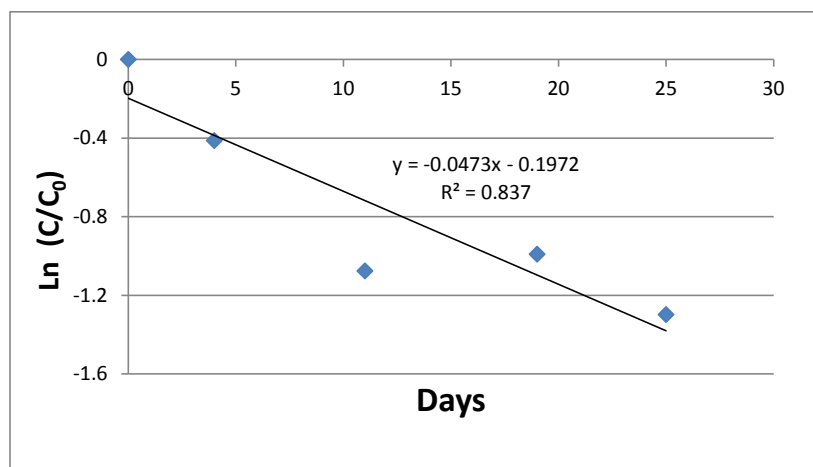
Figure 5.6. Linear Regression of the Bromide Data from the Borehole Dilution Test Performed at MW07-05R.

The bromide data are plotted in the form of Eq. 4 to facilitate determination of the ambient water flow rate into the borehole via linear regression. The linear regression to the data is represented by the solid line.

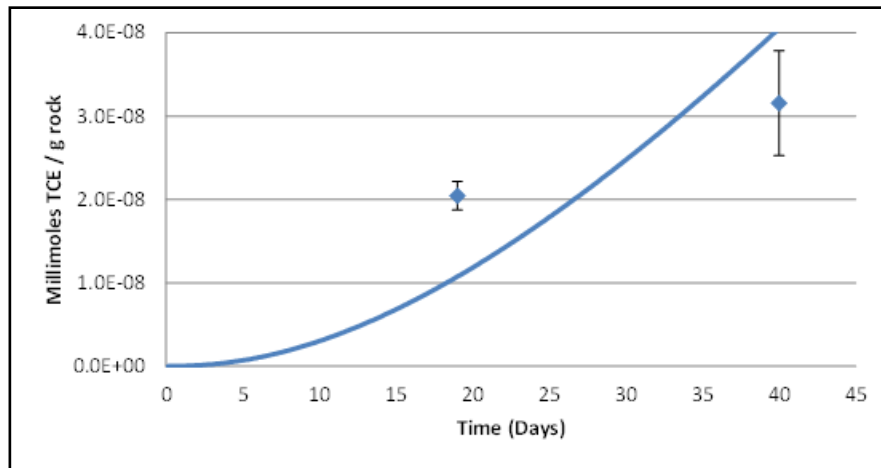
Figure 5.7. Abiotic Dechlorination of TCE in the Bench Scale Batch Testing.

Results of the abiotic batch dechlorination testing showed that abiotic dechlorination transformation products ethane and propane were generated in the TCE-spiked vials, consistent with previous abiotic testing in bedrock (Schaefer et al., 2013, 2015). Results plotted at total millimoles of TCE per gram of rock transformed are provided in Figure 5.7. Using a trial-and-error approach to estimate (within a factor of two) the first-order TCE transformation rate constant via application of a coupled diffusion and first-order TCE transformation model (Schaefer et al., 2013) yields a rate constant of $2.7 \times 10^{-8} \text{ s}^{-1}$. These results indicate that abiotic dechlorination of TCE occurs within the rock matrix. This information was used to develop the model and to provide insight regarding observations made during the field demonstration.

Total TCE transformation was based on the generation of ethane and propane. Error bars represent 95% confidence intervals. Only data from two of the three replicates was used, as one of the replicates exhibited clear indications of leakage. The solid line represents the model regression (Schaefer et al., 2013, 2015) to the data.

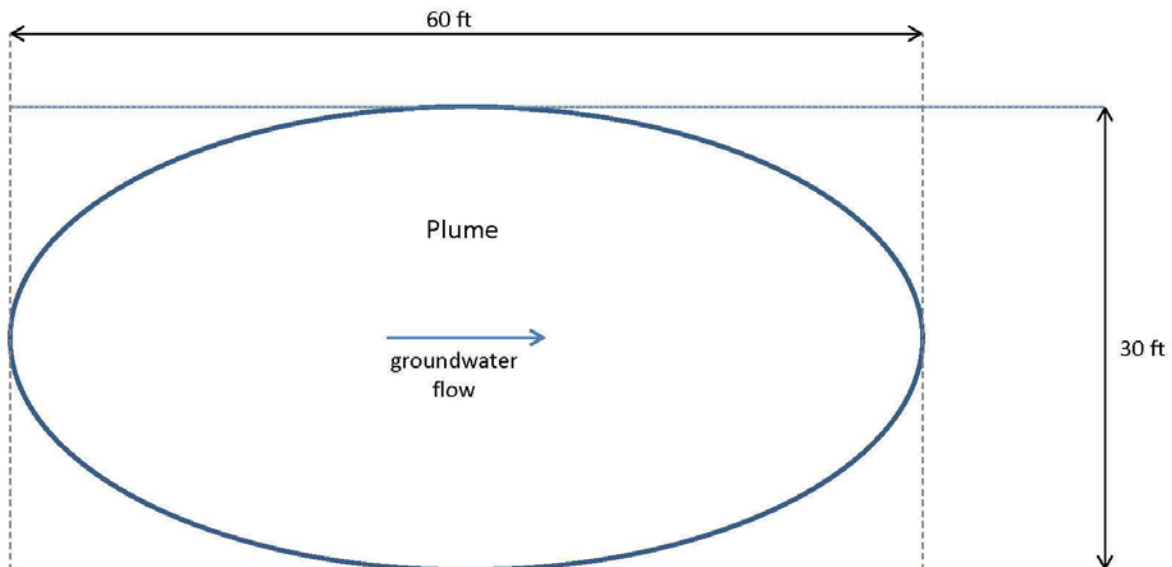
Figure 7.1. Base Plume Characteristics

The base case presented in Krug et al. (2009) is modified as a template for the cost analysis of the above technologies/approaches. The base case presents a situation where a bedrock aquifer contains a dissolved TCE source area extending to 75 ft bgs and is 60 ft long and 30 ft wide, perpendicular to groundwater flow (Figure 7.1). The specific base case site characteristics, including aquifer characteristics and design parameters for each of the remedial assessment approaches analyzed, are summarized in Table 7.2.

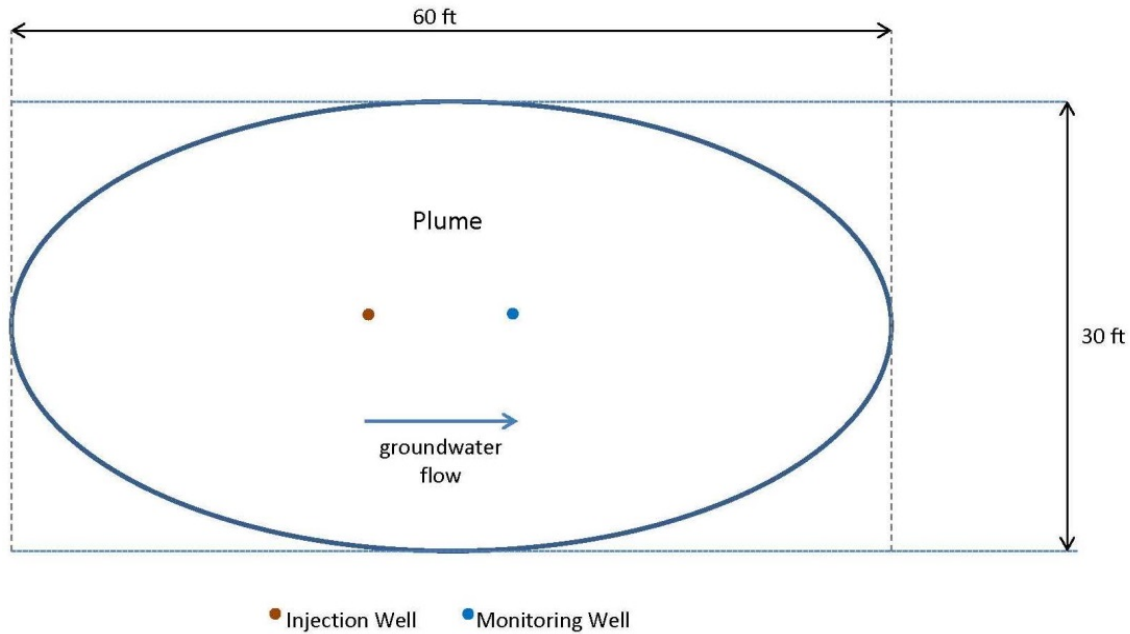
Figure 7.2. Rapid Assessment Technology Approach

The RA alternative assumes that one injection and one monitoring well will be installed in the source area as shown in Figure 7.2. The alternative will be operated as it was at CPP, discussed earlier in this document, with an operational period of six months.

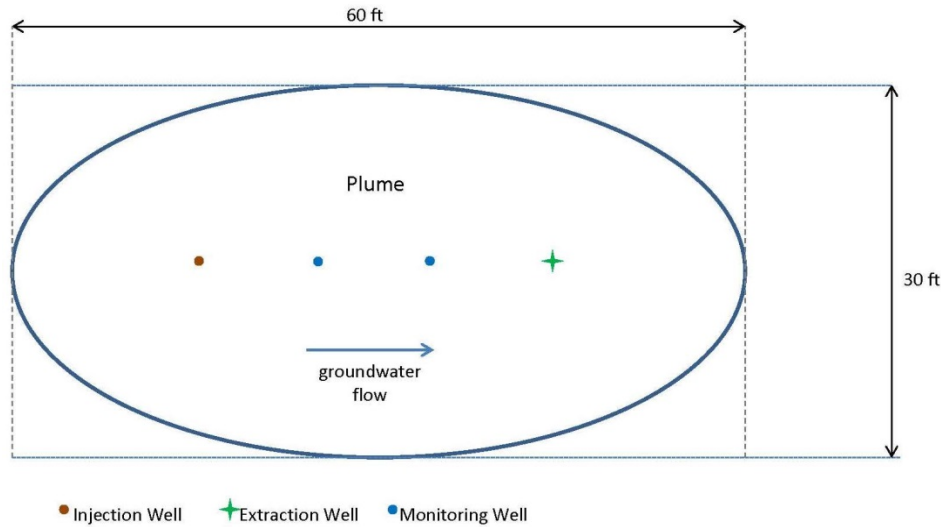
Figure 7.3. Bioremediation Recirculation Pilot Study

The Bioremediation Recirculation System alternative assumes that one injection and one extraction well will be installed in the source area as shown in Figure 7.3, with two monitoring wells in between along the groundwater flow path. Groundwater will be recirculated between the extraction and injection wells, and substrate added periodically over a period of one year, after which time the system will be shut down and a six month-long rebound assessment period will commence.
